DAMAGE EVALUATION OF SMART CFRP-PIEZOCERAMIC-MATERIALS USING NON-DESTRUCTIVE METHODS

Gerhard Mook , Juergen Pohl, Fritz Michel, Thomas Benziger

*Institute of Materials Engineering and Materials Testing
The Otto-von-Guericke-University
GPO Box 4120, D-39016 Magdeburg*

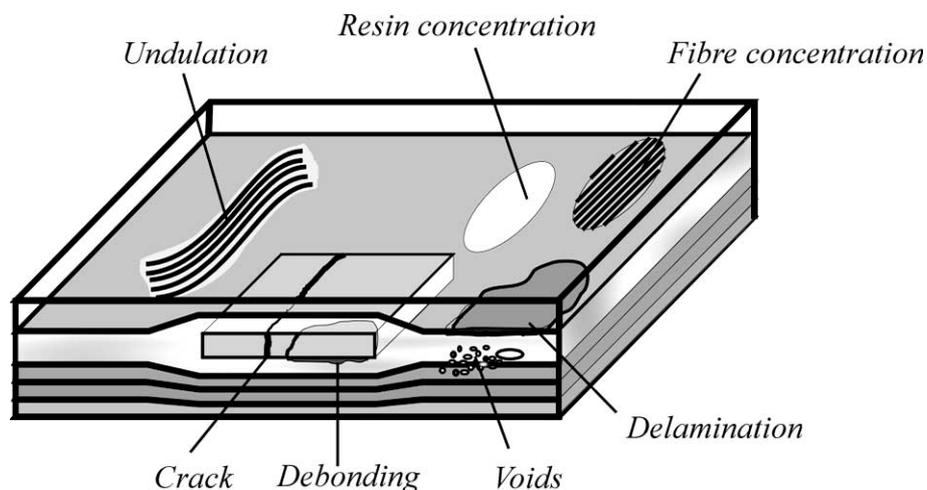
The scope of properties to be evaluated includes the internal structure of the composite (fiber orientation, ply sequence, sensor and actuator position, local fiber or epoxy concentrations), planar flaws oriented parallel to the surface (delamination, ceramic debonding), perpendicular oriented flaws (cracks of the matrix or of the patches) and volume imperfections (pores, voids, inclusions). Some typical imperfections in the smart material system are shown in Figure 2.

Fig. 2: Typical imperfections after manufacturing of a CFRP laminate with embedded piezoceramic patch

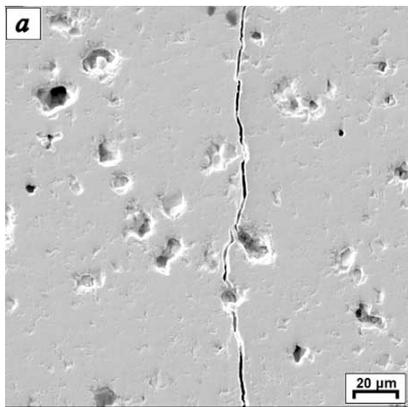
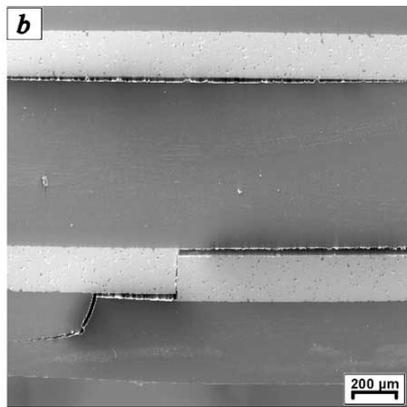
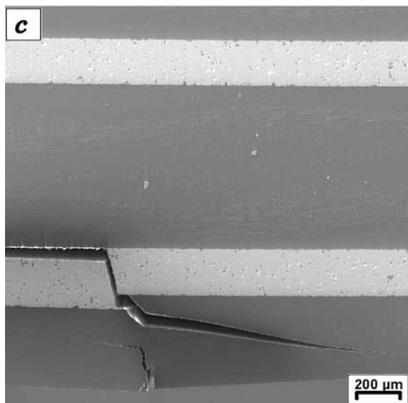
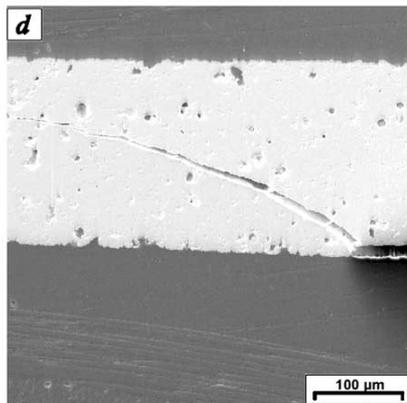
The bending test yields information on the behavior of the piezoceramics and the surrounding interface under tension and compression load. From the SEM images in Figure 6 the damage progress with increasing load (see marks in Figure 5) can be described as follows:

a) crack initiation in the tension stressed piezoceramic patch accompanied by first acoustic emission (AE) signals,

b) delamination without cracking in the compression zone with increasing AE,

c) crack initiation in the insulation fleece and propagation into the matrix and the carbon fibers,

d) crack propagation in the compression stressed piezoceramic patch.

Fig. 6: SEM images of damage propagation within CFRP containing two embedded piezoceramic patches during in-situ bending

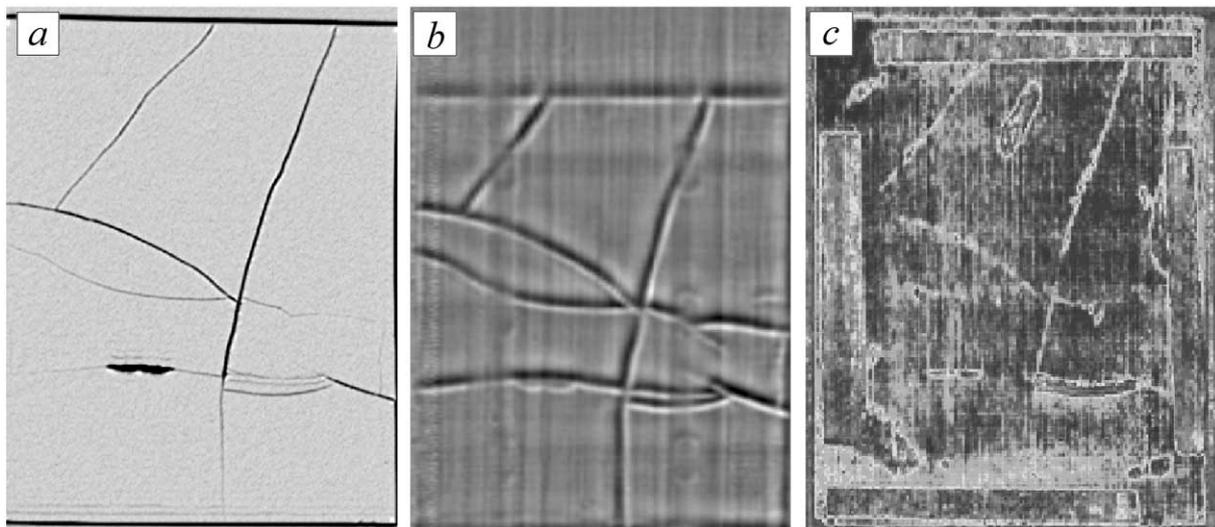
Figure 7 presents images of a cracked actuator in the laminate. The patch was broken before embedding into the laminate. Figure 7a results from an X-ray procedure using special aperture to limit the radiation to the actuator area. The eddy current image 7b reflects the metallic coating of the actuator and the CFRP layer. Since the metallic layer does not cover the ceramic patch completely, crack areas in the upper part remain unnoticed. The ultrasonic image 7c shows rectangular areas near the edges of the piezoceramic patch from adhesive tapes for fixing the broken actuator. Furthermore, the crack-network becomes partly visible.

Fig. 7: Fracture of embedded piezoceramics: a) x-ray, b) eddy current and c) ultrasonic images

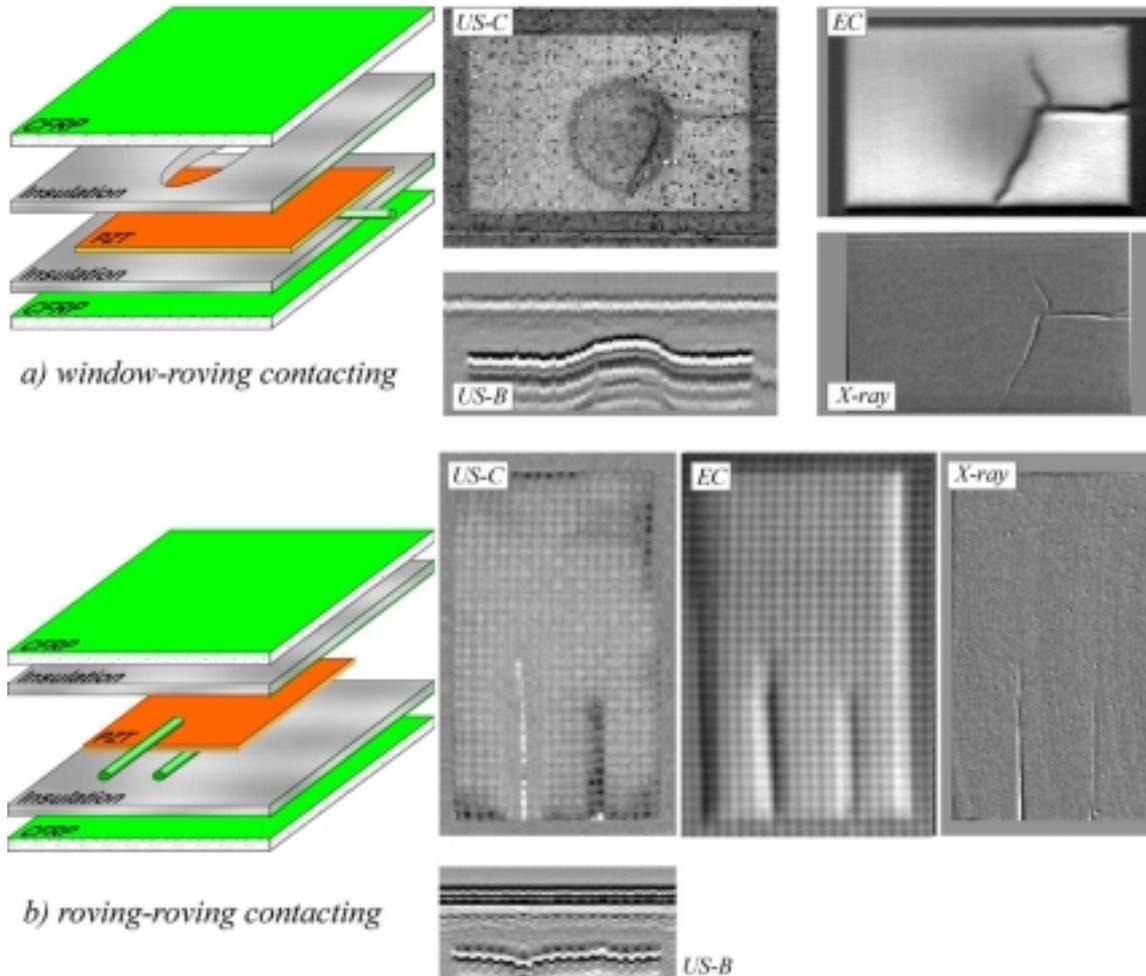
Fig. 8: Actuator deformation and cracking caused by conductor rovings

A very sensitive point is the contacting of actuators because it also may damage them during autoclave curing. First kind of contacting are dedicated windows in the insulation fleece as shown in figure 8a. The conducting CFRP layer acts as the common electrode for some actuators. The contact window causes an actuator deformation at curing. The resulting stresses deform the actuator and even may induce cracks. US-C-scan indicates this deformed area due to reduced time of flight of longitudinal waves. The degree of deformation can be measured in the US-B-scan with an accuracy up to 20 μm . Additionally, US-C-scan shows some branches of a crack and the contacting carbon fiber roving. EC image clearly makes visible the cracks and indicates the deformation as dark area due to the reduced distance between the actuator and the probe. X-ray image brings up the cracks but cannot detect the deformation.

A second kind of contacting are dedicated rovings (fiber bundles). Figure 8b presents the ply sequence around an actuator. Although being very thin and flexible, these rovings also lead to an inhomogeneous pressure distribution during manufacturing. Local pressure concentration around the rovings may induce cracks in the ceramic patches. US-C-scan shows the contacting carbon fiber roving above and below the piezoceramic as bright and dark lines [7]. This is even better visible in the US-B-scan which permits reconstruction of the layer structure in a cross section plane. Here, the obvious changes in actuator direction indicate cracking. EC technique indicates good conducting metal coating of the actuator as bright square. Cracks can be seen as dark lines. Although remaining unaffected by carbon fiber material, the X-ray image clearly shows both cracks.

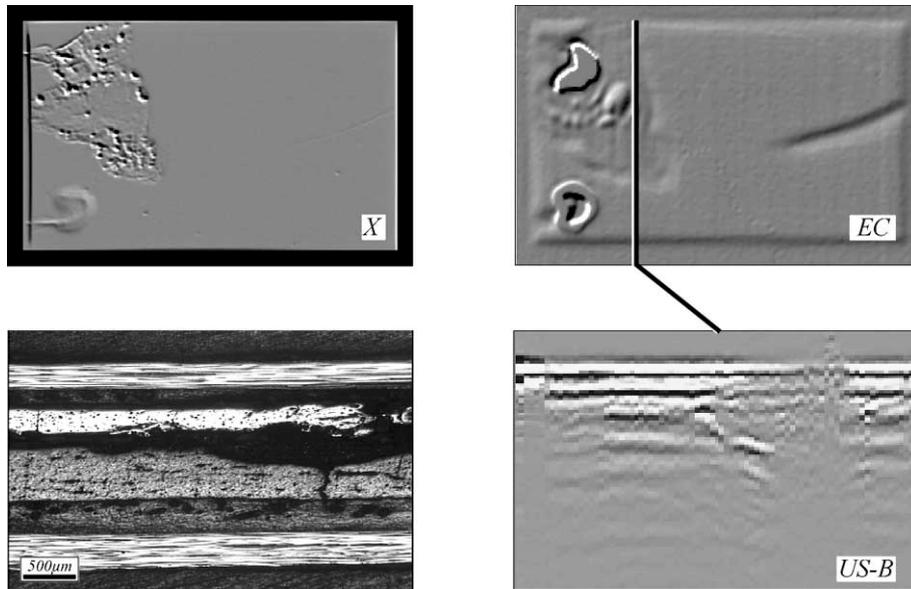
Fig. 9: Blown actuator, non-destructive imaging techniques indicate burned areas in the ceramic patch (X-ray), areas of redistributed metal coating and cracks (eddy current), destruction of the material (ultrasonic).

Figure 9 presents NDE results of a blown actuator. Electrical overload has caused burn out of ceramic parts spreading from one of the terminals (wire). Holes can be recognized in the X-ray. The EC image in its differential mode shows the termination and visualises the damage front starting from the upper terminal downward. Around this terminal a chain of well conducting spots was built by the redistributed metal coating. Additionally, a crack on the right side becomes visible. US-B-scan proves a high degree of material destruction in different depths. The longitudinal waves are screened by delaminated areas and broken material being unable to transmit elastic waves. The micrograph validates severe damage of the actuator, the insulation fleece, the inner CFRP layers and their debonding.

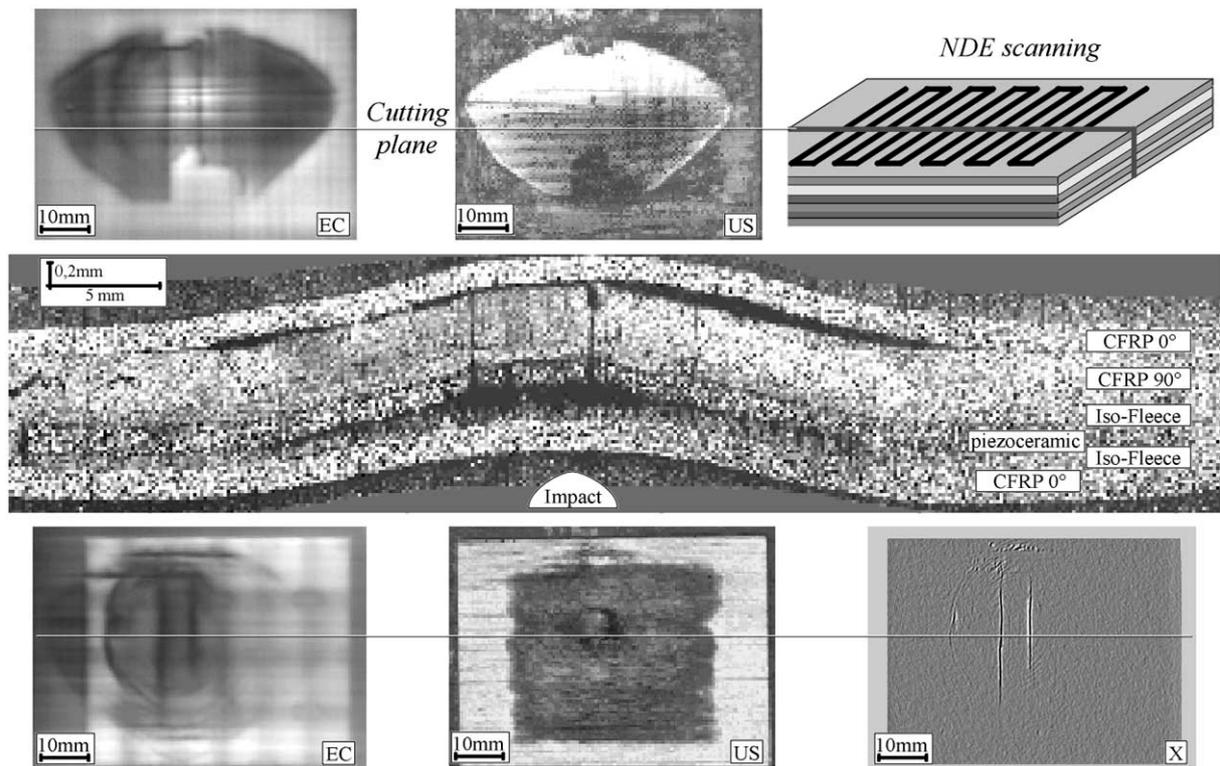
Impact investigations were conducted using a 5 Joule energy drop weight impactor. Figure 10 shows EC and US images from top and bottom sides and, additionally, an X-ray image. The top views indicate a wide delamination between 0° and 90° CFRP layers. EC and US images correspond very well at this type of damage. The reason for eddy current indication is the interrupt of interlayer circular currents [8]. EC bottom image indicates cracks in the actuator and nearly a circular damaged zone. US-C-scan shows a rectangular shaped area between insulation fleece and actuator corresponding with a delamination being caused by a pore-enriched zone in the insulation layer. The X-ray image brings up two large straight cracks and a circular cracked area confirming the EC image.

*Fig. 10: 5 Joule impact in CFRP laminate with embedded piezoceramic patch.
Above: NDE images from top, middle: cross section of the laminate along
the indicated line, below: NDE images from bottom.*

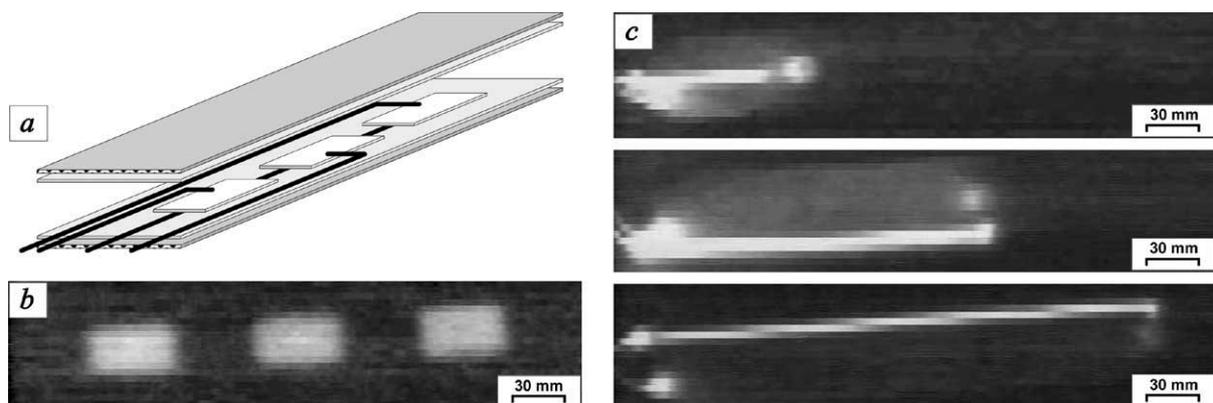
Figure 12 shows some examples of thermographic investigation with active excitation of a CFRP strip with three embedded piezoceramic patches and received by an infrared-camera. Figure 12a displays the stacking sequence of the specimen. Every actuator can be stimulated separately. The harmonic electrical stimulation results in vibration heating in the piezoceramic patches and resistance heating in the conductor rovings. In Figure 12b, the form and the position of the three piezoceramic patches become clearly visible at a frequency of 50 Hz. Furthermore, it is also possible to characterize other typical features of the material system. In Figure 12c, a single excitation of the piezoceramic patches with a frequency of 80 kHz was chosen resulting in a predominant resistance heating of the conductor rovings (due to the decreasing capacitive resistance of the piezoceramic patches at higher frequencies). The bright lines show the track of the heated rovings and the bright shining points indicate weak spots.

Fig. 12: Thermographic images of an electrically excited adaptive CFRP structure (a: tested structure, b: patches at excitation frequency 50 Hz, c: conductor rovings at excitation frequency 80 kHz) [8]
