INVESTIGATION OF THE FAILURE MECHANISMS FOR DELAMINATION GROWTH FROM EMBEDDED DEFECTS

E. Greenhalgh and S. Singh

Mechanical Sciences Sector, DERA, Farnborough, GU14 0LX, UK

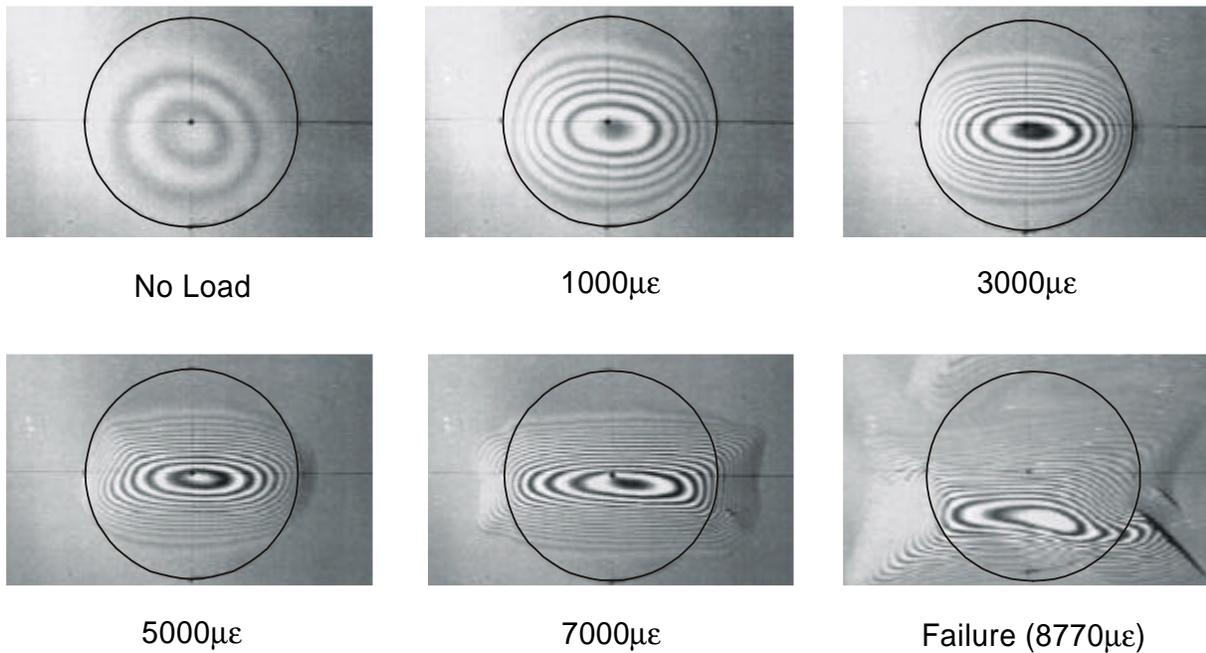
Figure 2: Damage growth from 50mm defect three plies deep ($0^\circ/90^\circ$ ply interface)

The typical damage evolution from defects three plies deep is shown in Figure 2. As the load was introduced, the delaminated region became elliptical, with the peak deflection increasing, until growth initiated at the transverse boundaries of the defect. Initiation occurred at applied strains of between $-1850\mu\epsilon$ and $-3350\mu\epsilon$ (although there was a large uncertainty associated with these values). The delamination formed a lozenge shape, with lobes growing on the right side, from just above the major axis of the ellipse and, on the left side, from just below the major axis, nearly parallel to the -45° ply. Secondary growth initiated from the transverse boundary of the damage and propagated parallel to the $+45^\circ$ ply. At a higher applied strain ($-6000\mu\epsilon$), the delamination developed into a rectangle and finally into a dog-bone shape. Rapid growth of the corner lobes occurred, followed by splitting of the surface plies. Finally, there was longitudinal damage growth from the axial boundary of the insert.

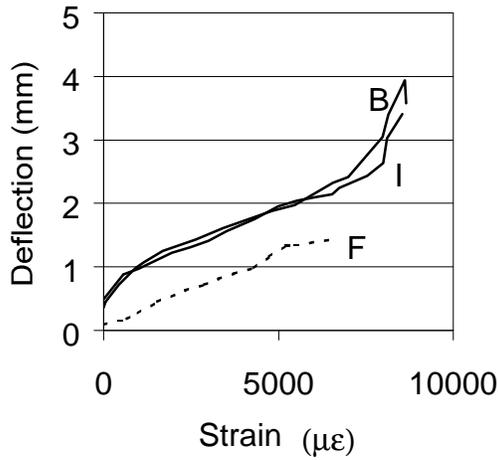
Figure 3: Out-of-plane deflections for 50mm circular defects three and five plies deep

For all the defects three plies deep the out-of-plane deflections increased linearly with applied strain until near failure, when the deflections increased at a faster rate (Figure 3). For a given applied strain the deflections of panels A and C (35mm insert width) were approximately 0.5mm lower than those in panels B, D and I (50mm insert width). After initiation, the

For all the defects five plies deep, the out-of-plane deflections were linear for the entire test (Figure 3) but the deflections were almost 1mm lower than for the defects three plies deep.

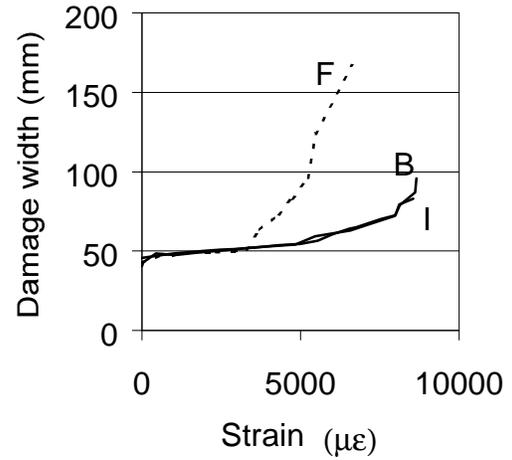
Figure 4: Damage widths for 50mm circular defects three and five plies deep

delamination width steadily increased, becoming unstable at the end of the test (Figure 4). Comparison between results from panels B and I indicated little specimen variability.

After initiation, the damage width increased almost linearly for most of the test (Figure 4). For a given applied strain, the damage in panels F and H (50mm insert) had extended about 20mm further than the damage in panels E and G (35mm insert). Perhaps unexpectedly, the damage grew much faster from the defects five plies deep than from those three plies deep.

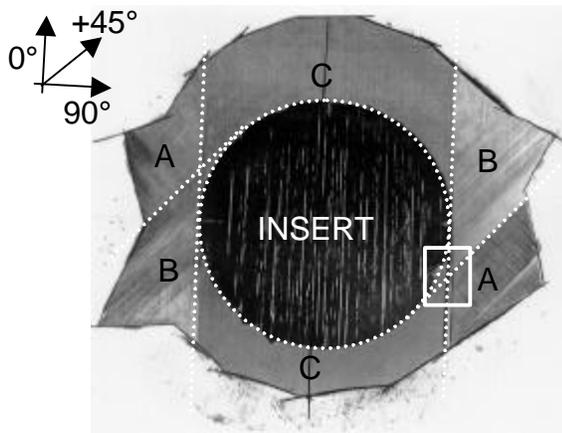
Figure 5: Damage growth from defect three plies deep ($0^\circ/90^\circ$ interface) (lower surface)

The damage surfaces from a 50mm circular defect located at the $0^\circ/90^\circ$ ply interface (panel I) are shown in Figure 5. The fracture surfaces and mixed-mode distributions exhibited rotational symmetry. Figure 6 is a micrograph of part of the delaminated material matching the surface from the substrate in Figure 5 and illustrates the different damage planes and failure modes.

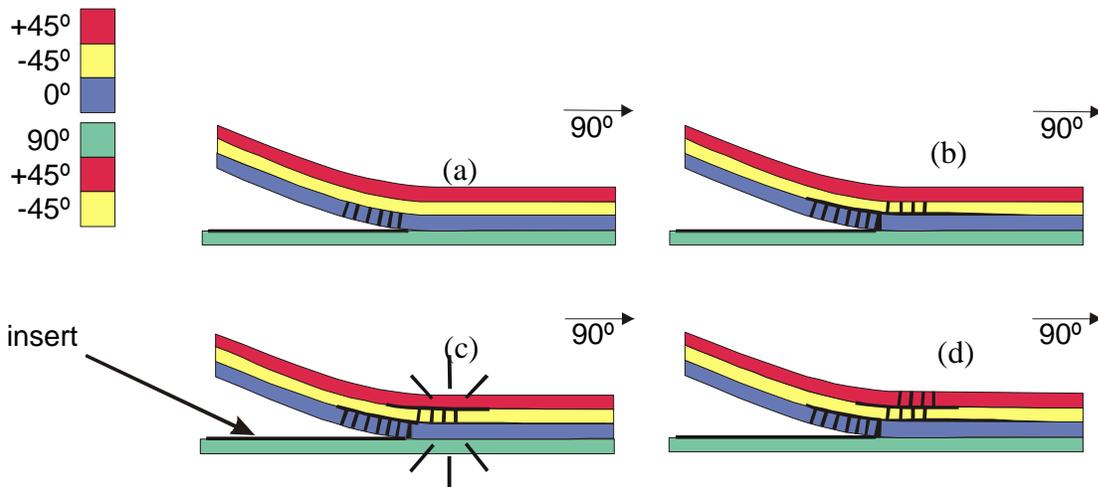
Figure 7: Damage sequence from defects 3 plies deep ($0^\circ/90^\circ$ ply interface)

Figure 7 shows the growth processes in the panels with defects at the $0^\circ/90^\circ$ ply interfaces. Firstly (Figure 7a), the tensile Poisson strains and curvature across the ply directly above the defect plane (0°) had led to the development of splits, tangential to the defect boundary. The delamination migrated through these splits (Figure 7b) and extended into the 2/3 ($-45^\circ/0^\circ$) ply interface (zone B in Figure 5). Within this interface the delamination had then grown parallel to the -45° ply as a mixed-mode fracture. Splits had also developed in the -45° ply (Figure 7b), through which the delamination migrated into the 1/2 ($+45^\circ/-45^\circ$) ply interface (zone A in Figure 5). The delamination had then grown within this interface, parallel to the $+45^\circ$ ply (Figure 7c) again as a mixed-mode fracture. The combined extension of these two zones gave rise to the elliptical, rectangular and finally dog-bone shaped damage contours. Ultimately, splits developed in the surface ply (Figure 7d) which alleviated the local driving forces at the crack tip and arrested the damage growth. Late in the growth process, the in-plane shear forces were high enough to cause fibre fracture (Figure 6). Finally, mode II delamination growth had occurred at the defect plane (zone C in Figure 8), at the axial extents of the insert.

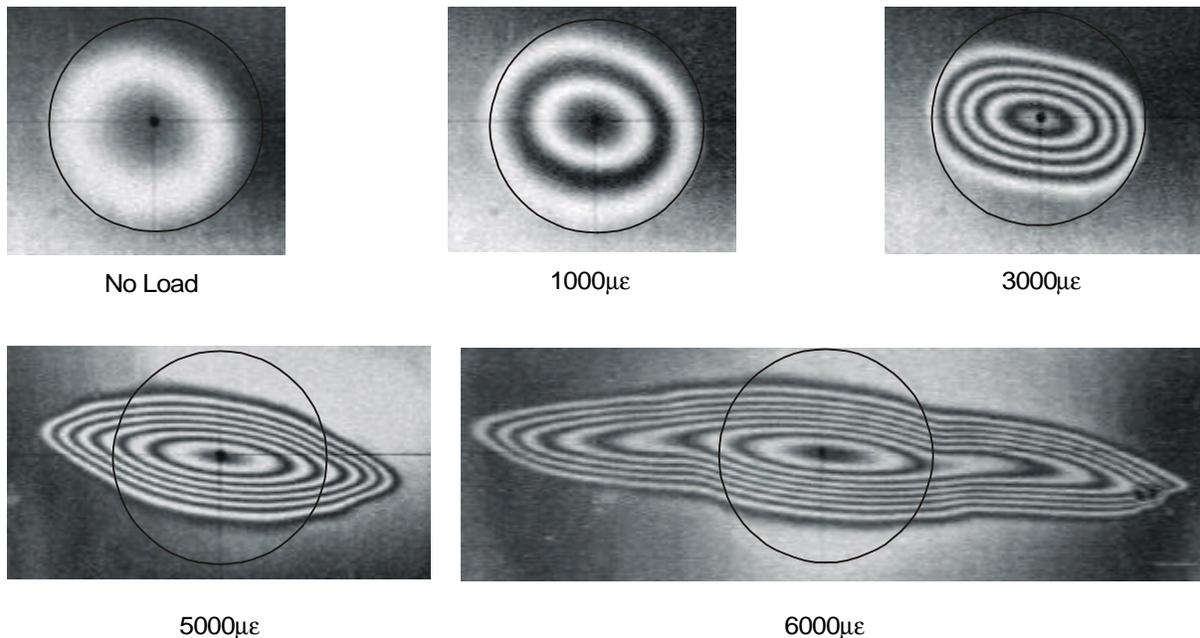
Figure 8: Damage growth from a 50mm defect five plies deep ($+45^\circ/-45^\circ$ ply interface)

The damage evolution from defects five plies deep differed from that from defects three plies deep, as shown in the Moiré images in Figure 8. As the load was applied, the delaminated region became elliptical, with the major axis at about 105° (clockwise) to the loading direction. At an applied strain of between $-2950\mu\epsilon$ and $-4150\mu\epsilon$, delamination growth initiated at opposing points on the defect boundary at about 100° to the loading direction. The delamination extended from these points (as slip-stick growth), developing into a flattened ellipse until the tests were stopped at applied strains of between $-6000\mu\epsilon$ and $-6900\mu\epsilon$.

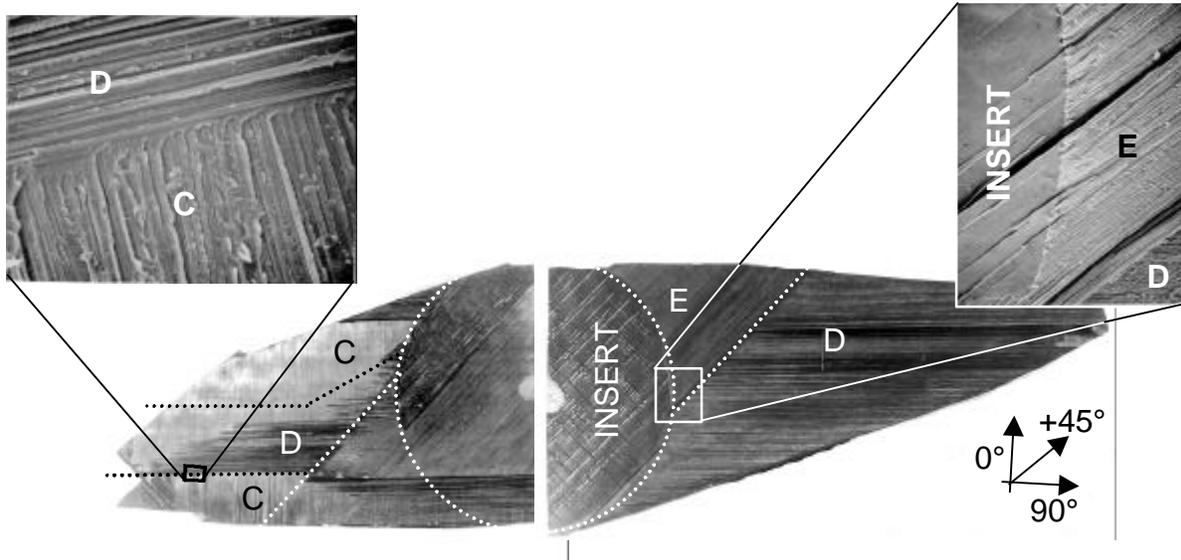
Figure 9: Damage growth from defect five plies deep (+45°/-45° interface) (upper surface)

Figure 9 shows a typical damage surface (panel E) from a defect five plies deep (+45°/-45° ply interface) whilst Figure 10 illustrates the damage growth processes in these panels. Unlike the panels with defects at the 0°/90° ply interface, the delamination failure initiated at the defect plane (Figure 10a) and extended as a mixed-mode fracture parallel the +45° ply (zone E in Figure 9). Splits then developed in this ply, through which the delamination migrated before extending along the 90° plies in the adjacent +45°/90° interface (Figure 10b). The delamination continued to grow quite rapidly within this interface (zone D in Figure 9), as a mode I dominated fracture.

On the left half of Figure 9, the fourth (90°) ply had been removed from the specimen during dissection, exposing two delamination zones C, three plies deep (0°/90° ply interface). This fracture surface was mode I dominated near zones D and mode II dominated nearer its outer

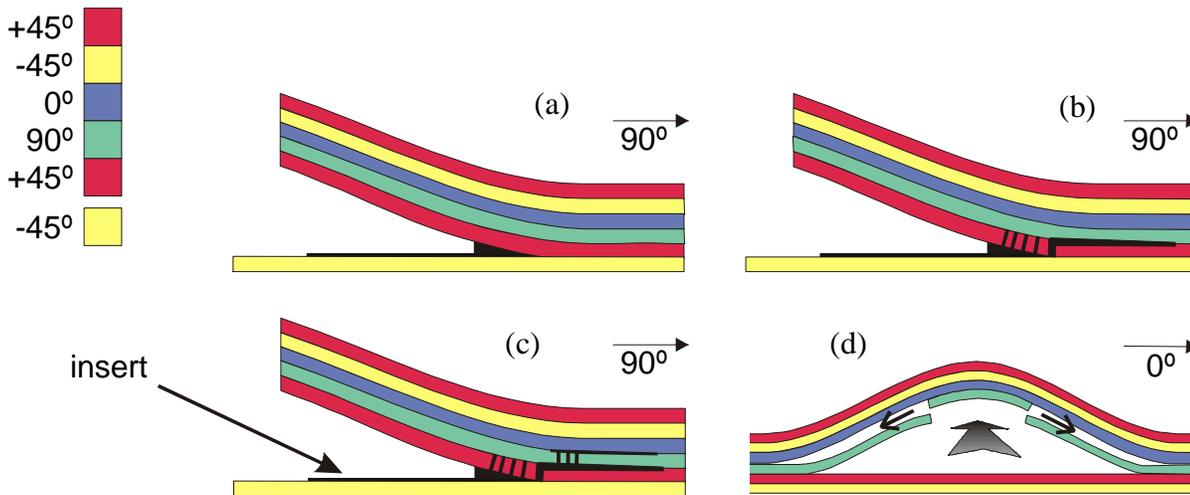
Figure 10: Damage sequence from defects five plies deep (+45°/-45° ply interface)

boundaries. Splits had developed in the 90° ply (Figure 10c), through which the delamination migrated into this $0^\circ/90^\circ$ layer, where it grew parallel to the 0° ply (zone C in Figure 9). Zones C and D had been generated simultaneously, as illustrated in Figure 10d.

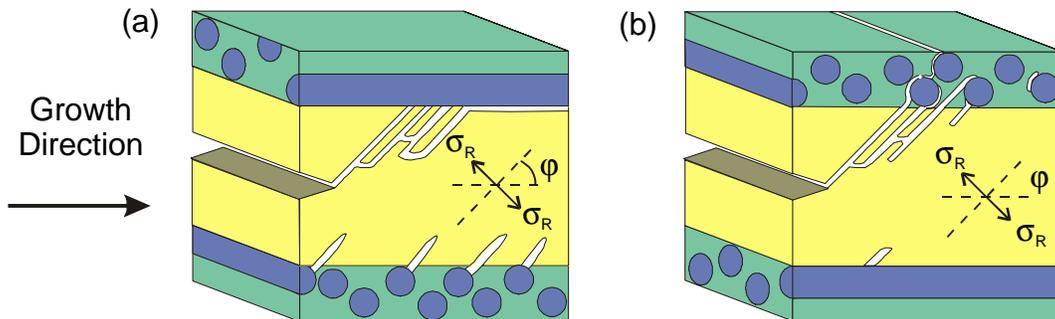
Figure 11: Comparison between crack growth at (a) $0^\circ/\phi^\circ$ and (b) $\phi^\circ/0^\circ$ ply interfaces

The orientations of the delaminated plies were also an important factor in the delamination growth. For these panels, in which global buckling was inhibited, cracks were driven from the insert plane through the delaminated plies towards the outer surface. As illustrated in Figure 11a, when the growth direction and the fibres of the outer (uppermost) ply of the interface were approximately aligned, the delamination remained within that plane and growth was

rapid. When these fibres were oblique to the growth direction (Figure 11b), the cracks were not constrained and migrated upwards into the next interface. Fuller explanations of delamination migration and local growth directions are given elsewhere [6].

These results suggest design rules for constraining delamination growth by appropriate selection of the stacking sequence. A delamination at an interface between two plies will tend to grow parallel to the fibres in the ply which is nearest the surface. It can migrate through the plies to interfaces even closer to the surface, but it always grows parallel to the fibre directions. For design, the critical depth for delamination growth under in-service loads should be determined from the predicted mode I component, and then the stacking sequence of the outer material within this critical depth should be engineered to ensure that none of the ply directions are coincident with the driving forces. For example, in skin-stringer panels under compression this would mean there should be no 90° plies in the outer material within the critical depth [9].
