ARE COMPOSITES SUITABLE FOR REINFORCEMENT OF SHIP STRUCTURES?

I. Grabovac, P.J. Pearce, A. Camilleri, K. Challis and J. Lingard

*Defence Science and Technology Organisation (DSTO)
Aeronautical and Maritime Research Laboratory
P. O. Box 4331, Melbourne 3001
Australia*

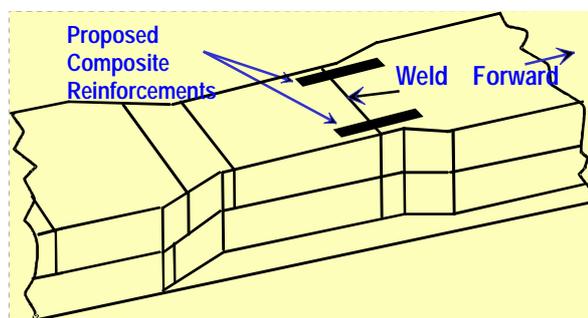
Figure 2. Upper mid-ship region of aluminium superstructure, FFG-7 class frigate.

The area circled in Figure 1 and shown diagrammatically in Figure 2 is the necked-down, midship region of the FFG-7 superstructure that is prone to cyclic fatigue cracking. The history of cracks, coupled with the numerical stress analysis of the region, enabled engineers to determine the precise location, material and the size of CF reinforcements. Thus it was proposed to construct two 5 x 1 metre, 25 layer CF reinforcements on each side of the upper 02-deck as shown in Figure 2. The laboratory development work that followed included: in-house manufacture of a single resin system suitable to perform both as a matrix for the carbon composite and a tough interface adhesive, composite and adhesive property evaluation and large-scale fatigue testing of a simulated deck reinforcement [4].

According to the original engineering estimates, a 25-ply CF composite was needed to reduce the stress concentration in the upper, mid-ship region (Figure 2) by approximately 20%. Theoretically, a stress reduction of this magnitude was expected to stop or significantly relieve cracking episodes re-occurring most commonly due to inherent weld flaws on the O2-deck plating.

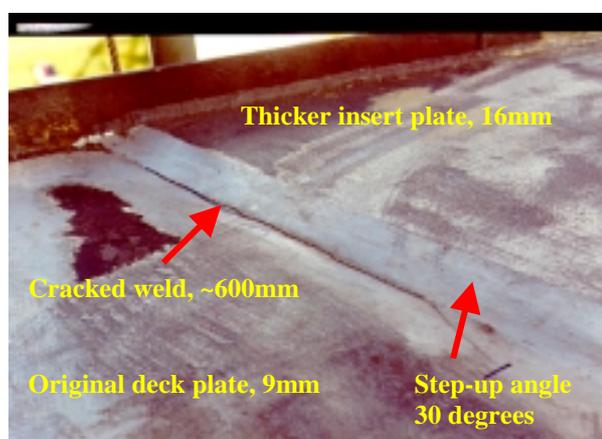
Figure 3. Welded connection between 9 and 16mm plate insert (Note the length of crack)

superstructure level (ie. 1, 01 and 02) also show a beneficial effect of reinforcement in the longitudinal strain which includes the most critical Frame 200.5 [1]. The anomaly in the output of strain gauges G4 and G5 (O2-deck starboard side, fore) indicate the influence of a crack (see Figure 3) present during the initial collection of experimental data.

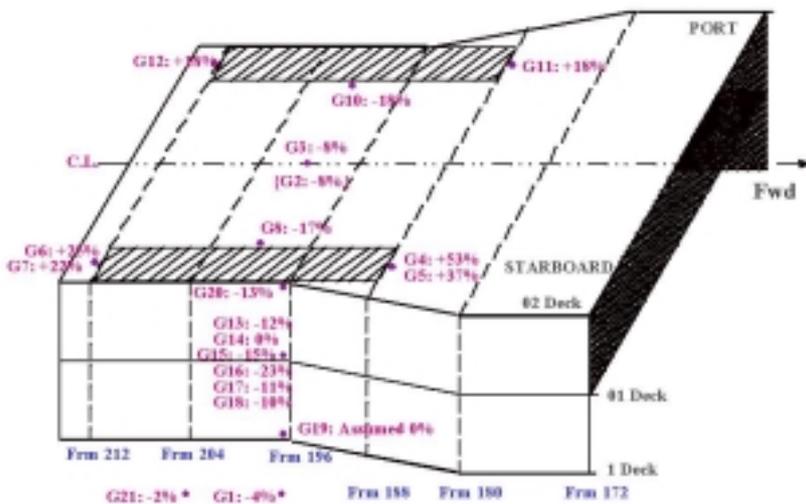
Figure 9. Changes in strain intensity level after composite reinforcement (neck-down region)

Seven strain gauges were installed on the O2-deck. The output of the four gauges located at the ends of each reinforcement show about 20% increase in strain level. In contrast, the deck area between Frames 188 - 212, indicate a corresponding reduction in strain. Installation of CF composite reinforcements also affected strain distribution in the vertical plating welds at frame 196. The three strain gauges (rosettes) positioned at each

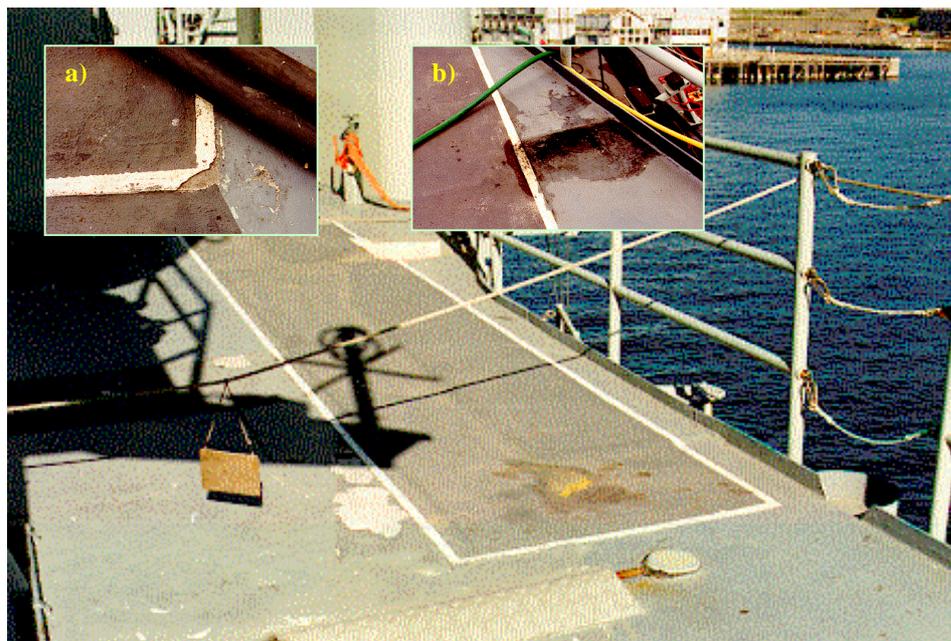
In January 1996, after almost three years in service there was a need for the first maintenance service to the CF reinforcements. The type of damage sustained by the composite on the 02-deck is evident in Figure 10 and insets a) and b). Local de-bonding at the GRP/aluminium interface and a small scale tearing, especially around corners, was consistent on both composite reinforcements. It is believed that a combination of factors (mechanical wear and tear, mismatch in thermal expansion between GRP - aluminium and presence of sea water) caused the failure of the bond. No damage to the surface of either CF reinforcement was noticed.

Figure 10. Weathering of composite reinforcement on 02-deck. A typical damage Inset a) and b)

Uneven surface of the deck also causes local water locks to form, see Figure 10, inset b). Once the surface protective paint system is breached, this condition, if left unattended, will in time result in progressive deterioration of the adhesive and corrosion of the aluminium surface.

To prevent progressive environmental degradation, it was decided to remove 150mm of GRP protective layer around the periphery of both reinforcements irrespective of their condition. The immediate bare surface of aluminium and composite was cleaned, prepared and the adhesive bond layer reconstructed using identical materials. The procedure used to produce the new 200mm wide GRP layer (allowing 50mm overlap), thus rebuilding the GRP/aluminium interface around the boundary of both reinforcements, was identical to that discussed earlier. In addition to the GRP reconstruction work, it was decided to include an enhanced edge sealing method developed in our laboratory. Besides a suitable epoxy and polyurethane-based paint, a glass reinforced polysulphide elastomer was also introduced to account for differences in thermal expansion and additional protection against water ingress at the critical GRP/aluminium interface, Figure 11.

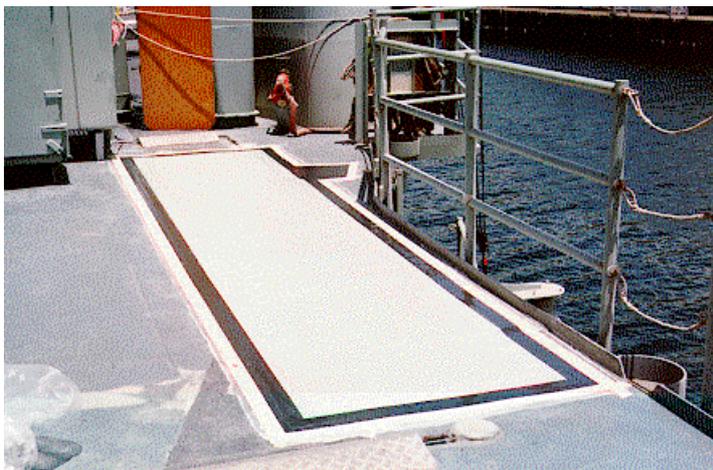
Figure 11. Additional edge protection – polysulphide elastomer

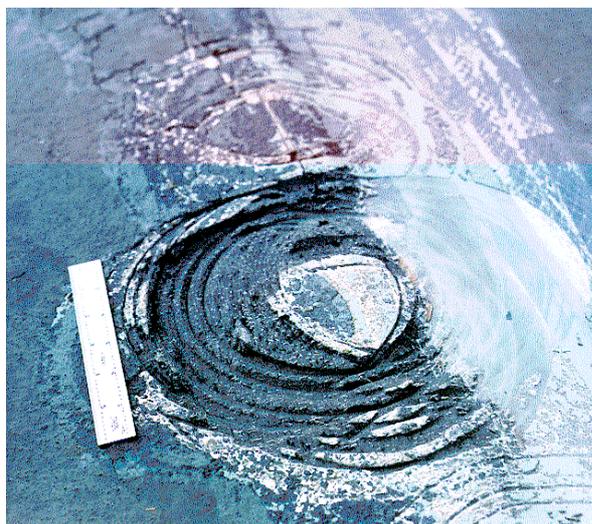
In January 1998 the port side CF reinforcement suffered mechanical damage during a maintenance schedule. High-pressure rotary water jet equipment, used for surface paint removal, had accidentally collided with the composite reinforcement. The type and the extent of damage are shown in Figure 12.

The circular groves shown in Figure 12 represent the most serious damage. In some places cuts have penetrated through the composite and exposed the aluminium deck.

Figure 12. Physical damage to CF composite

The repair procedure again first included the reconstruction of adhesive bond layer followed by rebuilding of a matching CF composite structure. The reconstruction and vacuum consolidation of a GRP surface protection included the repair of an approximately 1m long edge-sealing strip and completed the task. At the time of writing this paper no further incidents have occurred.

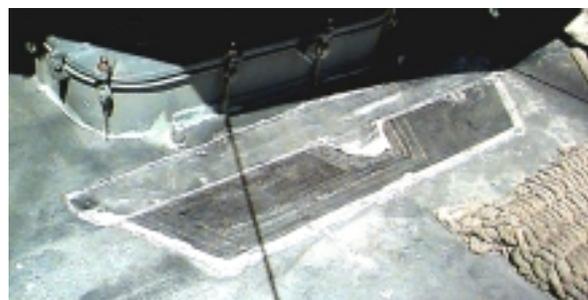
Furthermore, it was established that excessive water pressure had also caused local delamination within the composite. The total area affected and prepared for repair was close to 900mm in length and 400mm in width, Figure 13.

Figure 13. Composite repair area

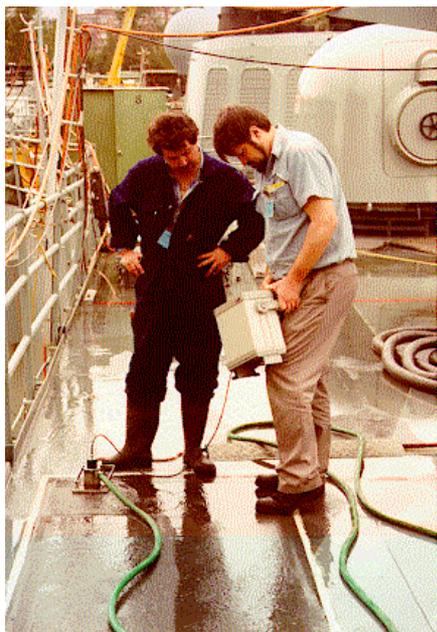
Figure 14. NDE assessment of adhesive interface

Although the tests were conducted approximately 18 months apart, the findings indicated that no detectable deterioration (ie. de-bonding) of the adhesive interfaces had occurred.
