NONDESTRUCTIVE INSPECTION AND EVALUATION METHODS FOR COMPOSITES USED IN THE MARINE INDUSTRY

SUMMARY: The paper reports on a test and evaluation programme to compare different non-destructive inspection and evaluation methods for the inspection of single skin and sandwich panels and joints. As part of the benchmark test programme a number of T-joints and top hat stiffener specimens were built using single skin and sandwich construction. These specimens contained defects of various sizes which were located at different depths. The specimens were tested in the laboratory using ultrasonic and thermographic methods. In addition field tests on ship structures were carried out in ship yards to determine the performance of the ultrasound, infrared and automated coin tap methods in a production environment. These included tests on an old 2/3 scale section of a single-skin GRP minesweeper and a small ship section of sandwich construction which had been used in explosion trials. The paper summarises the results, comparing the different methods and showing their respective capabilities and limitations.

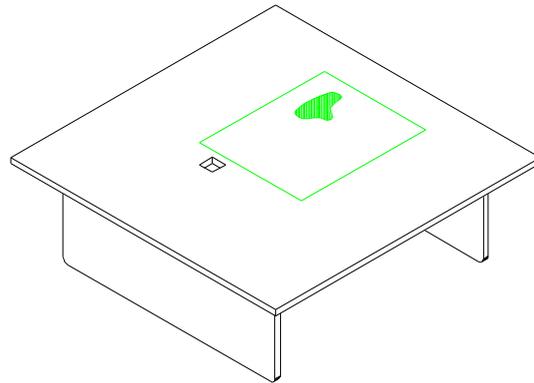
- The method could easily detect the debonding areas between the main panel and the stiffeners. A few other defects were found outside the stiffener area.
- The inspection from the outside was more difficult. However, it seems that the method could distinguish the signal of an intact stiffener from a debonded stiffener by inspecting from the outside. All other methods were not capable to analyse the structure from the outside.

Figure 4 Possible defects detected by smart hammer system (delaminations near the stiffeners are not shown in the sketch)

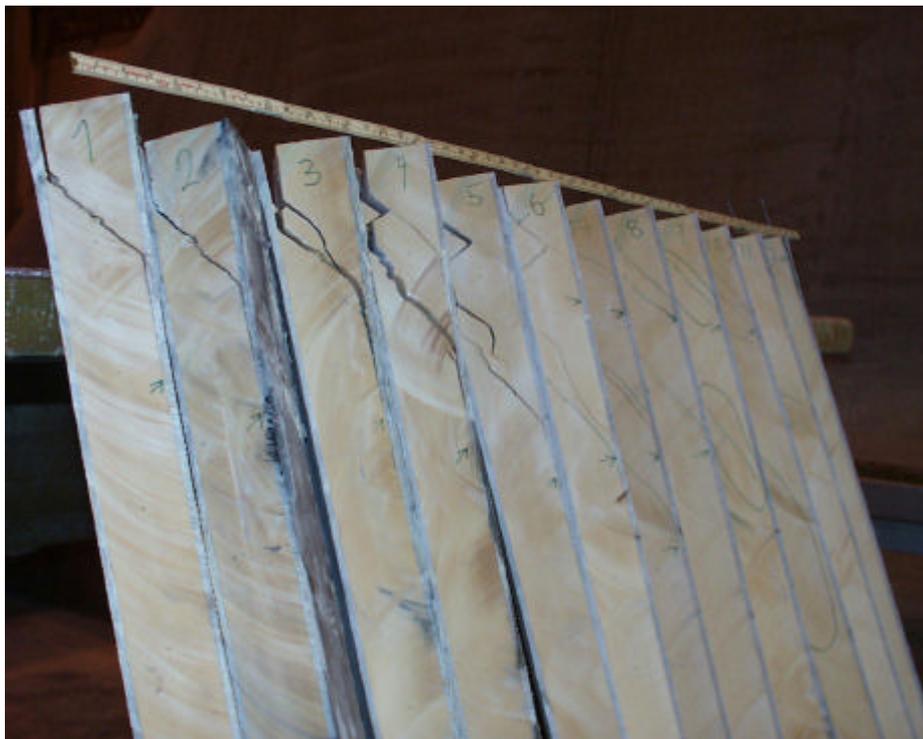
To verify the findings made with the three inspection methods a panel was removed from the test section and cut into narrow beams (see Figure 6). The beams are shown in Figure 5. They clearly show core damage, delamination and debonding. But there were no areas with excess or lack of resin. The observed defects are summarised in Figure 7. The results obtained with infrared thermography and the smart hammer seem to correlate quite well with the observation from the destructive testing. The main areas of core damage and debonding have been detected by both methods. In addition, infrared thermography found other possible defects which are not visible on the beams removed from the test section. Ultrasound did not find any defects in the panel, only the delaminations of the stiffeners.

Figure 5 Damage in panel

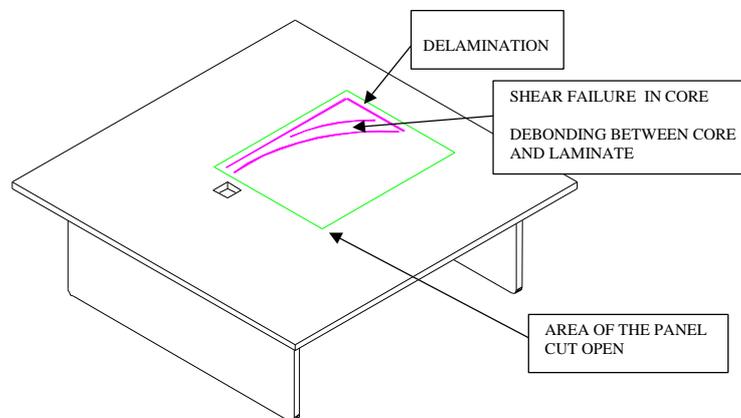
Figure 7 The defects detected by removing beams from the test section

The smart hammer method is the fastest of the methods considered in this study as shown in Table 1. Delaminations located at the interface between the flange of the top-hat stiffener and the base plate were easily detected. The main damage area shown in Figure 7 with shear failure and debonding between core and laminate was detected by inspecting from the inside and the outside. The smart hammer method was the only method that could detect defects by inspecting the structure from the outside. The field trials have also demonstrated that the smart hammer method can be set up quickly. Access requirements are minimal, the method can be used as long as the operator can reach the area of interest. This means ladders or simple scaffolding is fully sufficient. The only ancillary items needed are pressurised air and a power supply to run the PC. The fastest way to scan an area seems to be to inspect the structure quickly by using a hammer to identify possibly critical areas. In a second step the smart hammer method is applied to evaluate the critical areas more carefully. Areas with defects can be marked with chalk and positions can be recorded afterwards. If a very accurate inspection is desired the structure can be inspected carefully at every point.
