APPLICATION OF ANOMALOUS WAVE PROPAGATION IMAGING METHOD WITH ADJACENT WAVE SUBTRACTION TO ACTUAL DAMAGES IN COMPOSITE WING

Abstract

Anomalous wave propagation imaging method was applied for the on-site in-situ nondestructive evaluation of actual debonding and impact damages in a composite wing with high density of structural elements. The promising results showed that it has high potential as on-site nondestructive evaluation method of other complex engineering structures.

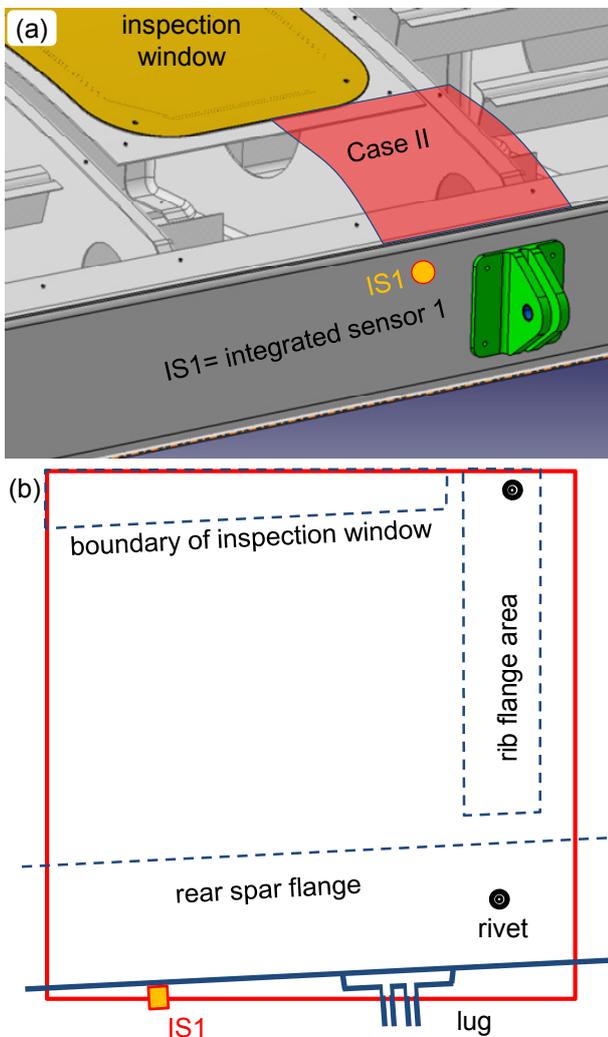
Case II was conducted after the wing underwent a series of destructive bending tests. The inspection area was selected at a damage hot spot, as shown in Fig. 3. This inspection area was selected because it contained many other structural elements including the boundary of the inspection window, rib flange, and the lug, and an integrated ultrasonic sensor (IS1) was available at the spar web. It was selected intentionally to show that the high density of structural elements would not interfere with the normal AWPI inspection. The size of the inspection area, the fluence of the QL, the bandpass frequency, and the sampling time interval were set to $200 \times 200 \text{ mm}^2$, 34 mJ/cm^2 , 60-200 kHz, and $T=0.6 \text{ }\mu\text{s}$, respectively.

Fig. 3. Inspection Case II. (a), (b) high density of structural elements within the inspection area.

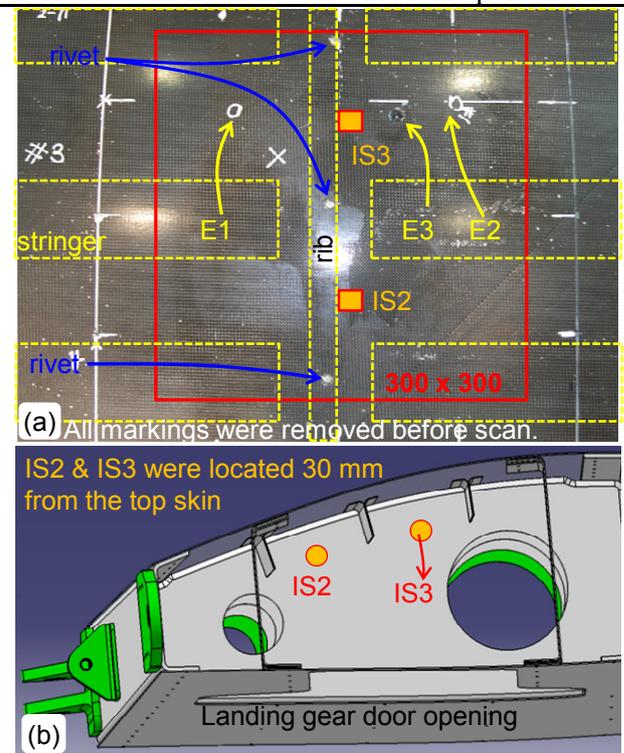
The testbed was impacted in order to find the critical impact energy of the testbed, and to show the capability of the developed AWPI method for real impact damage evaluation. The impact site was selected near one of the most complex areas of the testbed, as shown in Fig. 4. Three impact events tabulated in Table 1 were made between the rib and stringers using an indenter of 4 mm diameter. Two integrated sensors were available for the inspection of the impact damages. The IS2 and IS3 were integrated at the web of the rib, 30 mm from the upper skin, as shown in Fig. 4. The redundancy of the sensor within a small region of the wing was designed to crosscheck the results obtained from two sensors. The size of the inspection area, the fluence of the QL, the bandpass filtering, and the sampling time interval were set to $300 \times 300 \text{ mm}^2$, 75 mJ/cm^2 , 60-200 kHz, and $T=0.8 \text{ }\mu\text{s}$, respectively.

Event	Energy	Visual inspection
E1	15 J	Invisible
E2	15 J	Invisible
E3	25 J	13 mm diameter puncture

Fig. 4. Inspection Case III.

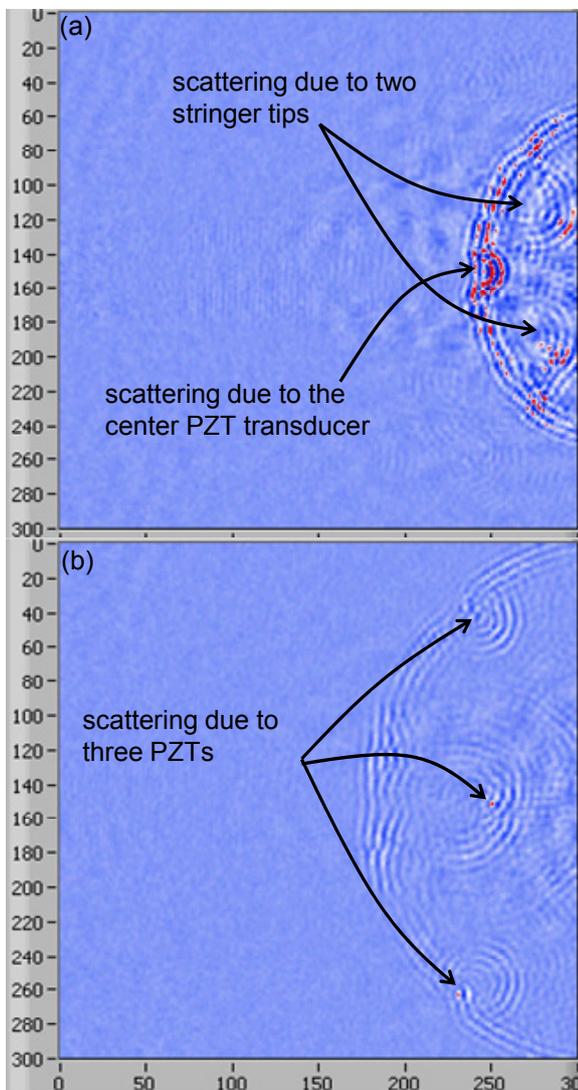
The freeze-frames of the AWPI movie at 74 and 114 μs are given in Figs. 5(a) and (b), respectively. The residual of the incident wave is shown as if emanating from the signal sensing point, and its encounter with the stringer tips generated scattering waves as shown in Fig. 5(a). Its encounter with the bare PZT elements as added masses generated another scattering wavefields, as shown in Fig. 5(b). The freeze-frames show no occurrence of confining wave within the PZT transducers. In other words, they were detected as simple structural discontinuities. This was an encouraging result

Fig. 5. Freeze-frames of the AWPI movie at (a) 74, and (b) 114 μs showing no confining waves in PZTs.

because it suggests that the AWPI method can be used for structures with integrated PZT elements. No confining wave is shown in the freeze-frame after the residual of the incident wave swept through the area of inspection. This result also proves that the system works well in the field environment.

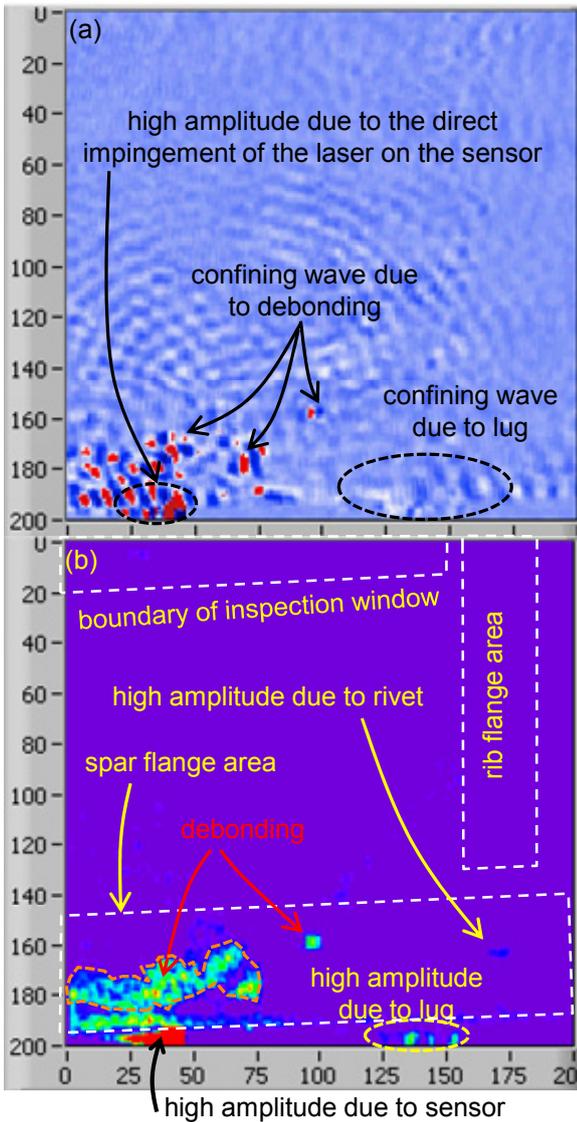
The freeze-frame of the AWPI movie at wave propagation time of 120 μs is given in Fig. 6(a). It shows the anomalous wave at the bottom left. A part of the anomalous wave with higher amplitude was due to the direct impingement of the laser on the IS1 and the lead wire used for this inspection. Also shown in this freeze-frame are the confining wave for a small damage and the silhouette of the lug. The VTWAM in Fig. 6(b) shows clearly two damage events (with bright colors), corresponding to the rear spar-skin debonding. The high amplitude due to the sensor and the lead wire is shown in red, and the high amplitude due to a part of the lug is also shown. These results show that the AWPI combined with the VTWAM method is effective in evaluating the debonding damages, and the boundary of the inspection window, rib flange, and lug would not adversely affect the inspection.

Fig. 6. Results of Case II. (a) Freeze-frame of AWPI movie, (b) VTWAM showing two debonding.

The results showed the rear spar-skin debonding damages between two riveted locations, indicating skin buckling during the wing bending. Also, stringer debonding due to wing bending occurred at all stringer tips in the wing tip direction, which agreed well with the notorious stringer tip debonding damage commonly found in aerospace structures.

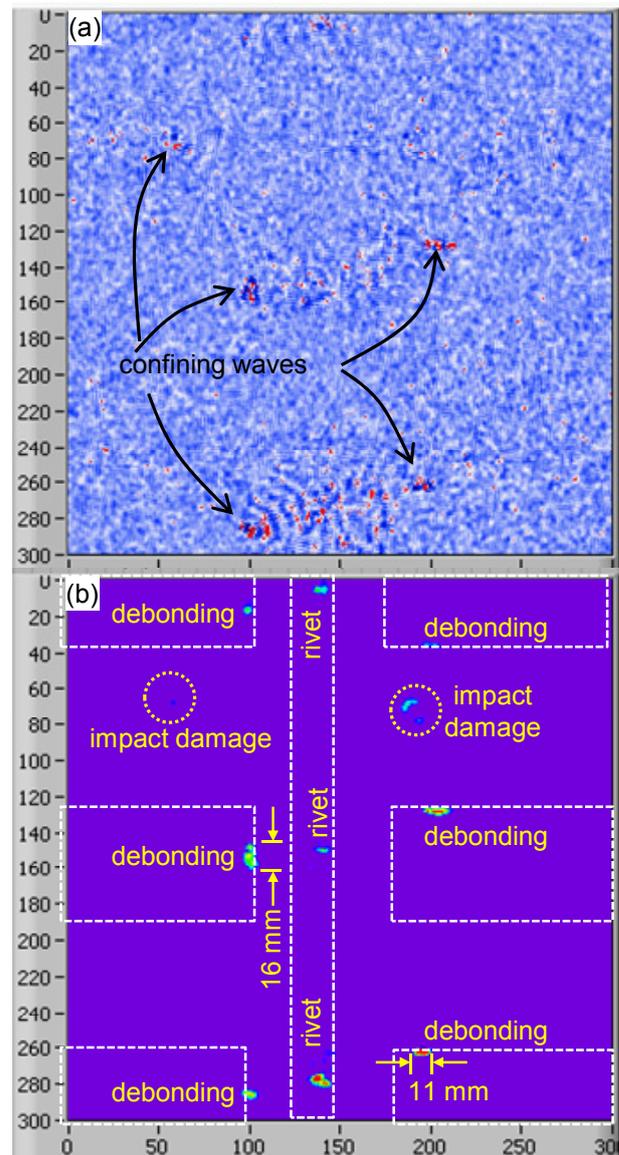
For inspection using IS2, the freeze-frame of the AWPI movie at wave propagation time 168 μs is given in Fig. 7(a). It shows the confining anomalous waves at the edges of the stringers and the impact location E1, which implies damages there. The VTWAM is shown in Fig. 7(b) with the outlines of the internal structural elements. The VTWAM show two damages related to impact E1 and E3, but no sign of damage for impact E2. In addition to the impact damages, it reveals the debonding in the stringer edges in the wing tip direction. Since the damages in the stringer tip were not found in inspection Case I before structural loading tests, it provides strong evidence that the upward bending of the testbed at the wing tip generated debonding at the stringer tips. In fact, this type of damage is notorious in the stiffened panels widely used in the aerospace industry. Three more areas with high amplitudes are shown in the VTWAM at the side boundaries of the stringers. We believe that stringer-skin debonding also occurred at these locations. For the crosscheck based on IS3, the freeze-frame of

Fig. 7. Results of Case III using IS2. (a) Freeze-frame of AWPI movie, (b) VTWAM image.

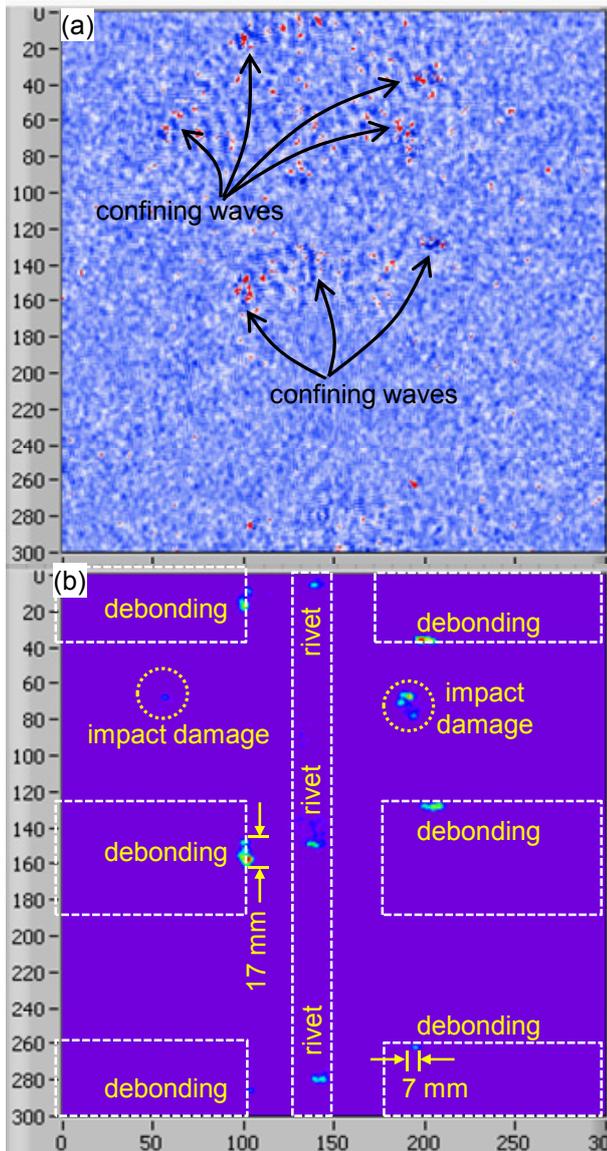
the AWPI movie at wave propagation time 220 μ s is given in Fig. 8(a). Similar to the inspection based on IS2, the confining anomalous waves are also shown in the freeze-frame at the edges of the stringers and the location of impact E1 and E2. For better damage evaluation, the VTWAM was generated and shown in Fig. 8(b). Comparison of Fig. 7(b) and Fig. 8(b) shows good agreement in the damage size evaluation. The size of the damages varied between 7 and 11 mm for the damage with greatest size deviation, while between 16 and 17 mm for the damage with smallest size deviation. These two VTWAMs show the presence and location of the

Fig. 8. Results of Case III using IS3. (a) Freeze-frame of AWPI movie, (b) VTWAM image.

Furthermore, it can be deduced that the critical impact energy for the testbed was 15 J. This is because the results of Case III based on IS2 and IS3 showed that only impact E1 damaged the wing testbed despite both the impact E1 and E2 were 15 J. The presence of structural elements or features such as spars, stringers, ribs, lugs, inspection windows, and even surface mounted PZT elements did not adversely affect the inspection process. This proved the suitability of the method for the NDE of complex engineering structures. Lastly, the robustness of the system for on-site application is self-explanatory
