DELAMINATION GROWTH MECHANISM FROM EMBEDDED DEFECTS IN COMPRESSION

C.Canturri^{1*}, E.S. Greenhalgh¹, S.T. Pinho¹, S. Nilsson²

¹ The Composite Centre, Department of Aeronautics, Imperial College London, London, UK

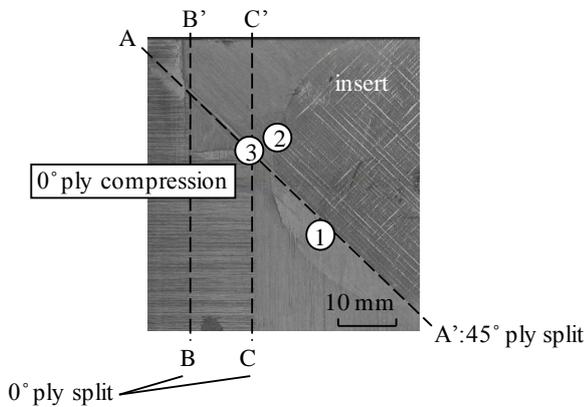
Firstly, consider the baseline specimen (L) which contained an initial defect at the 45°/-45° interface. Visible inspection (Fig. 1) identified a large ply split of the 3rd (45°) and 2nd (0°) ply and compression failure of the 2nd ply.

The same in-plane shear failure then extended into a 0° compression failure until reaching ply split B-B' in the 2nd (0°) ply. Since the compression failure of the 2nd ply was confined between two ply splits (B-B' and C-C' in Fig. 1) it was inferred that these two

Fig. 1 Lower most fracture surface of specimen L: $45^\circ/-45^\circ$

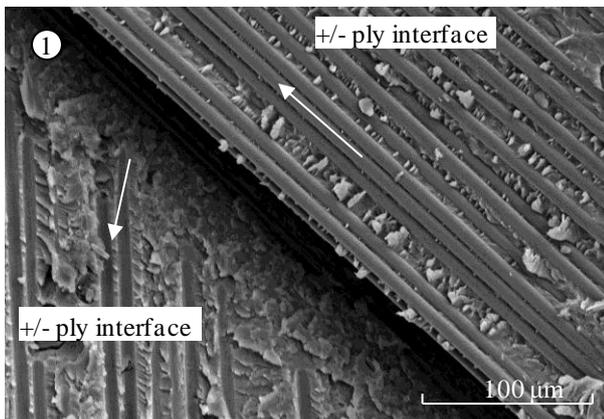
Fig. 2 shows a detail of a ply split parallel to ply split A-A' that crossed from the top-left to bottom right separating the image in two distinct zones: the top right region, a fibre rich region, which had failed by mode II dominated delamination and the bottom left, a matrix rich region, with fibre imprints of the adjacent 0° ply, which has failed by mode I dominated delamination. The discontinuity of the features encountered on either side of the ply crack indicated the growth of this intralaminar crack had been prior to the formation of the adjacent delaminated surfaces. Furthermore in Fig. 2 the features near the 45° ply split suggested that the delamination of the bottommost 0°/45° region had initiated from the ply split.

Fig. 2 Ply split of the 45° ply

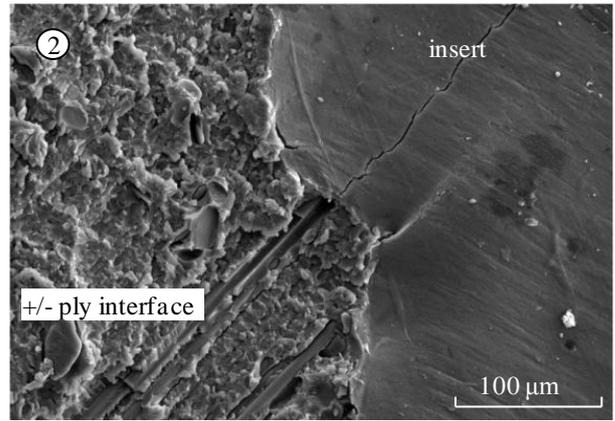
However, there was some evidence that a number of intralaminar cracks had occurred after the delamination growth (Fig. 3). This region on the insert boundary, near of the delamination onset site, exhibits a mode I dominated delaminated surface. Contrarily to Fig. 2 the features either side of the split were continuous enough to establish that the delamination had been before the ply split.

Fig. 3 Ply split of the 45° ply. Uppermost matching surface

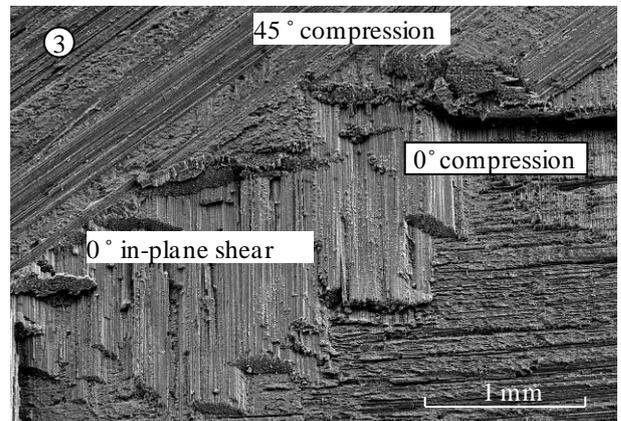
Fig. 4 was taken close to the intersection of a band of compression failure and the ply splits A-A' and C-C' in Fig. 1. These ply splits A-A' and C-C' may have acted as an initiation site for the 0° shear failure pictured in Fig. 4 as its path seemed to have followed the 45° ply split, which also present a compression failure.

Fig. 4 In-plane shear and compression failure of 45° and 0° plies. Uppermost matching surface

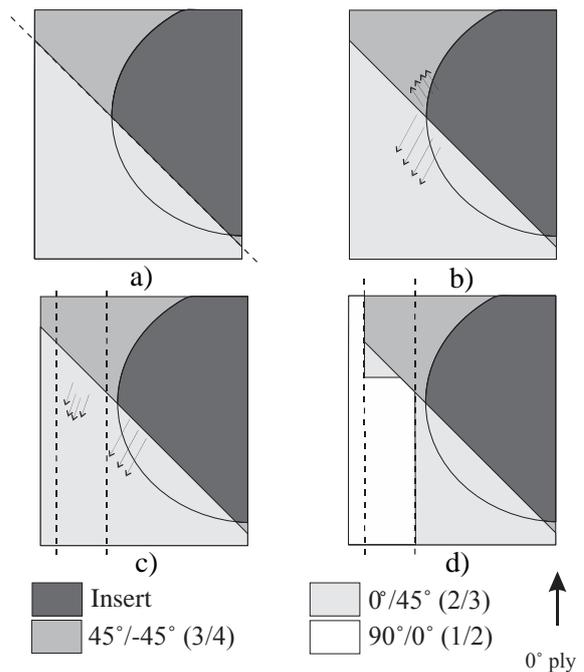
Fig. 5 summarises the sequence of the events for specimen L.

Fig. 5 Failure sequence: ply interface $45^\circ/-45^\circ$

a) Ply split first develops b) delamination grows on ply interfaces $45^\circ/-45^\circ$ and migrates through the ply split to interface $0^\circ/45^\circ$ c) ply splits develop in the 0° layer d) in-plane shear failure and compression failure of the 0°

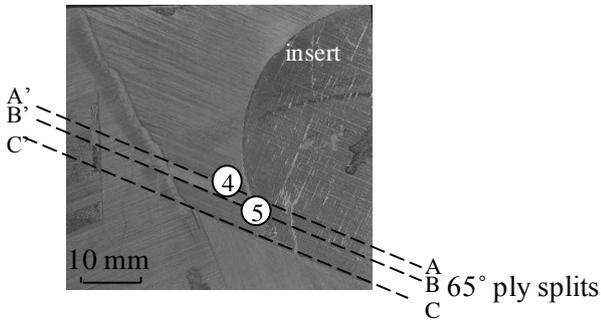
The next configuration studied (specimen K) had a stacking sequence that had been rotated through 20° with respect to the previous specimen, such that the defect was located at a 65°/-25° ply interface. This specimen exhibited three ply splits (A-A', B-B' and C-C' which resulted in a jump of the delamination interface.

During microscopic observations, further extensive ply splits of the 3rd ply were noted in the matching upper surface that had initiated from the insert and extended in to the rest of the ply. Uniquely, these three ply splits had led to a change of the delamination growth interface. Similarly to specimen L these ply splits (A-A', B-B' and C-C' in Fig. 6) had been prior to the delamination growth. Since these splits were located within the domain of the delamination growth initiation when the delamination front had encountered these ply splits the delamination was prompted to jump.

Fig. 6 Lowermost failure surface of specimen K: $65^\circ/-25^\circ$

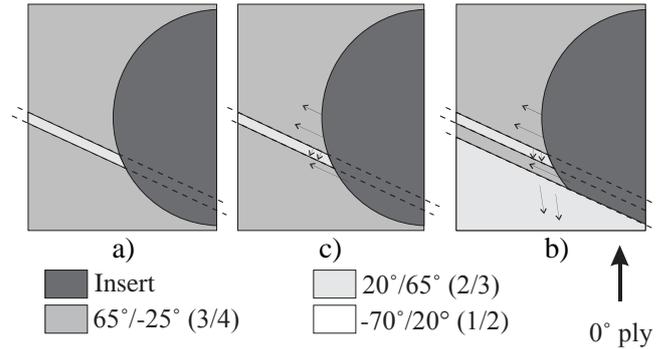
Finally, no compression failure was observed in any of the plies being the only specimen not showing this mode of failure. Nevertheless fibre failure was present; an in-plane shear failure (Fig. 8) between two ply cracks was noted along the insert boundary. The sequence of failure events is detailed in figure Fig. 9.

Fig. 9 Failure sequence specimen L: ply interface $65^\circ/-25^\circ$

a) Ply splits first develop in the 65° ply
b) delamination grows on ply interfaces $65^\circ/-25^\circ$ and migrates through the ply split to interface $20^\circ/65^\circ$ c) ply splits develop in the -70° layer

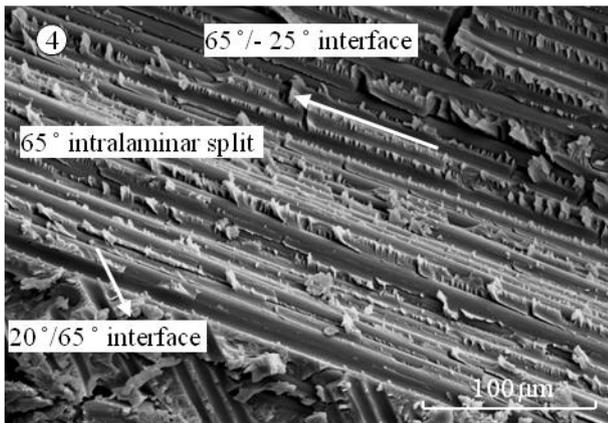
Fig. 7 shows the boundary of the angled ply split. In this image, the upper region was a 65°/-25° interface whereas the bottom region was a 20°/65° interface. Both regions are matrix dominated and had failed by mode II dominated delamination. The central region of the image shows the flank of the 65° ply split which exhibited intralaminar shear cusps. No delamination was observed underneath the ply split which is consistent with the ply split having been present when the delamination had reached that site. This is similar to the observation in the previous specimen L (45°/-45°) where ply splits in the 3rd layer developed both before (Fig. 2) and after (Fig. 3) the delamination growth.

Fig. 7 Flank of 65° ply split

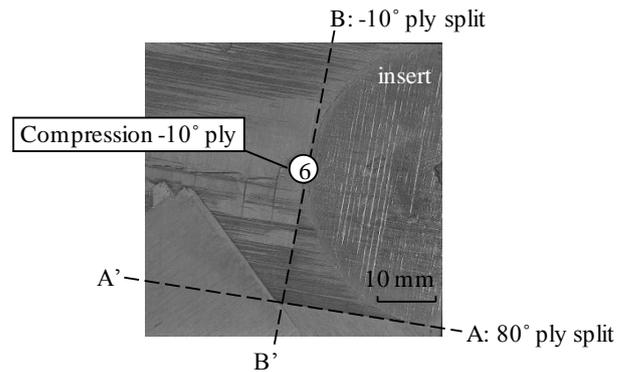
The failure surface in specimen G was entirely contained within the defect interface 3rd/4th ply (80°/-10°), which had not been observed in specimen L. Ply split A-A' had developed in the 3rd (80°) ply tangentially to the insert, however its location was distant from the delamination growth initiation sites. Therefore, unlike the baseline (specimen L), no interaction between ply splitting and delamination had occurred. From the absence of delamination beneath 35°/80° ply interface region it was deduced that the ply split A-A' in Fig. 10 had occurred prior to the delamination growth in this zone.

Tangential to the lateral boundary of the defect, a ply split of the 4th (-10°) ply had developed (B-B' in Fig. 10). From the middle of his ply split a -10° compression failure had started to extend away from the defects. Fig. 11 shows the surface of the 4th (-10°) ply with a visible ply split. On the top left of the image a region of failed fibres can be observed. From the continuity of the fracture morphology it was inferred that the delaminated surfaces were generated prior to the ply split of the 4th (-10°) ply.

Fig. 10 Lowermost failure surface of specimen G: $80^\circ/-10^\circ$

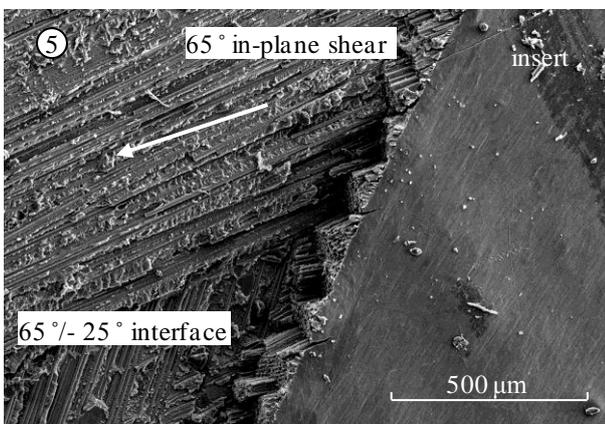
Fig. 8 Boundary of the insert showing an in-plane shear failure. Upper most matching surface.

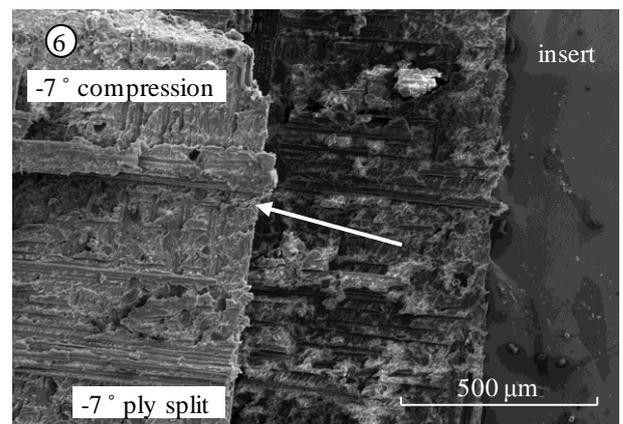
However, compression was after both, delamination and ply splitting, which could be deduced by the presence of the compression failure only one side of the ply split B-B', where compression was thought to have originated. Similarly to specimen L, the compression failure was situated in the ply which was best aligned to the load direction.

Fig. 11 Boundary of the insert showing compression failure and ply split of the -10° ply.

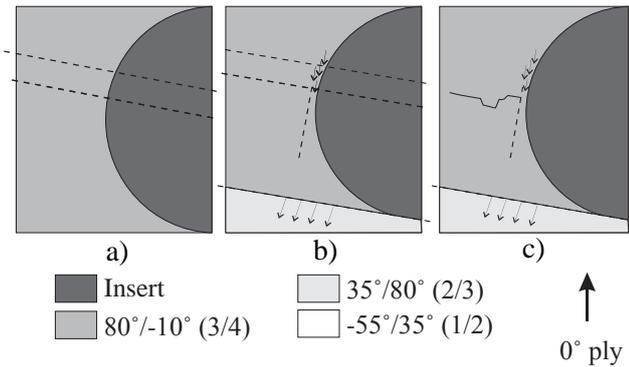
The sequence of failure events is detailed in figure Fig. 12.

Fig. 12 Failure sequence specimen L: ply interface 80°/-10°

- a) Ply splits first develop in the 80° ply
- b) delamination grows on ply interfaces 80°/-10°, ply -10° splits c) compression failure of the -10° ply

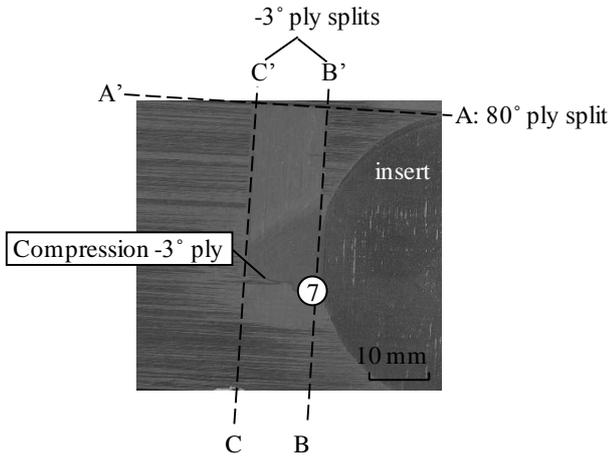
Together with specimen G these specimens were the only ones showing fibre failure within the 4th ply. Visually the present failure morphologies were similar; however close examination led to the determination of a different failure sequence. Ply split in the 4th ply (-3°) was after the translaminar compression failure of the ply contrarily to the observations in specimen G (80°/-10°).

This sequence was deduced by the observation that ply splits B-B' and C-C' in Fig. 13 stopped at the compression failure and the similarities in the

Fig. 13 Lowermost failure surface of specimen C

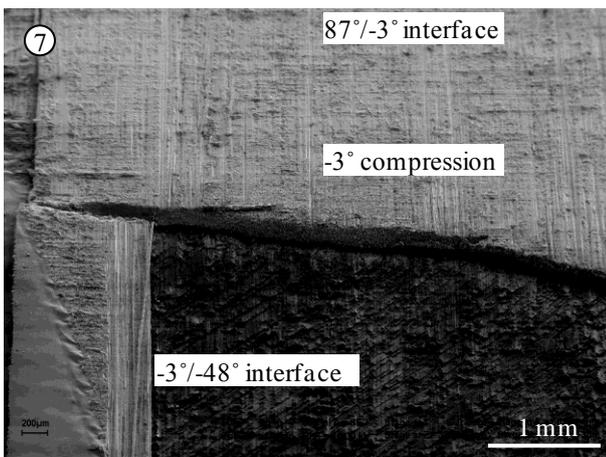
fracture morphologies either side of the crack in Fig. 14.

Fig. 14 Boundary of the insert showing compression failure and ply split of the -3° ply. Image rotated 180°

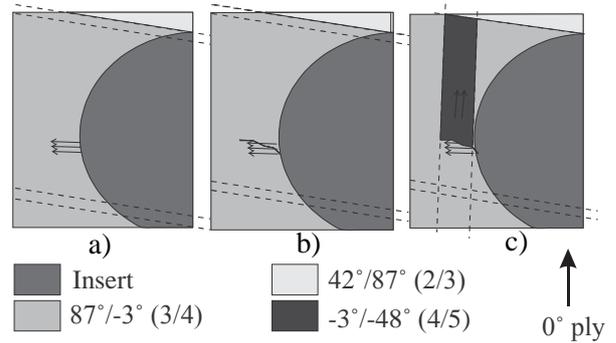
The sequence of events is summarised in Fig. 15.

Fig. 15 Failure sequence specimen L: ply interface 87°/-3°

- a) Ply splits develop in ply 87° and delamination grows on ply interfaces 87°/-10° b) compression failure of the -3° ply c) ply splits on the -3° ply
