DAMAGE CHARACTERISATION AND THE ROLE OF VOIDS IN THE FATIGUE OF WIND TURBINE BLADE MATERIALS

J. Lambert^{1*}, A.R. Chambers², I. Sinclair³, S.M. Spearing⁴

¹⁻⁴ School of Engineering Sciences, University of Southampton, Southampton, UK

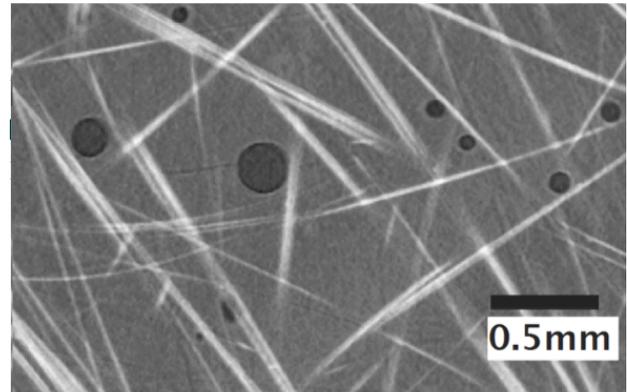
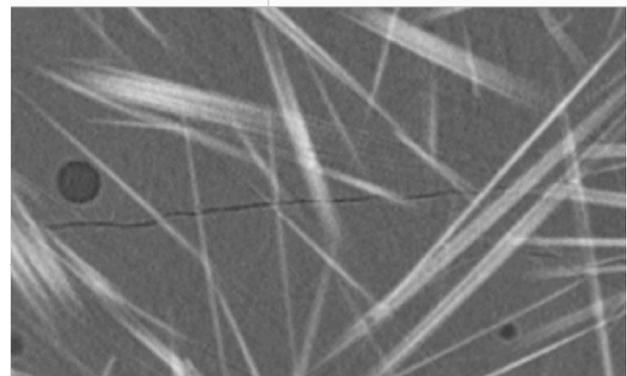
The initial fatigue damage mechanism was found to be transverse matrix cracking in the surface resin ply. This was found to occur along the entire specimen gauge length, however not at regular intervals. Some of the transverse matrix cracks interacted with voids in the resin ply, however others were completely independent of them, as shown in Fig 4.1.

It can also be seen from Fig 4.1 that the crack path remains relatively unaffected by the randomly orientated fibres present in the resin rich "fleece" layer. There was a prevalence of surface layer transverse matrix cracking at the edges of the specimens. These edge cracks had usually grown to a longer length than the other surface cracks, and some were also found turn to propagate at +45° as they grew inwards, allowing them to run parallel to the fibres between the tows of the +45° layer. These "turned" matrix cracks, combined with the specimen edge, provided a favourable stress state facilitating the next stage of damage. This further damage was found in all instances to be a delamination propagating along the specimen length between outer +45° and -45° fibre layers. This can be seen to support the experimental evidence of two previous studies: delamination propagation from the edge of the specimen, as documented by O'Brien^[10], and also from an existing matrix crack, as identified by Kashtalyan^[9]. Figs. 4.2 and 4.3 illustrate this interaction of damage, showing the same specimen with the outer material sequentially cropped away to reveal the sub-surface damage. The voids and cracks have been enhanced in yellow and red respectively by digital segmentation.

Fig 4.1 In-plane 2D CT slices, parallel to fibre plies, of the outer resin rich ply showing a) a transverse matrix crack interacting with a spherical matrix void b) a transverse matrix crack propagating independently of any voids

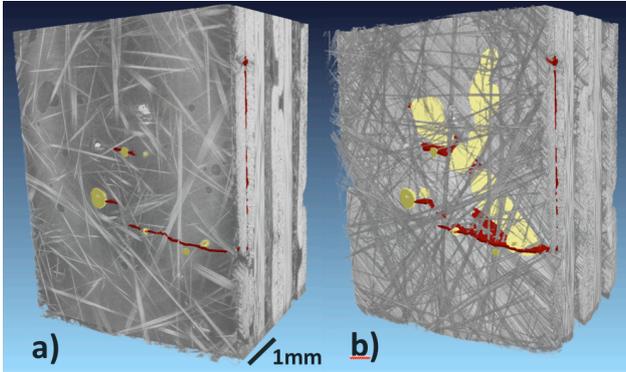
Figure 4.2 a) 3D reconstructed view of a tested 3x3.8mm cross-section “matchstick” specimen 5 mm in length containing a transverse matrix crack. b) The same scan with the matrix material revealed to show defect extension into specimen bulk

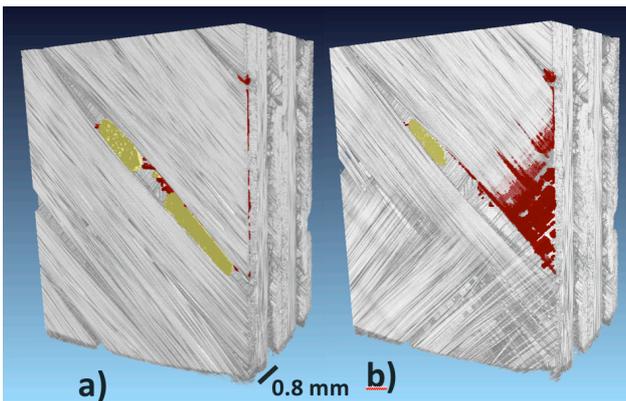
The role of the voids in allowing the crack to propagate more freely is visible in Fig 4.3 (a), where the majority of the cracked length is occupied by large inter-tow voids. Fig 4.3 (b) shows the partial edge delamination (in red) that has formed at the final crack depth, corresponding to the +45°/-45° interface. It is important to note that these edge delaminations were stable in growth rate and occurred well before coupon failure; at roughly 50-70% of the nominal estimated life. It was only when the damage progressed to the inner plies that critical accelerating degradation occurred. This was found to occur due to some critical

Figure 4.3. a) 3D reconstructed view taken 0.2mm from the front face of the specimen. b) 3D reconstructed view taken 0.6mm from the front face of the specimen.

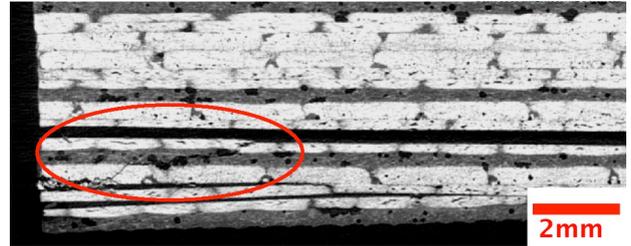
“damage event” that allowed crack propagation inwards to the 2nd (or 5th, from the opposite face) ply, usually resulting in its immediate delamination. This damage event was in some cases concentrated tensile or compressive fibre failure in the 0° tow nearest the edge, and in others a delamination that was able to turn inwards. Fig 4.4 shows a cross sectional view of fibre failure in the edge 0° tow that has caused a crack to pass through the 2nd ply resin rich layer, by means of a void, to form a large total-width delamination at the 2nd ply 45°/-45° interface.

The nine specimens that were tested to failure were analysed using the void segmentation procedure described in Section 2. The measured global parameters are described in Table 1., containing the extreme values of individual specimens, and the overall mean. Although many further individual specimen parameters were analysed, these have been omitted as no positive correlation with fatigue life was identified. Spatial distribution was also examined, looking for regional concentrations in void population that may have contributed to a raised local stress state and thus a shorter fatigue life. As this analysis also provided no positive result, a more local approach was adopted. As explained in Section 4.1, it is believed that the critical damage stage occurs when delamination propagates from the outermost ply to the inner plies. As shown in Fig. 4.4, this has been experimentally observed to occur through voids in

Fig 4.4 Cross-sectional 2D CT slice showing a crack passing through a void in order to allow damage to progress from an outer ply edge delamination to a 2nd ply total delamination

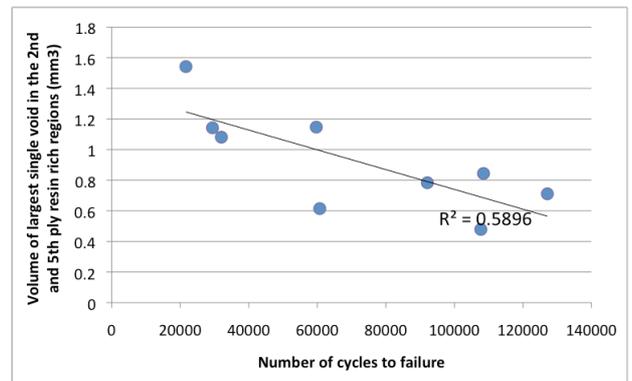
the 2nd/5th ply resin rich layer. These layers were thus extracted and analysed explicitly within each specimen. In this instance the size of the largest void within these resin layers was found to be inversely proportional to the fatigue life, with reasonable correlation, as shown in Fig 4.5.

Fig. 4.5 Localised largest void size in the 2nd/5th ply resin layer compared to the specimen’s fatigue life
