AN EXPERIMENTAL STUDY OF STIFFENED OPEN-HOLE COMPOSITE PANEL WITH BVID UNDER UNIAXIAL COMPRESSION

Jianzhuo Sun, Qun Zhao, Peng Shi, Hainan Yang and Chuanjun Liu

Beijing Key Laboratory of Civil Aircraft Structures and Composite Materials, Beijing Aeronautical Science & Technology Research Institute of COMAC, Future Science and Technology Park, sunjianzhuo@comac.cc

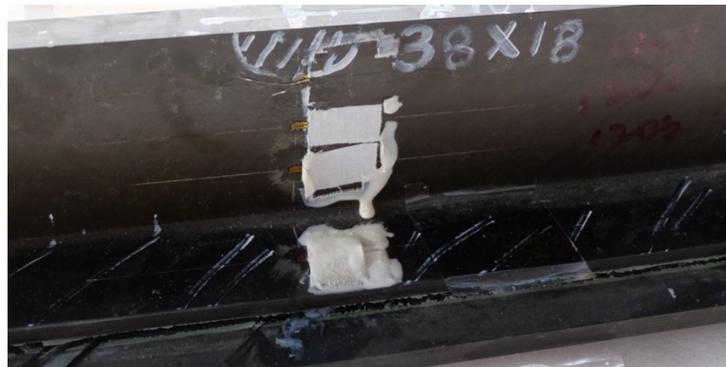
Figure 11 Delamination area of A position

After the specimen was impacted by the drop weight tower, the area around the impact position was inspected by the C-scanned device, and the depth of the dent was measured by a calliper. The inspection results are shown in Table 1. The delaminated area of the stringer around A area is shown in Figure 11. For the B position, no delamination was found.

Impact Energy	Depth of Dent	Delamination area
Position A	10.07 J	0.12 mm	508 mm ²
Position B	35.23 J	0.08 mm	0

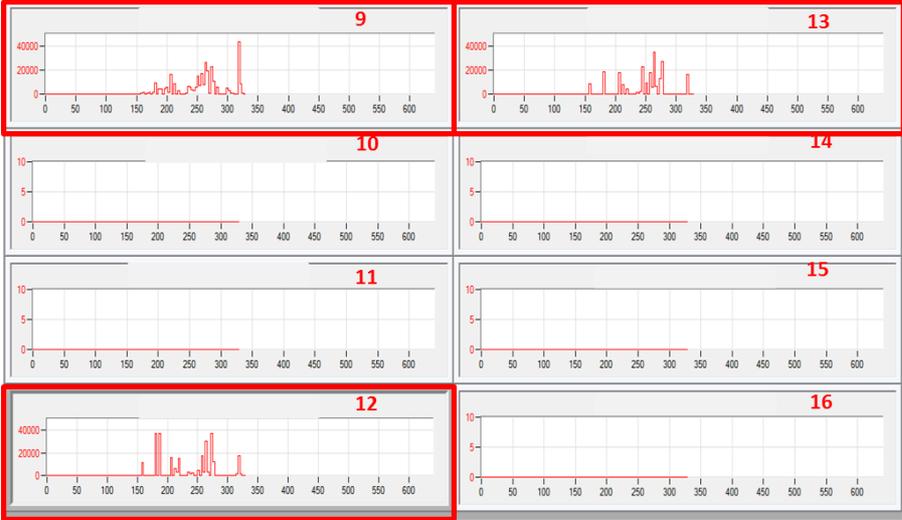
Figure 12 Acoustic sensor signals (9-16) of 110% DLL

During 110% DLL loading test, the strain gauge signals show good agreements with the FE results, the differences between each other are less than 7%. However, the acoustic emission sensors around the manhole impact position (sensor #9, #12, #13) start to receive the irregular signal from 70% DLL, which is shown in Figure 12. The C-scanned result shows that there is no delamination at impact A position, but the stringer and skin got deboned, as shows in the red section in Figure 13. Since the signal of acoustic sensor is relatively low and there is no de-bounding sound heard by human ears. It is highly suspected that the impact near the manhole results in the detachment of the stringer and skin, though the de-bonded area wasn't scanned by the NDI device before test.

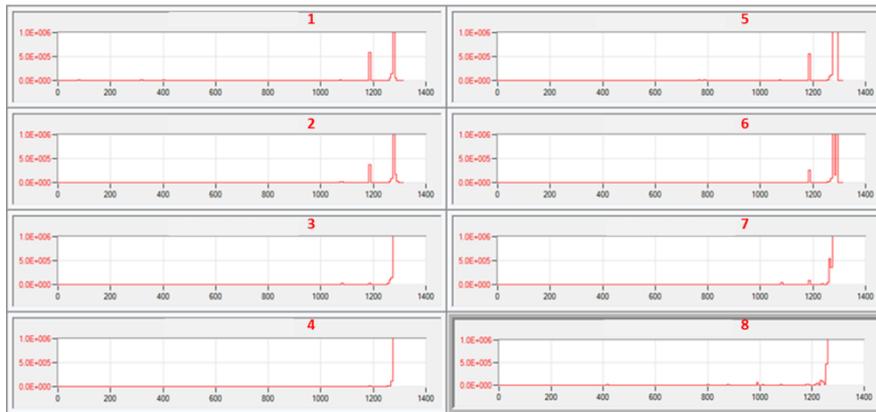
Figure 14 Acoustic sensor signals (1-8)

In the specimen failure test, the acoustic sensors around the manhole impact position (sensor #9, #12, #13) start to receive the irregular signal from 70% DLL as well, which may indicate that the initial detachment begin to grow gradually after 70%DLL. The magnitude of the signal increase dramatically after the specimen loaded to 200% DLL, which shows that the detachment expands much faster than the expansion at lower load. The signals from the sensors, which are located on the opposite side of the manhole to the impact position (sensor #1, #2, #5), has no change until the load goes up to 220% DLL. After that, the sensor receive a pulse signal, but there is no significant noise heard by human ears, which may inform that the stringer and skin get deboned rather than material failure. After a few seconds, with a huge noise, the signals go up to a very high level, which is shown in Figure 14&15. The stiffened panel get crashed at 229% DLL.

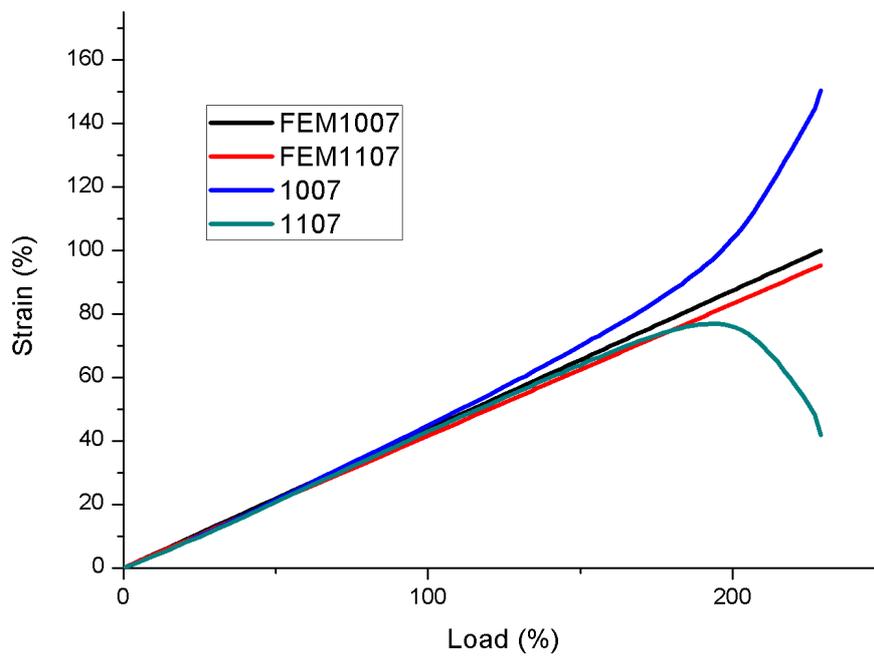
Figure 17 Strain Comparison

For the strain measurements, when the load goes higher than approximate 130% DLL, the back to back strain gauge signals (1007/1107, 1008/1108, 1009/1109, 1010/1110) around the impacted position become diverged, which is near the man-hole. The signals of 1007 and 1107, where located at B impact position as show in Figure 16, are compared with the FE results and shown in Figure 16. The divergence increase dramatically after the load goes higher than 200%, which is at the same time that the acoustic signals enlarge significantly. Besides, the signal of 1012 located on the stringer keeps being linear, but the signal of 1112 located on the backside of the skin goes down, which is shown in Figure 17. In summary, it is inferred that the stringer and the skin got massively de-bonded after the load reached 200% DLL, and the skin became highly buckled until the material failed. The crashed specimen is shown in Figure 18. The skin is broken, and detached with the stringer. The failure mode is the same as the inference from the acoustic signals and strain gauge signals.

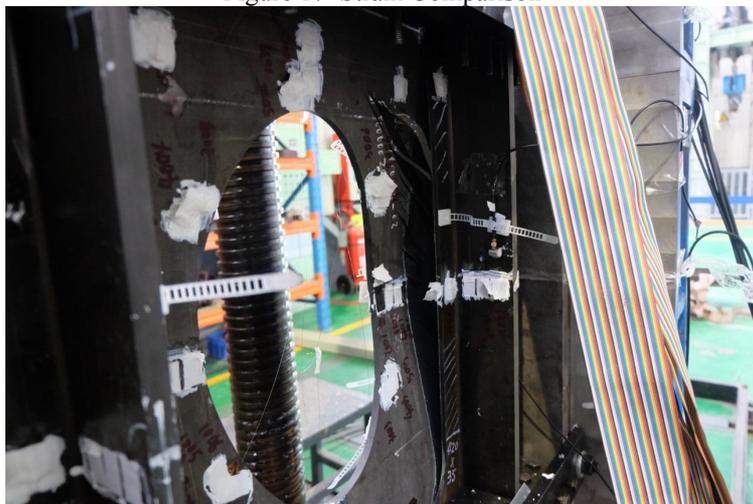
Figure 18: Crashed Specimen

From the results of this study it can be suggested that the incident impact energy could cause damages not only at the impact position, but also the area around it, especially the impact position is at

the edge of structures. The stress wave would go back from the free edge, and propagate to the other structures. If the interfaced bonding is not strong enough, it may cause unexpected de-bonds. Although the detachment is extremely fatal, it is barely visible. To avoid the detachment, fasteners are suggested to install at such positions.
