INJECTION REPAIR OF COMPOSITES FOR AUTOMOTIVE AND AEROSPACE APPLICATIONS

Robert S. Pierce¹, William C. Campbell² and Brian G. Falzon³

Keywords: Injection repair, Dry spots, Sandwich, Delamination

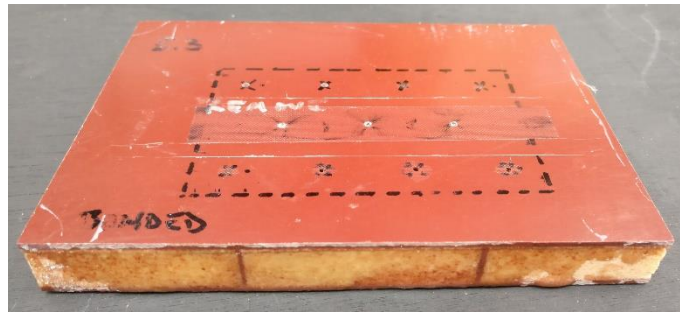
Visual observation generally provided a good indication of the success of each infusion, where resin could be seen at the outlet holes after having clearly travelled through the interior delamination region. This is shown for a sandwich sample containing a 90×60 mm delamination area, with three inlet and eight outlet holes, in Figure 3. Further inspection via NDI was used to confirm the interior filling, as seen in Figure 4. With only some small areas that remained quite dark in the thermographic images, suggesting that they may not have been filled completely.

Figure 3: Repaired GFRP/foam sandwich sample.

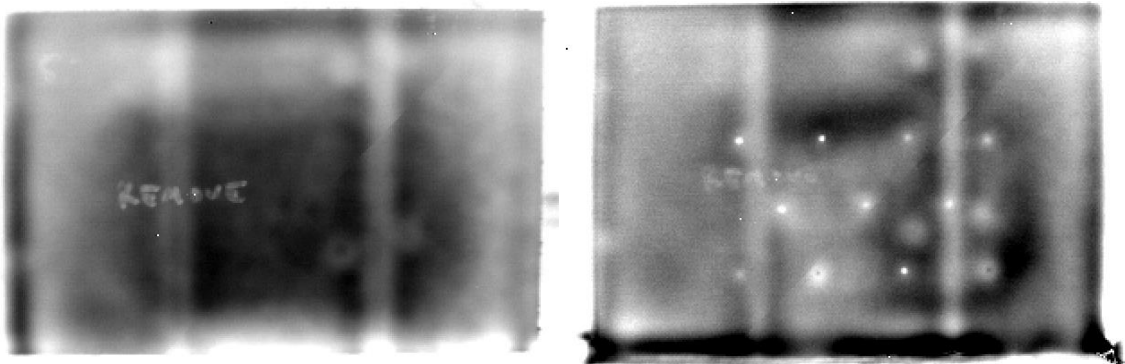
Figure 4: Infrared thermography of a sandwich sample before and after injection repair.

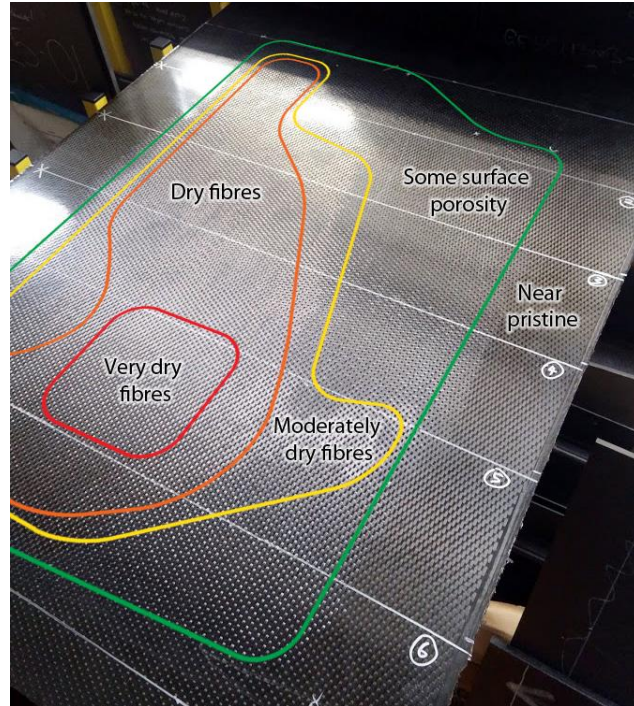
Subsequently, a series of six samples were cut across the full width of the defective panel, spanning the transition from dry to pristine regions, as shown in Figure 5. After sectioning, each sample was wiped clean using solvent and cloth, then the edges were inspected to measure the depth of dryness throughout the panel. Figure 6 shows the extent of the dryness in the cross-section of the 'dry fibre' region, where the top plies are completely dry and easily separate from the laminate. In the worst affected region of the panel, the maximum depth of the defect was found to be more than 25% of the panel thickness, at 2.8 mm deep.

Figure 5: Categorisation of dryness and sectioning of the defective panel.

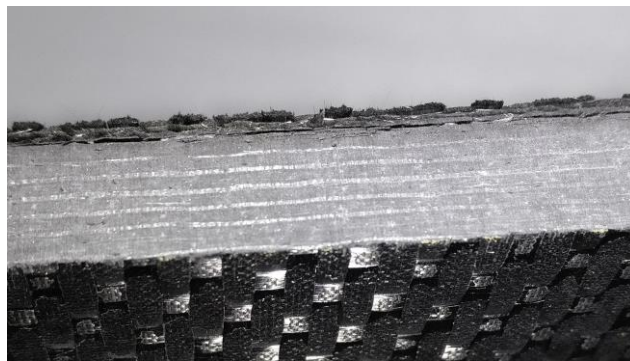
Figure 6: Panel cross-section in the 'dry fibre' region.

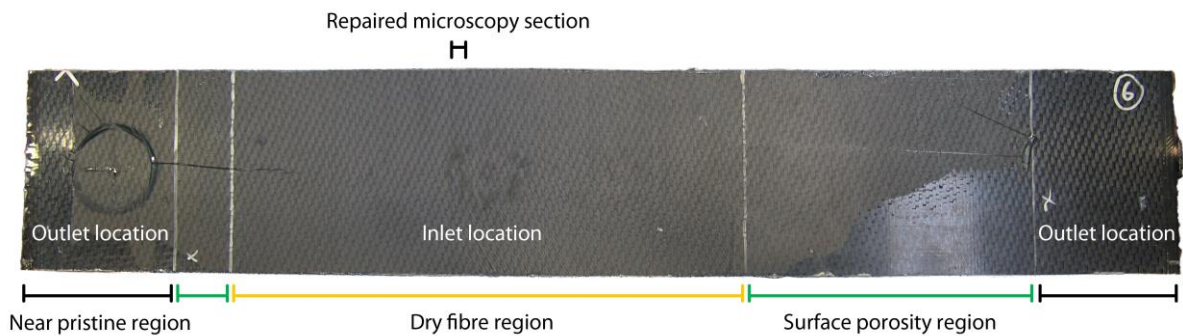
Three similar samples with moderately large dry fibre regions (identified as samples '6', '3' and '4') were repaired and evaluated using a range of visual, non-destructive and microscopic inspection techniques. Visual inspection revealed that the worst dry fibre regions of the defective panels had been successfully filled, although the larger areas of surface porosity did not completely fill in all cases. Repositioning of the inlet location, flow-enhancing media or a heated repair environment would likely resolve this issue. The repaired surfaces of samples '6' and '3' are shown in Figure 7 and Figure 8 respectively. A small section was cut away from the repaired edge region of sample '6' for subsequent microscopy, seen in Figure 9. Here the top plies from the repaired region appear to have been well wetted and filled with resin as a result of the injection repair process, exhibiting no voids. However, considerable porosity appears to have also been introduced through the full thickness of the laminate as a by-product of the defect's manufacture.

Figure 7: Injection-repaired top surface of sample '6', highlighting the cross-section used for microscopy.

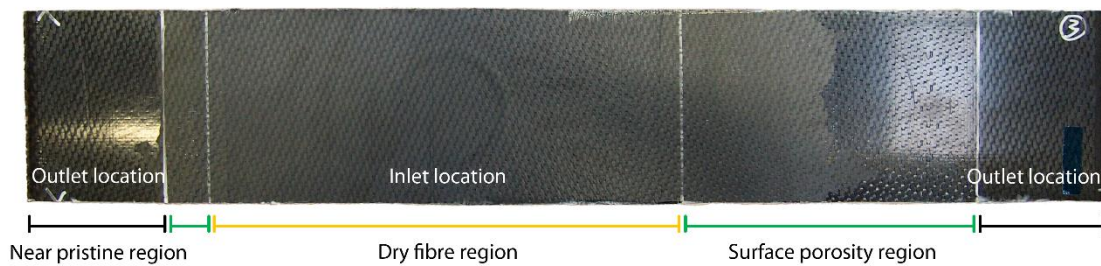
Figure 8: Injection-repaired top surface of sample '3'.

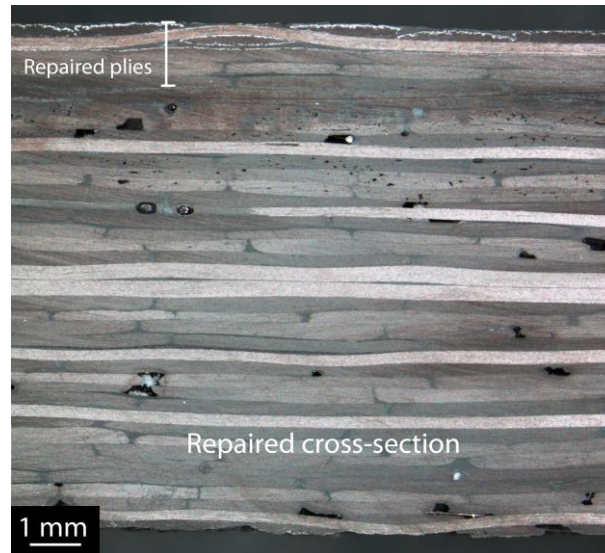
Figure 9: Microscopic cross-section from repaired edge of sample '6' (as depicted in Figure 7).
