ASSESSMENT OF WIND TURBINE BLADE TRAILING EDGE FAILURE WITH SUB-COMPONENT TESTS

F. Lahuerta¹, M. J. de Ruiter¹, L. Espinosa¹, N. Koorn¹, D. Smisjaert¹

¹ Knowledge Centre WMC. Kluisgat 5, 1771 MV Wieringerwerf, The Netherlands

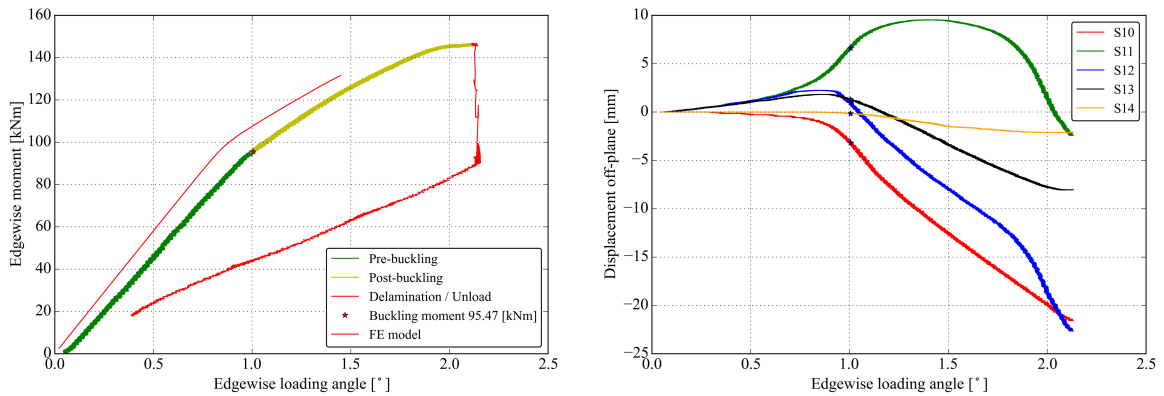
Figure 7: Edgewise moment versus edgewise loading angle of the rotating arms (left plot). Off XY plane displacements versus edgewise loading angle of the rotating arms (right plot), displacement sensors S10 to S14.

The sub-component coupon was loaded with an edgewise moment at constant speed until failure. The test was characterised by the formation of a buckling wave along the trailing edge which promoted the full delamination of the trailing edge adhesive joint. During the static test three main stages were observed (see Figure 7, left): the pre-buckling, the post-buckling and the ultimate failure and delamination stage.

The *pre-buckling stage*. In this first stage the mechanical behaviour of the blade section was characterised by a linear edgewise stiffness until the buckling moment was achieved. The buckling wave during the pre-buckling stage was characterised by low amplitudes of the off XY plane displacements (see Figure 7 right).

The *trailing edge post-buckling stage*. In this stage it was observed a drop of the sub-component edgewise stiffness and a non-linear stiffness behaviour until the final failure. The loading position between the pre-buckling stage and the post-buckling stage showed an inflection point due to the change of the stiffness's. This inflection point was determined as the buckling point located at 1 degree of edgewise loading angle and an edgewise moment of 95 [kNm]. Beyond the buckling point and during the trailing edge post-buckling stage, the amplitudes of the buckling wave formed along the trailing edge showed a rapid increase leading to maximum amplitudes of 30 [mm] before the final failure (see Figure 7 right).

The *ultimate failure stage*. The failure was characterised by a sudden delamination failure of the trailing edge adhesive joint. The full delamination occurred at an edgewise moment of 142 [kNm], where a dramatic decrease of the edgewise stiffness was recorded once the trailing edge was delaminated. The failure occurred at the highest buckling wave amplitudes recorded.

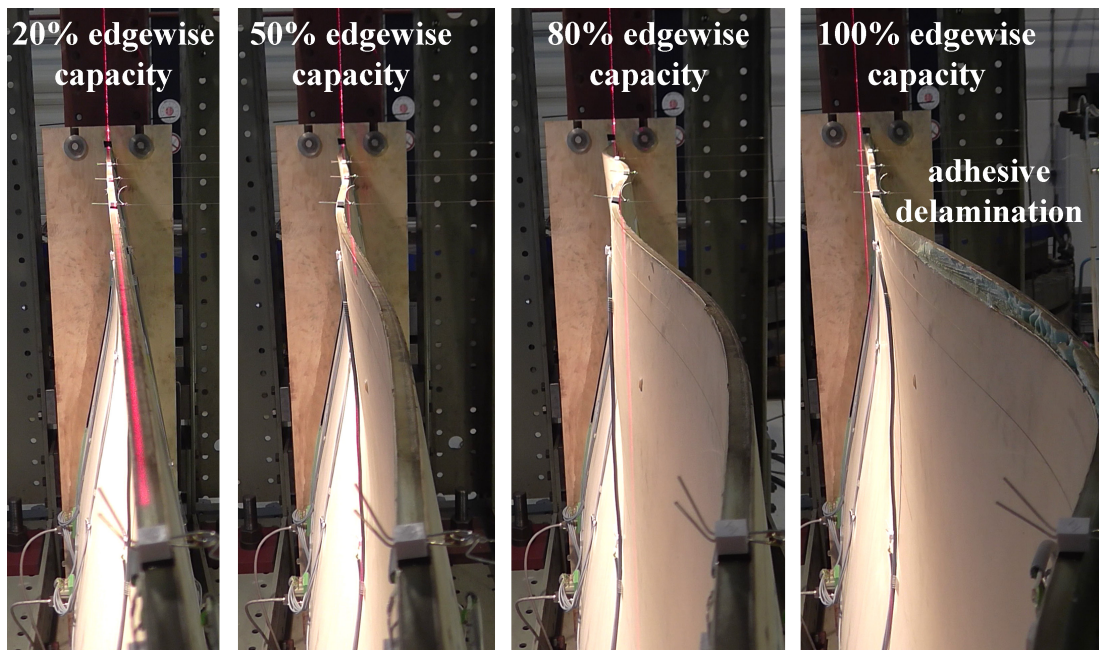
Figure 8: Side view of the trailing edge during the test. Buckling wave formation and adhesive joint delamination failure mechanism.

Figure 8 shows the top view of the trailing edge during the test, where it is described how the buckling wave is formed at different levels of edgewise moments. While at 20% of the total edgewise capacity the buckling wave is barely visible, higher edgewise moments show higher buckling wave amplitudes until final adhesive delamination. The failure mechanism of the trailing edge adhesive joint is driven by the buckling wave formation. The increment of the buckling wave amplitude is associated with a multiaxial load state in the trailing edge adhesive joint, where the inboard and outboard panel tends to separate (also denominated as “the breathing of the blade”) leading to higher peeling loads along the adhesive joint. Similar failure mechanisms have been reported for blade test [13], [14] and trailing edge blades failures on service [5], where due to the action of combined flapwise and edgewise moments adhesive joint failures were promoted. According to the failure mechanism recorded with the cameras [17] and strains distributions, the tests setup was able to mimic the loading conditions of an edgewise moment which drive the adhesive failure of the trailing edge.

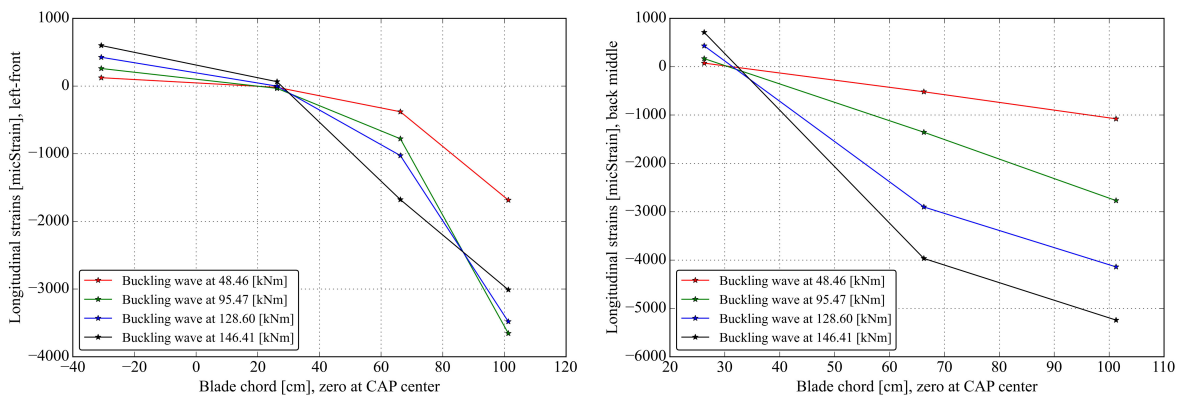
Figure 9 describe the evolution of the longitudinal strains at different edgewise moments and across the blade chord. The longitudinal strains plotted across the blade chord are equivalent to the strain distribution that can be expected for an edgewise moment. Right and left figures show that longitudinal strains are distributed from maximum compression state at the trailing edge, to a minimum tension state at the leading edge. In addition, the longitudinal strain distribution shows null values for chord positions crossing the CAP location or neutral axis. The distribution of the longitudinal strains across the chord shows that the setup was able to mimic an edgewise moment stress distribution across the subcomponent. Maximum compression longitudinal strains of 6000 [micStrain] were recorded close to the failure and compression longitudinal strains of 3000 [micStrain] were recorded at the buckling load. Moreover, Figure 10 describes the evolution of the transverse and shear strain across the blade chord. Shear strains caused by the edgewise moment loading showed values of 6000 [micStrains] at the trailing edge position.

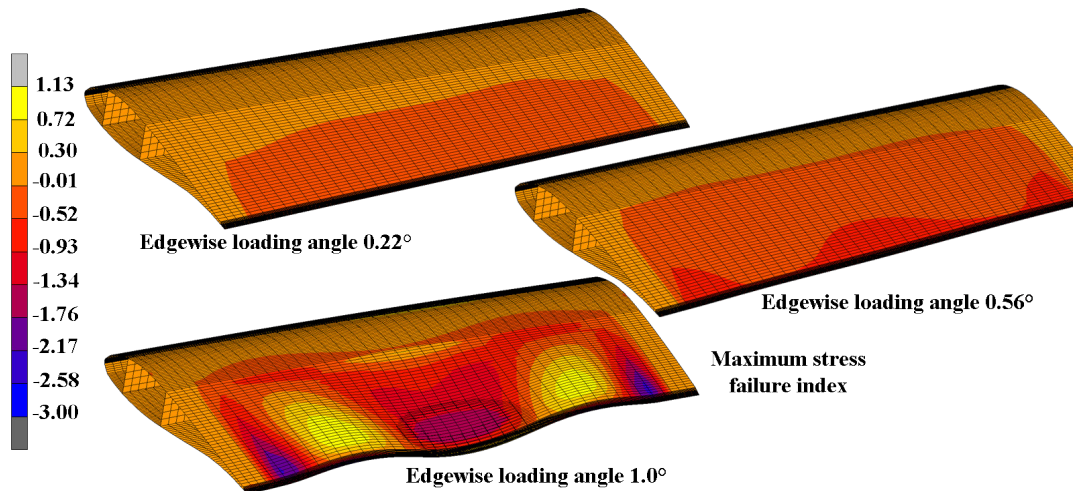
Figure 11: FE model maximum stress failure index at different load intervals.

The test setup was 2.5D modelled following the scheme described in Figure 2 and according to the specifications of section 2.1. Figure 11 shows the model deformed shape and maximum stress failure index. The model deformed shape shows a buckling wave on the third order located on the trailing edge, which is comparable with the one recorded during the static test (see Figure 8). Larger failure indexes values are located on maximum and minimum buckling wave peaks where multiaxial strain fields can be expected. The model suggests that the opening at the trailing edge (or breathing of the blade) caused by an edgewise moment can be related to the compression loads formed along the trailing edge. Figure 12 (right) shows the opening angle of the trailing edge plotted versus the edgewise loading angle, where the opening angle of the trailing edge was computed by trigonometry according to the displacements of inboard and outboard nodes. The figures describe the opening angle of the trailing edge is intrinsically related with the pre-buckling and post-buckling stages. While during the pre-buckling stage the opening angle of the trailing edge shows weak dependence with the edgewise moment, once the post-buckling stage is achieved edgewise moment and trailing edge opening angle show a linear dependence. Moreover, large trailing edge opening angles can be related with the final delamination, due to the mode I fracture failure of the trailing edge adhesive joint. On this regards several publications have described similar reasons for thick adhesive joints failure from the point of view of fracture mechanics with experimental tests [6], [10], [18], [19] or with dissipative fracture mechanics FE models [7], [12], [14].
