SPECIMEN DEVELOPMENT AND FAILURE MODES INVESTIGATION IN IOSIPESCU INTRALAMINAR SHEAR TEST

KEYWORDS: failure modes, Iosipescu shear test, specimen preparation

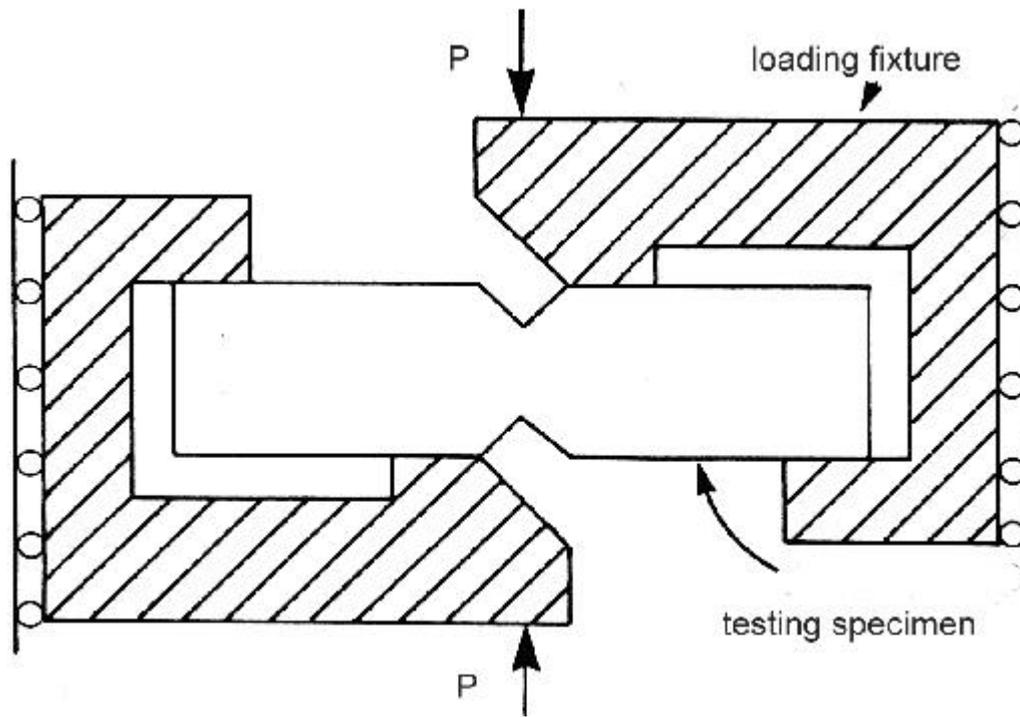
Figure 1. Diagram of Iosipescu test for 0 degree GF/PA6 composite specimen

The principle of this test is that a double-V-notch specimen was employed and through the action of a force couples, a state of pure shear in the middle length of the specimen are achieved. The force couples produce counteracting moments and that the moments exactly cancel at the middle length of the specimen. A constant shear force is induced through the middle section of the specimen, thus producing a pure shear loading at that location (see fig1).

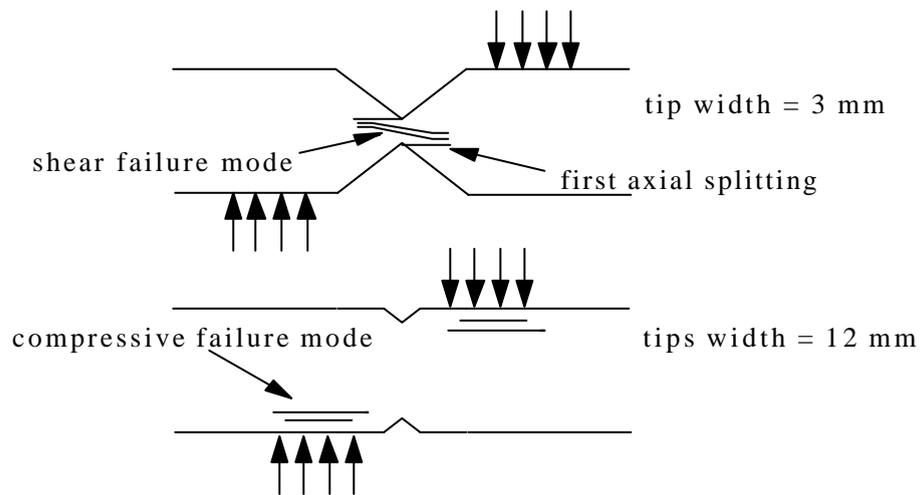
Figure 2. Illustration of Iosipescu test failure modes with different tips width

The double-V-notch specimen preparation was a very important part of the Iosipescu test. The specimen has to be prepared with the right notch angle, depth and radius to achieve a pure shear failure during the test. Otherwise, the specimens will be compressively crushed at the loading zone as figure 2 illustrates. There are maybe many ways one can achieve a pure shear failure in the test. In our study we used one of them to optimise specimen performance for the particular composite which was to vary notch depth in the specimen, and observing failure modes and performance under a microscope during the test.

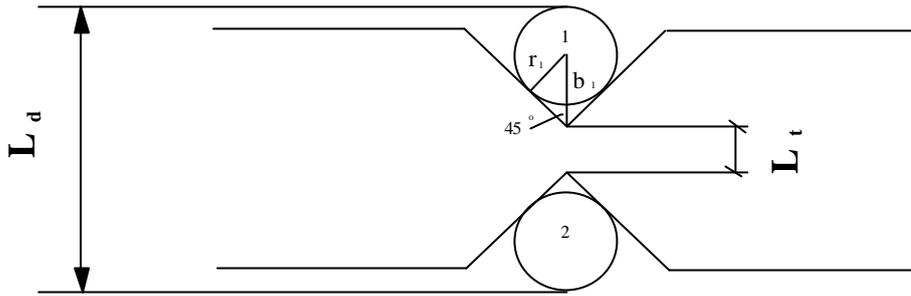
Figure 3 Measurement of the tips width of Iosipescu specimen

To measure the width between the two tips of the notches accurately two dowel pins were used to fit in the two notches and the length L was measured by a vernier. The width between the two notch tips can be calculated as the geometry shows in the figure 3.

$$L_t = L_d - (b_1 + r_1) - (b_2 + r_2)$$

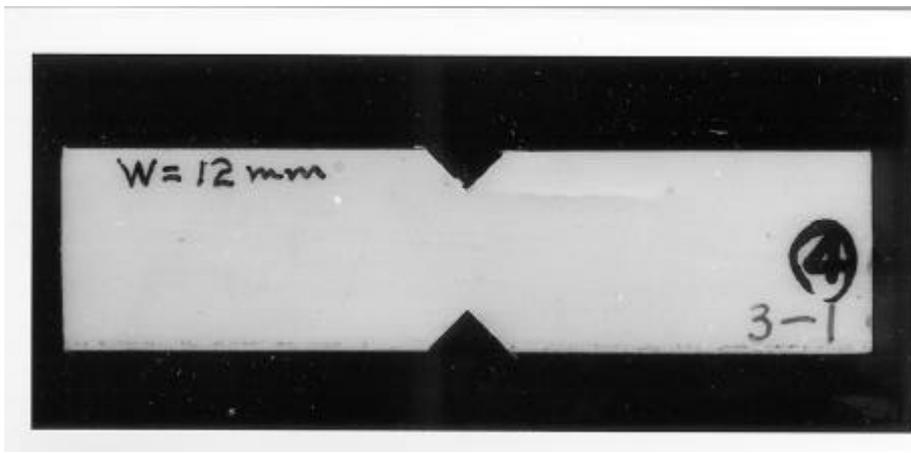
Figure 4 Iosipescu specimen with 12 mm notches' tips-width and without reinforcing fixture

The width between the two notches' tips varied from 12 mm down to 3 mm to find the best pure shear failure mode in the test. As it can be seen in figure 4, the width between the two notch tips was 12 mm as ASTM specified. There was a very clear compressive damage line under the loading zone, which was next to the top notch. This means the failure mode of this specimen was compressive failure instead of pure shear failure.

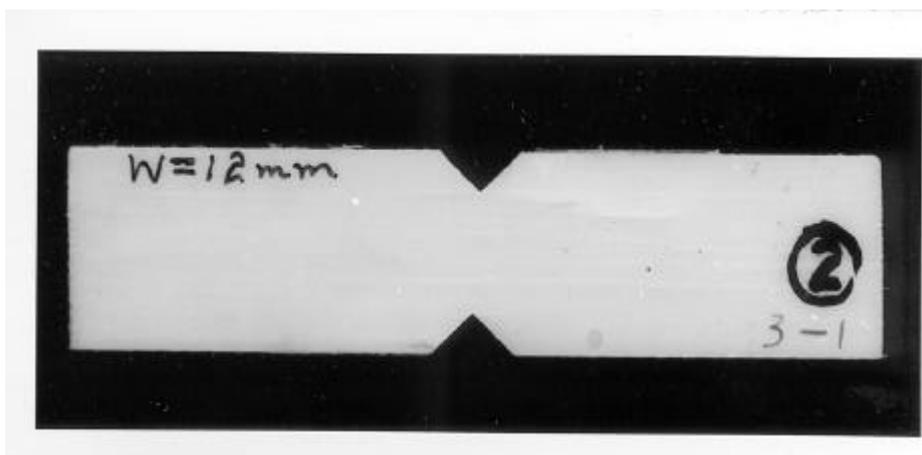
Figure 5 Iosipescu specimen with 12 mm notches tips-width and a thin steel layer reinforcing fixture glued on each side of the loading zone

To avoid the compressive failure in the 12 mm tips-width specimen, a thin steel sheet was glued on each side of the loading zone. One was attached on the top of the right side of the notch, and the other one was attached on the bottom of left side of the notch to reinforce the composite as shown in figure 5. However, it still failed in compressive crushing.

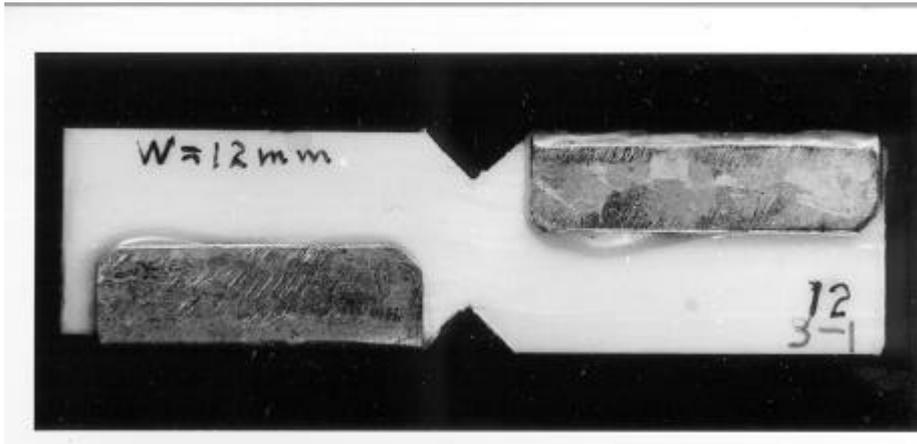
Figure 6 Iosipescu specimen with 12 mm notches tips-width and a thick steel channel section sheath glued on each side of the loading zone

Next, a steel channel section sheath was glued on each side of the loading zone, but the specimen still failed in compression (see figure 6). It was found that a few slight shear deformed lines appeared between the tips of the notches and were accompanied with compressive failure. Figure 7 indicates that 9 mm tips-width specimen with no reinforcing fixture attached on produced a similar failure as the specimen in the figure 6.

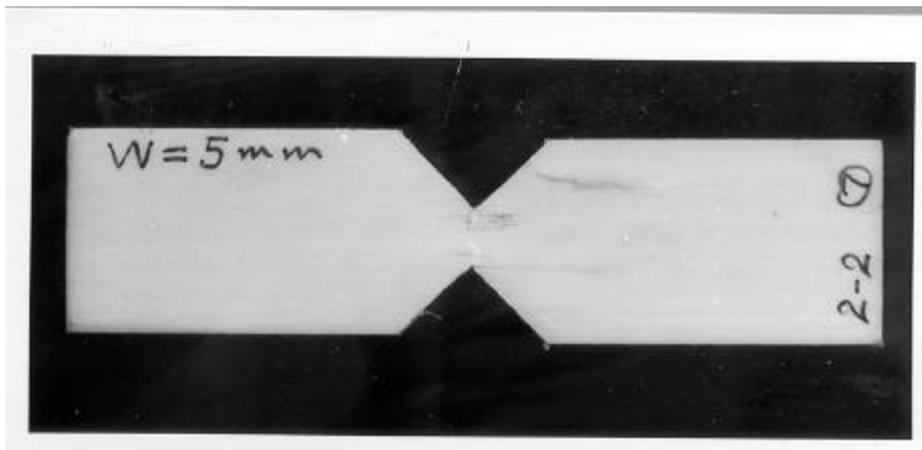
Figure 8 Iosipescu specimen with 5 mm notches tips-width

Reducing the tips-width to 5 mm with no reinforcing fixture attached on, produced shear flowing lines between the two notches' tips, as seen in figure 8. Shear failure appeared first and then followed by an ultimate compressive failure at the loading zones. Therefore the ultimate failure data was still not reliable for measuring the maximum pure shear strength in the composite.

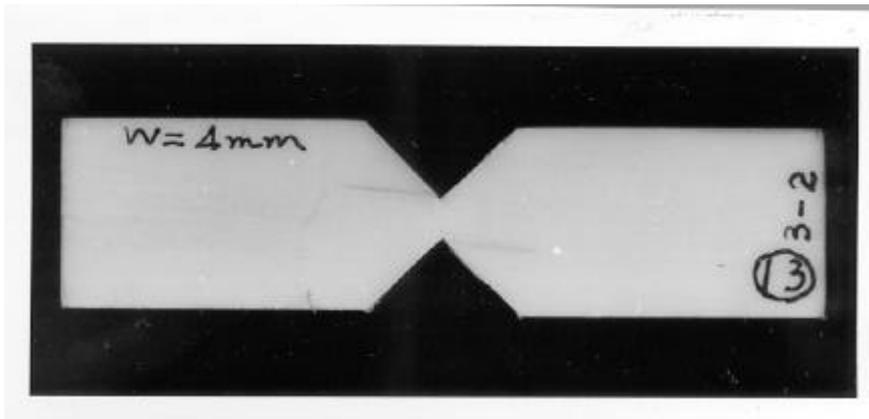
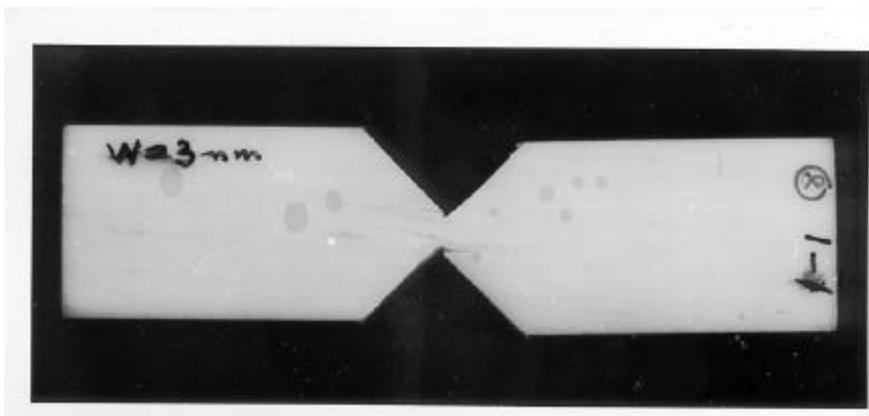
Figure 9 Iosipescu specimen with 4 mm notches tips-width

Figure 10 Iosipescu specimen with 3 mm notch tips width

Figures 9 and 10 show that the failure in specimens with tips-width 4 mm and 3 mm, which were no reinforcing fixture attached. The failure modes of the specimens were pure shear failure in the specimens as the photos show. However, it can not be guaranteed that the shear stresses will uniformly distribute in the middle section of the specimens, especially for the 4 mm tips-width specimen. Nevertheless, those specimen geometries have been found to yield reliable shear strength data falling into the typical acceptable pure shear failure modes as ASTM specified. Thus the optimum tips width for this particular composite should be 3 mm. The shear dislocating lines in this test were found as opposite to the ASTM stated in its failure mode of the unidirectional 0° specimen (ASTM D5379-93, figure 11, 1993). Figure 11 illustrates the difference between this test and the failure mode of ASTM D5379-93.

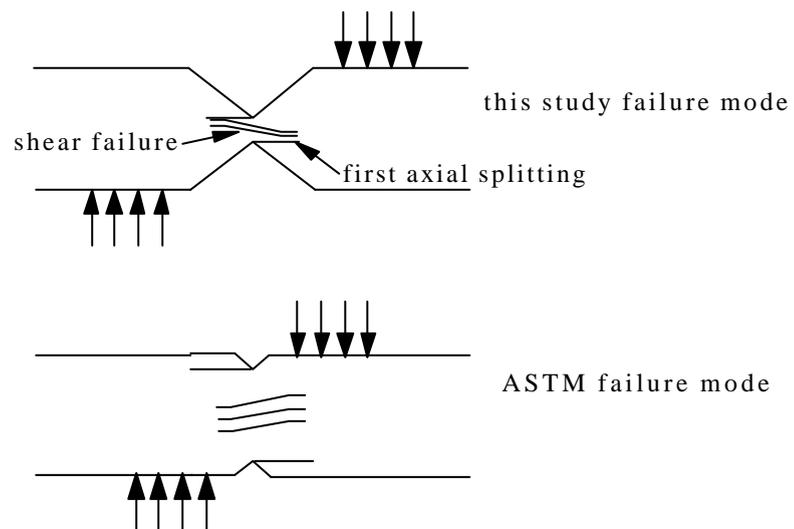
Figure 11 Comparison of unidirectional 0° composite specimen failure modes in Iosipescu test

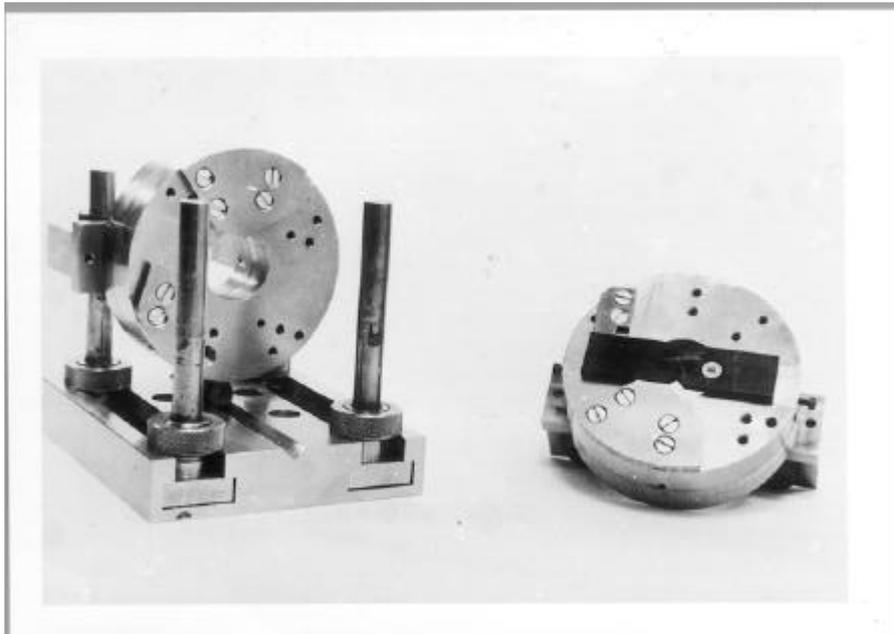
Figure 12 Iosipescu test fixture

The test fixture was based on the original Wyoming University test fixture developed by Walrath and Adams, and made by this research centre (see figure 12). Iosipescu tests in this study were performed under monotonously applied compressive loads normal to the longitudinal axis of the specimen. A microscope observed the mechanical dynamic response of the tests.

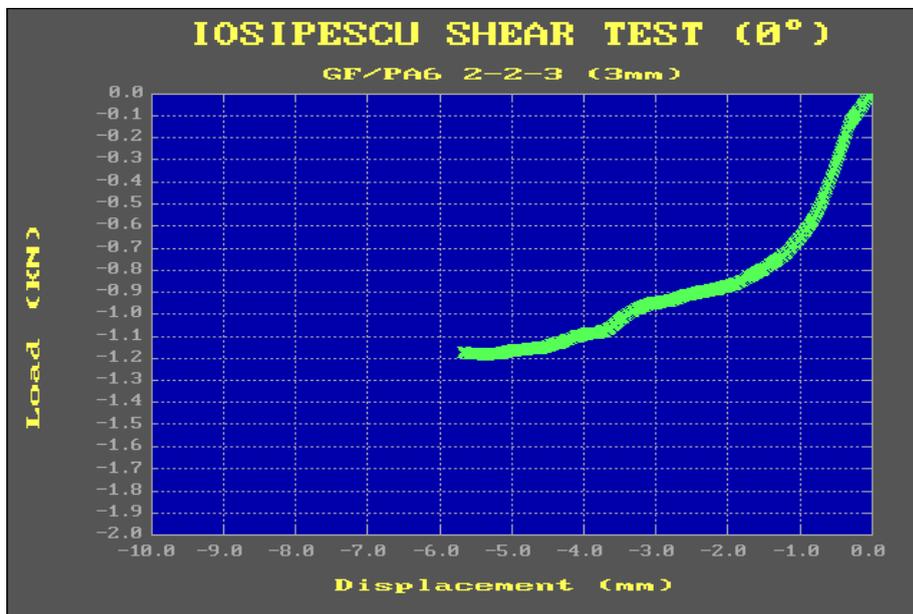
Figure 13 Load-displacement curve of air cooled 0 specimen in Iosipescu test

A microscope was used to observe the mechanical dynamic response of the Iosipescu test. The dynamic response of the 0 degree oriented specimens was initially linear as figure 13 shows. The on-set of a non-linear behaviour occurred at approximately 0.7 KN. First axial splitting under the notches (at the tips) were observed, manifested by load drop appearing at the load-displacement curves (0.8 KN). The axial crack tended to initiate at the notch root and propagate parallel to the axis on one side of the notch tip and opposite to the loading points (see figure 10). The axially aligned fibres stopped the growth of the cracks in the principal stress plane, 45° to the axis. The shear stress concentration at the notches' tips was primarily responsible for the cracking initiation. These cracks relieved the local stress concentrations at the notch tips.

Subsequently, a few cracks along the fibre orientation appeared between the notches' tips in the specimen mid-section. The load drops again significantly, which was termed as secondary failure at 1.1 KN in the test. The cracks consisted of numerous short interfacial cracks. They were manifested in the SEM photos and will be discussed in the next section. The cracks propagated into both directions along the fibres and finally caused ultimate failure at 1.45 KN in the specimen. The shear strength at the failure points is 91.7 MPa for secondary shear failure and 120 MPa for ultimate failure. The interfacial shear strength from this study and tensile strength from flexural study are listed below:

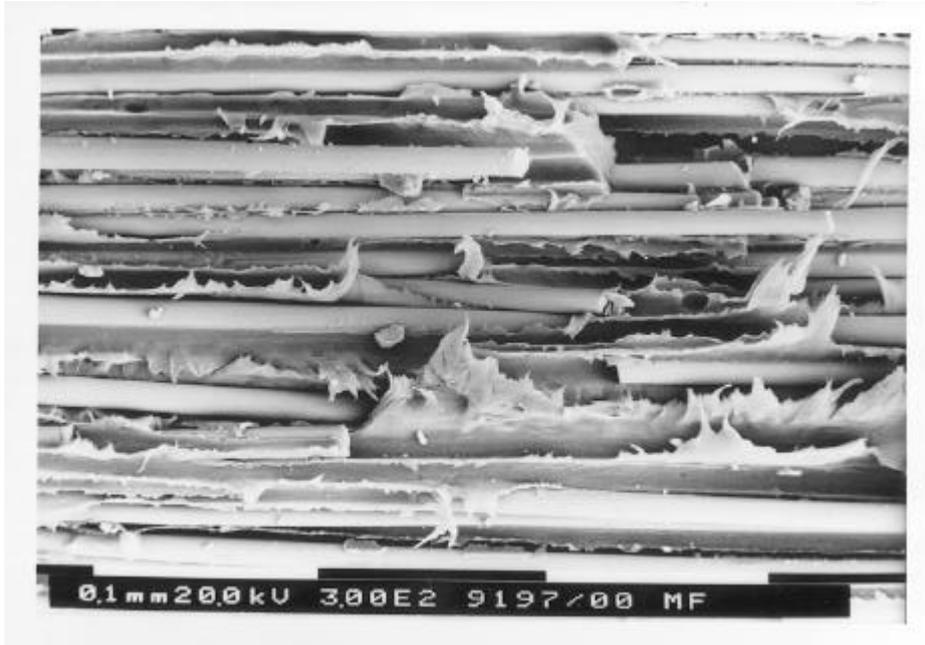
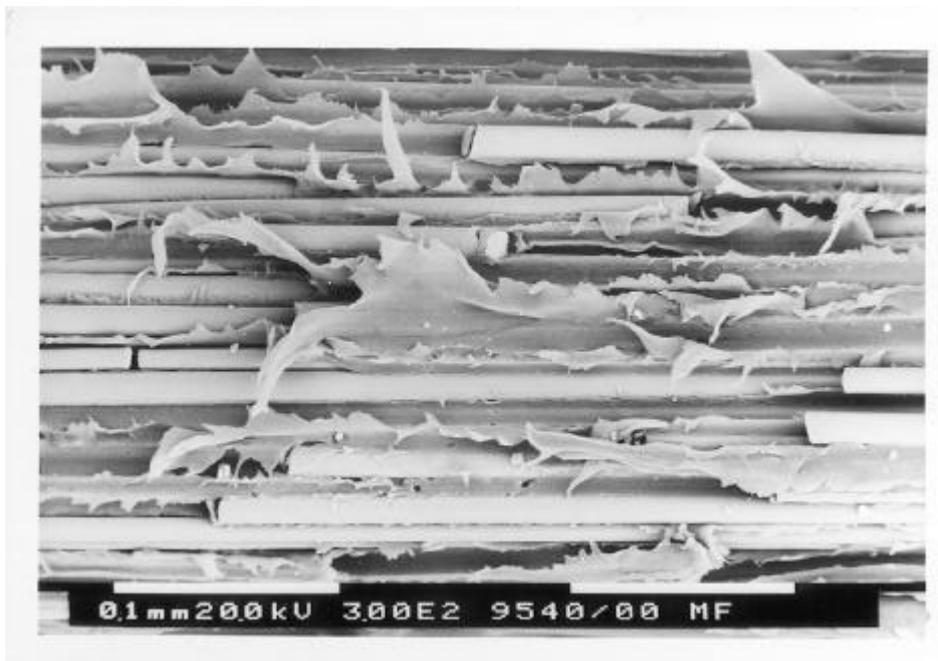
Figure 14 SEM photo of Axial splitting section fracture surface of Iosipescu test

Figure 15 SEM photo of midspan section fracture surface of flexural test

From the stress state analysis of the V-notch root axial splitting section, the stress states at this point was tensile stress as mode I fracture dominated the damage zone. It can be seen in SEM photos (see figures 14 and 15). Figure 14 shows that the fracture surface features of the axial splitting section were similar to the flexural fracture surface, which was typical mode I fracture (figure 15). It has been seen in the both SEM photos taken from flexural and Iosipescu fracture surfaces, that the matrix was torn off from the fibre surface vertically to the fibre axis which means mode I fracture contributed to the damage zones in both tests. Thus, the first axial splitting stress may give information of the tensile strength of the interfacial bond of the composites.

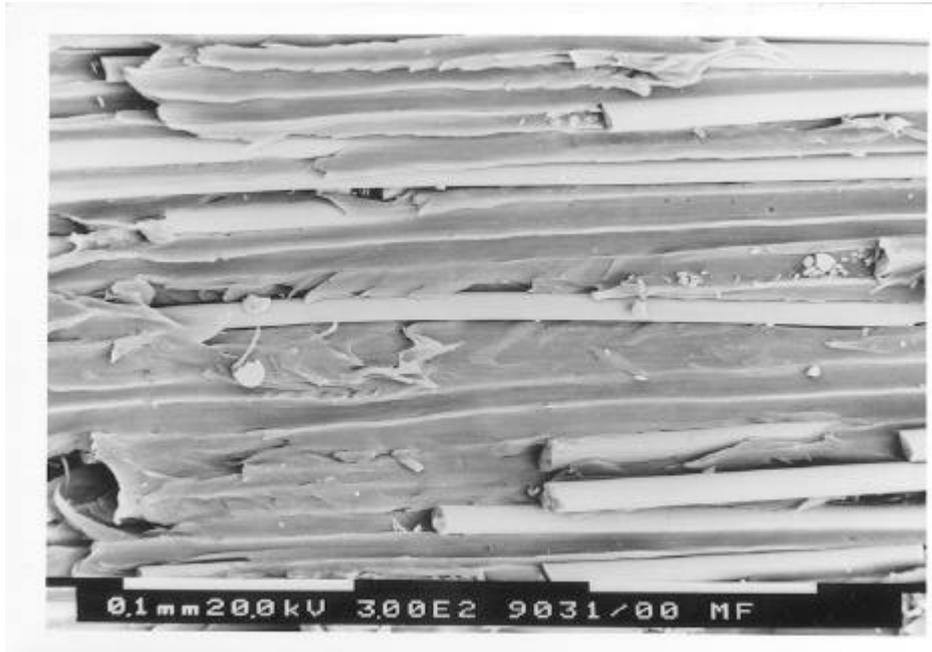
Figure 16 SEM photo of midplane section fracture surface of Iosipescu test

Subsequent to the axial splitting, secondary failure and ultimate failure followed with increasing load. The failure modes of the latter (secondary and ultimate) were pure shear failure. It can be verified by the SEM study of the midplane cracking section, figure 16. The surface feature

shows typical shearing plastic deformation. The matrix was torn off and plastic flow 45° to the fibre axis approximately as shown in figure 16. Thus, the secondary failure stress and ultimate failure stress may directly indicate the shear strength of the interfacial bond of the nylon6/GF composites.
