# LOW VELOCITY IMPACT DETECTION AND DAMAGE ASSESSMENT IN COMPOSITE MATERIALS USING FIBRE BRAGG GRATING SENSORS

Leonidas Dokos<sup>1</sup>, Matthew Mowlem<sup>1</sup>, Alan Chambers<sup>1</sup>, Gilberto Brambilla<sup>2</sup> and Valerio Pruneri<sup>2</sup>

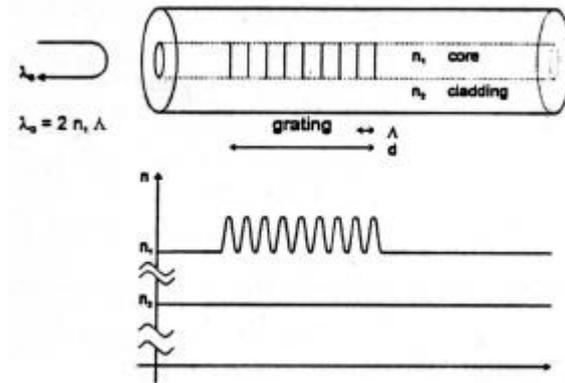
Fig. 1 Fibre Bragg grating sensor

A fibre optic Bragg grating is a periodic variation in the index of refraction along a certain length of the core of a single-mode optical fibre. This periodic structure makes the grating act as a wavelength-selective reflector. The centre wavelength of this reflection spike is determined by the Bragg relation  $\Lambda = 2n_1L$ , where  $\Lambda$  is the period of this index modulation and  $n_1$  is the average refractive index of the fibre core. The strain response arises due to the physical elongation of the sensor (and corresponding fractional change in grating pitch) and the change in fibre index due to photo elastic effects [6]. Once the grating is subject to a strain, both the grating period length and the average refractive index will change and so accordingly will the reflective wavelength (Figure 1).

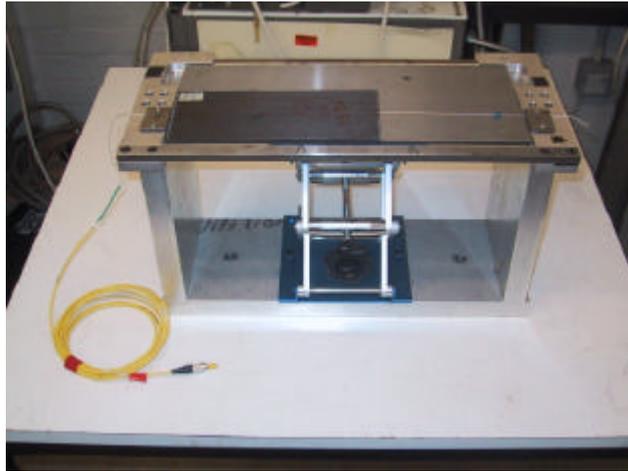
Fig. 2 Special rig for embedding FBGS in composite panels

During manufacturing of the samples, the FBGS have to be embedded in the composite panels without being damaged especially during the curing cycle, in which a temperature up to 125°C and pressure of several bars is reached. To achieve this a special rig has been developed at the Department of Engineering Materials, University of Southampton. The optical fibre is placed carefully in special constructed slots and aligned as shown in Figure 2.

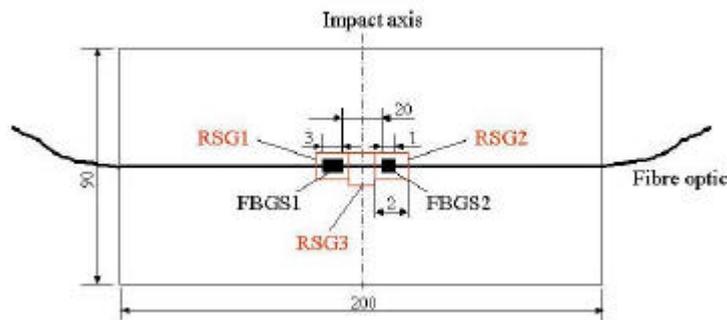
Fig. 3 Schematic diagram of the test coupon with the embedded FBGS

The integration plane is situated at a specific depth, which determines the sensor sensitivity to damage created by the impacts. The depth and the orientation of the FBGS was chosen according to the existing literature referring to the optimum position of embedded FBGS [10-12] in order to avoid the local perturbation in the geometry of the structural fibres resulting in local waviness. The FBGS were embedded at the upper face of the internal skin during plate manufacture, parallel with adjacent structural fibres and before the curing process. The two spectrally multiplexed FBGS are located on the same optical fibre and operate at two different wavelengths of 1530 and 1545 nm respectively. The detailed position of the FOS is shown on Figure 3.

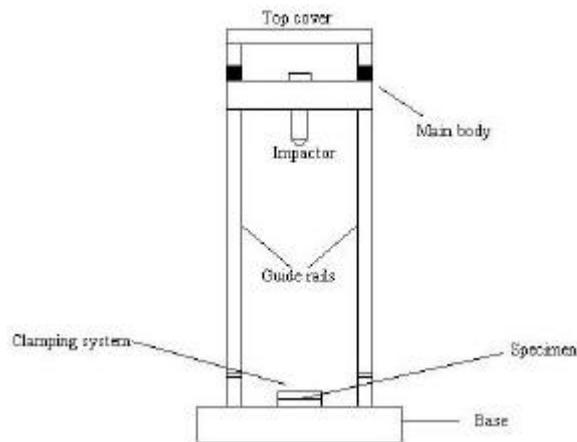
Fig 4. Schematic of the impact rig used for low velocity impact tests

An instrumented drop weight impact tower has been developed enabling low velocity impact tests to be conducted on clamped panels under similar test constraints shown in Figure 4. The drop-weight (0.359 kg) had an impactor with a hemi-spherical nose of 25 mm in diameter. The instrumented indenter is released from a predetermined height by a manual clutch. The specimens were clamped at all edges between two picture-frame plates with a circular opening of 60 mm in diameter. Re-strike of the drop weight was prevented by automatically covering the circular opening with a special designed mechanism exactly after the impact event.

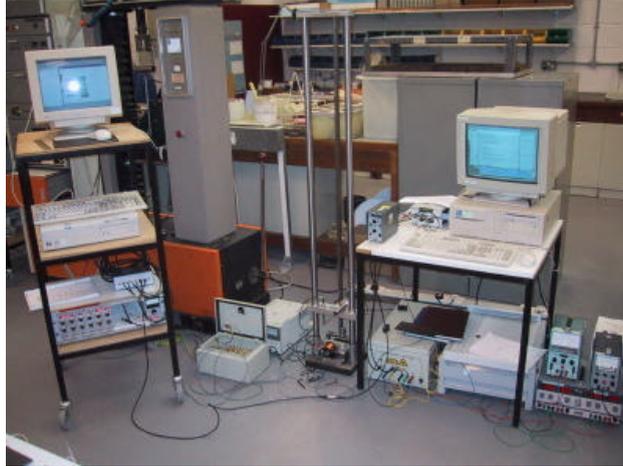
Fig. 5 Experimental set-up

The four transducers are connected to a DT300 Series data acquisition board by Data Translation, which is installed in Dell Pentium II PC desktop computer. The system has a maximum sampling rate of 250 kHz. For monitoring of the four transducers four channels are employed and the data sampled at a rate of 62.5 kHz per channel. With more advanced, and expensive, equipment it is possible to sample all channels at a higher rate. The data acquisition system for the strain gauges and the accelerometer was triggered manually. The experimental configuration and set-up is illustrated in Figure 5.

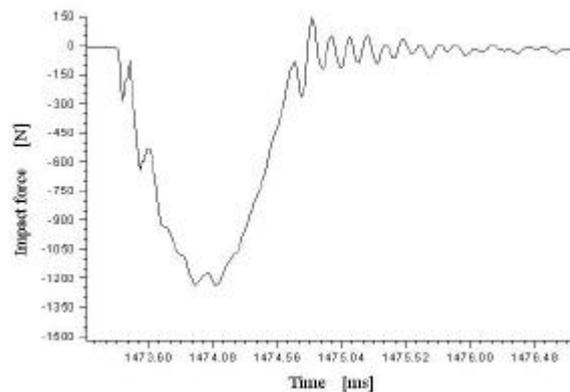
Fig. 6 Impact force versus time signal as captured from the accelerometer for a 0.335 J impact.

The impact tests were undertaken in the speed range of 1.3557 and 4.0808 m/s as these were calculated from the kinetic energy equations. Typical force-time trace from the accelerometer for impact of 0.335 J, for composite laminate with embedded FBGS is shown in Fig. 6.

The above trace is very similar with the one obtained from the laminate without FOS for the same impact condition. The only difference is in the detected maximum impact force due to slight variation in the impact location, which approaches the  $-1400$  N as opposed to the one from the above figure of  $-1200$  N. The strain traces for the same impact condition were obtained from the two RSG and are shown in Fig. 7. The central RSG did not provide data due to debonding. The RSG detect the impact event and provide dynamic strain data during the impact event. The stress waves that were produced from the impact are present for sometime until they get absorbed from the laminate. However, the RSG are not adequate to monitor and assess the internal damage of the composite test panel.

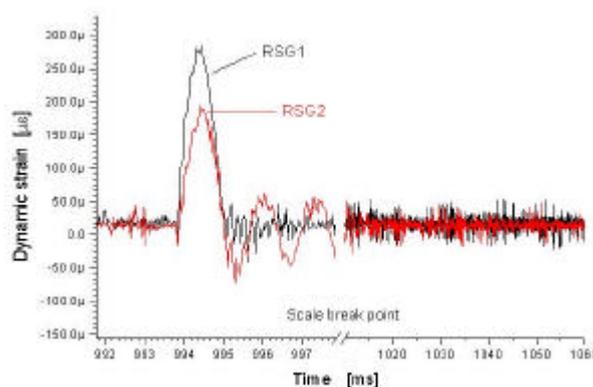
Fig.7 Detected transient strain from RSG for a 0.335 J impact

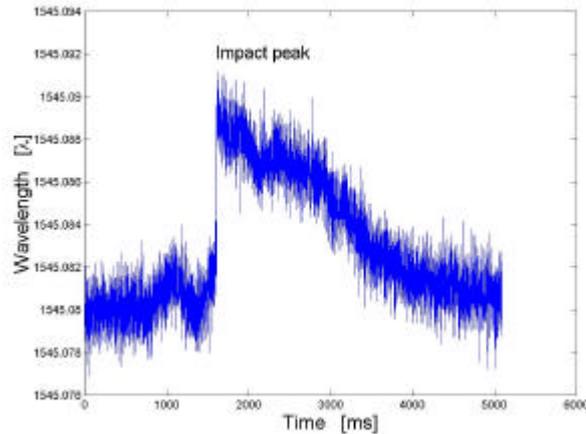
Fig. 8 Shift of wavelength during and after the impact event from FBGS no 2

Figure 8 presents the real-time detection of the impact and the shifting in the wavelength of the embedded FBGS after the impact manifesting the existence of internal damage. The interrogation system recorded the operating wavelength of the FBGS as a function of time and by using the following equation the residual strains from the impact event are obtained:

$$Strain(\boldsymbol{ne}) = \frac{(\Delta \boldsymbol{I})_{avg}}{1.2} \times 10^{-3} = \frac{(\boldsymbol{I} - \boldsymbol{I}_0)_{avg}}{1.2} \times 10^{-3} \quad (1)$$

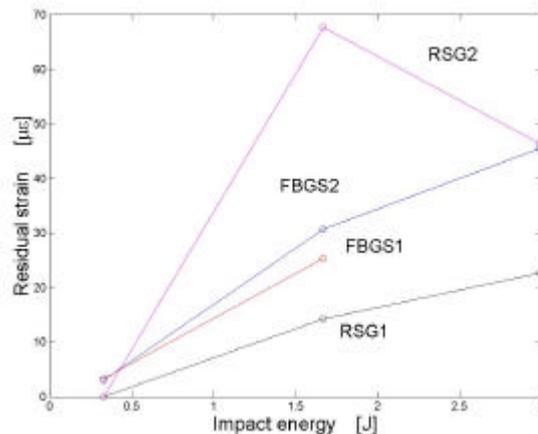
Fig. 9 Detected impact-induced damage in the form of calculated residual strains

Figure 9 illustrates that as the impact energy increases the detected residual strain from the FBGS increases as well.

It can be seen that the embedded FBGS experience slightly different strains than the RSG as well as the RSG between them. The reason is that the RSG are located on the backside of the composite laminate where we expect to get higher transient strains. The out-of-trend RSG2 reading under a 1.67 J impact could be explained by electromagnetic interference from other lab equipment operating during the experimental tests. As it has already been mentioned the FOS are immune to EMI.
