POLYMER MATRIX COMPOSITES IN HIGH VOLTAGE TRANSMISSION LINE APPLICATIONS

M. Kumosa*, D. Armentrout, B. Burks, J. Hoffman, L. Kumosa, J. Middleton, P. Predecki

Mechanical and Materials Engineering Department, University of Denver, Denver, USA,

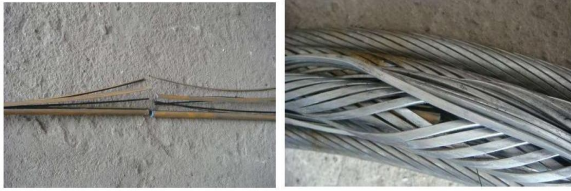
Fig. 9. In service failures of ACCC conductors [18].

Using the critical bend radius determined numerically and verified experimentally through our research, three catastrophic failures of the conductors which occurred in Poland in 2008 [18] (Fig. 9) and an additional failure in the US were explained. Our explanations were reported to the transmission line community in 2010 (IEEE PES, Minnesota July 2010) [17].
