FATIGUE BEHAVIOR OF A 3D BRAIDED CARBON/EPOXY COMPOSITE

V. Carvelli^{1*}, J. Pazmino¹, S.V. Lomov², A.E. Bogdanovich³,
D.D. Mungalov³, I. Verpoest²

¹ Department of Structural Engineering, Politecnico di Milano, Italy

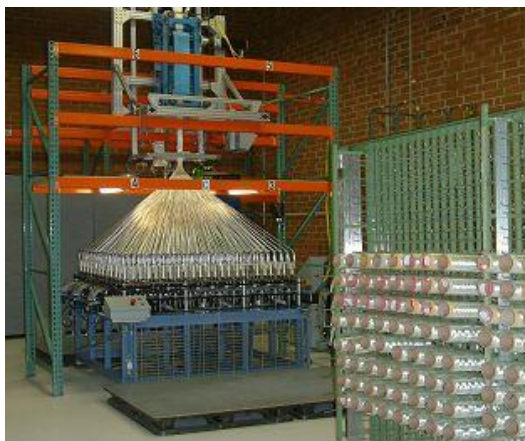
Fig. 1. 3D rotary braiding machine at 3TEX, Inc. with full 576-carrier fiber set up and axial fiber supply from the creel.

The fabric is made of Toho Tenax 12K HTS carbon yarns. The preform material was produced on the 144-horngear, 576-carrier 3D rotary braider at 3TEX, Inc. (Fig. 1). The manufacturing of 3D braided preform, having rectangular cross section, involved the total of 96 fiber carriers and the braiding pattern shown in Fig. 2. Fig. 3 illustrates fiber architecture of the 3D braid. Linear weight of the fabric is 78.8 ± 0.5 g/m.

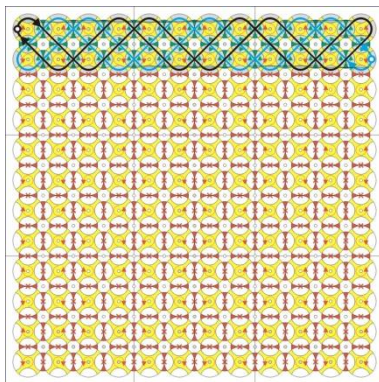
Fig. 2. 3D braiding pattern utilized for the rectangular cross section preform fabrication.

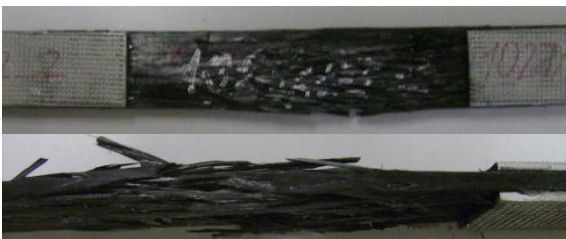
Fig. 4. Fatigue failure of a specimen.

The fatigue tests of composite $V_f = 55.6\%$ involved different maximum stress (σ_{max}) levels in the cycle, ranging from 950 MPa (the respective average static strength is 1351 MPa) to the stress level at which complete failure did not occur before 5 million cycles (σ_{5m}). The complete specimen failure means that it separated into two parts during cyclic loading (as illustrated in Fig. 4). At least three valid tests have been performed for each stress level. A cyclic test was considered “valid” if the specimen did not break in the tabs, or close to the tabs. This requirement was not satisfied for the cyclic tests involving stress levels higher than 950 MPa.

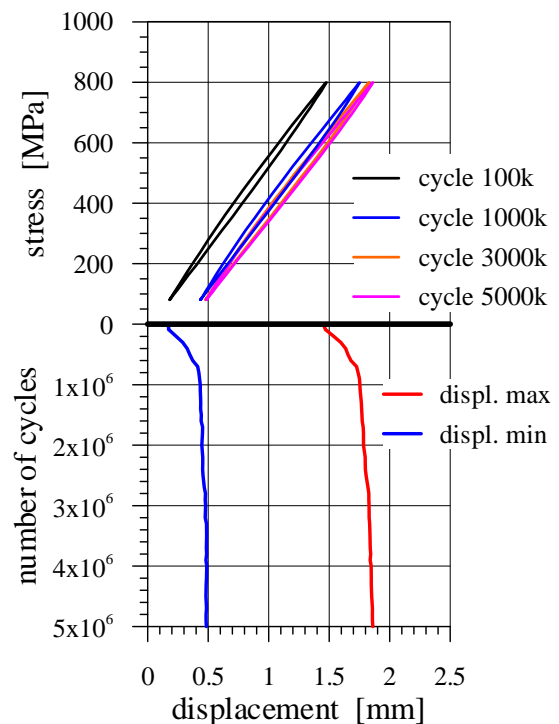
Fig. 5. Cyclic test with maximum stress 800 MPa. Some stress vs. displacement curves; maximum and minimum displacement vs. number of cycles for a specimen of $V_f = 55.6\%$.

Some information on the behavior of the composite material during the cyclic loading was extracted from the observed variation of the shape of the fatigue stress–displacement cycles during the test. The upper part of the plot in Fig. 5 shows the comparison of some cycle curves of the specimen loaded with a maximum stress of 800 MPa (e.g. the stress level defined as σ_{5m}). The slope of the cycle curve segment passing through the points of maximum and minimum stress (“cycle slope”) continuously decreases up to 3 million cycles, as seen in Fig. 5. Above 3 million cycles, the slope remains nearly constant. These observations are further confirmed by observing the evolution of the maximum and minimum displacements under increasing number of cycles (see the lower diagram in Fig. 5). The reduction of the cycle slope within initial 3 million cycles suggests that there is some stiffness degradation of the material caused by the damage accumulation during cycling.

develop for a number of cycles higher than 1 million (see those in the regions named 1 and 2). The observed cracks seem to be originated in the resin rich zones; then they develop along the matrix-yarn interfaces. The mechanism on the damage development extracted from the diagram in Fig. 5 seems to be confirmed by the analysis of the micro-CT pictures. The damage initiates and develops within 3 million cycles, when the stiffness degradation of the material is mainly observed, and does not show further increase that may lead to a complete failure before 5 million cycles.

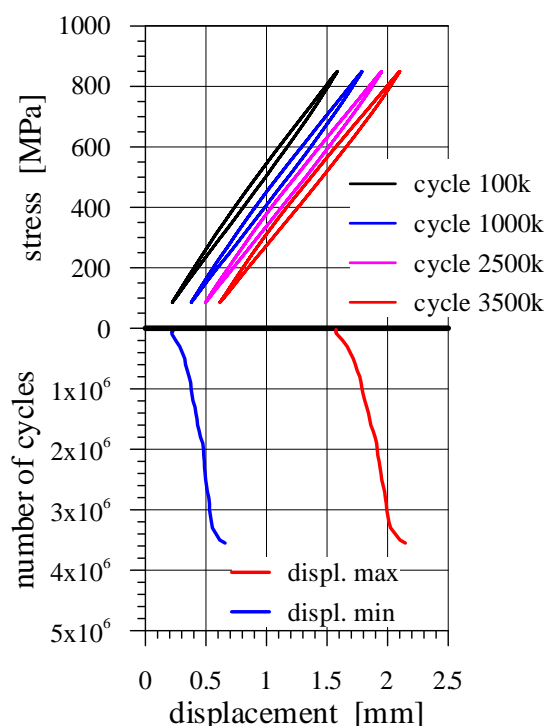
Fig. 6. Cyclic test with maximum stress 850 MPa. Some stress vs. displacement curves; maximum and minimum displacement vs. number of cycles for a specimen of $V_f = 55.6\%$.

Differently, the evolution of the damage reflects in a continuous decrease of the material stiffness if the maximum stress is 850 MPa. The specimen fatigued with this stress level shows continuous decrease of the cycle slope (respectively, continuous decrease of the stiffness), as depicted in Fig. 6. The increasing hysteresis area of the cycles and the increase of the recorded maximum and minimum displacements (as seen in Fig. 6) demonstrate a gradual damage development, leading to the ultimate failure of the specimen.

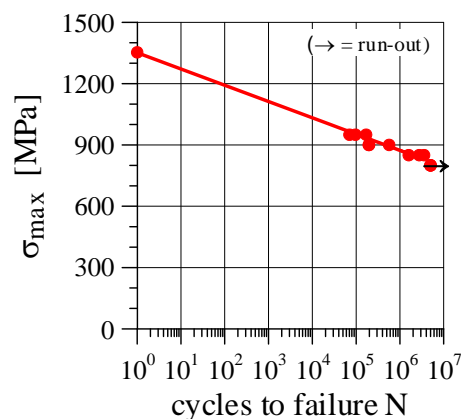
Fig. 7. Fatigue life curve of the 3D braided carbon fiber composite ($V_f = 55.6\%$).

The fatigue tests performed in the considered stress range enable for depicting a fatigue life curve (Wöhler-type diagram) for the braided composite with $V_f = 55.6\%$. In Fig. 7, the valid tests of the composite are represented by the maximum stress in the cycle (σ_{max}) vs. the number of cycles to failure N . In the diagram, the average static tensile strength is also indicated in its correspondence to the extrapolated lowest number of cycles, $N=1$.

Appropriate fitting equation was applied to the obtained experimental fatigue data. It enables for reliable predictions of the fatigue life corresponding to the other stress levels, which were not investigated in the present experimental study. The diagram in Fig. 7 shows the fitting of obtained experimental results (run-outs are not included) by means of a linear segment. The semi-logarithmic function adopted is $\sigma_{max} = a \log N + b$, where a and b are -34.6 and 1351 , respectively.

The quality of the fitting is related to the coefficient of correlation R^2 [7]. Values of R^2 close to 1 confirm the reliability of the fitting. The curve in Fig. 7 has a coefficient of correlation of 0.998.
