# THE RESIDUAL STRENGTH TEST AND ANALYSIS OF COMPOSITE RUDDER AFTER LIGHTNING STRIKE

X.Chen<sup>1\*</sup>, G.Liu<sup>1</sup>, H.Wang<sup>1</sup>

<sup>1</sup> School of Aeronautics and Astronautics, Shanghai JiaoTong University, 800 Dongchuan Road, 200240, Shanghai, P.R.China

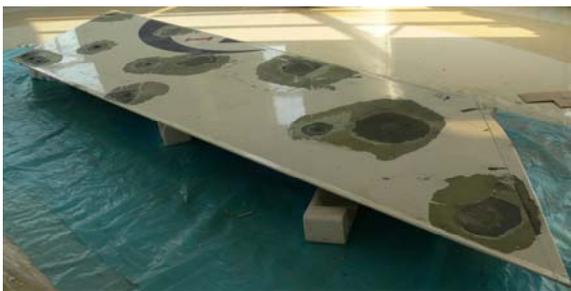
Fig.1. Light strike point and damage shape of the composite rudder

A light strike test was simulated with high voltage electrical method to prefabricate the damages. After the light strike, there are nine strike damages in the laminate skin of the honeycomb sandwich plate. To determine the delamination area of each strike damage point, the ultrasonic C-scan technology is used. The light strike damage points and shape are shown in Fig.1.

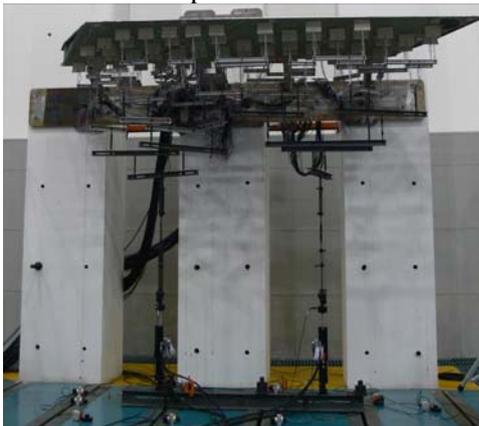
Fig.2. Picture of the real static test

The rudder is installed vertically in the real aircraft fin structure while its position is changed and fixed by a set of jigs horizontally in this test program for the convenience of fix the load servo control actuators.

There are three load cells mounted to the strong back to get the reaction force of the rudder which simulate the actuators of the rudder. The connection beam has the function of supporting the rudder. On the front beam of the rudder, there are six hinge support beam unit welded to a thick steel plate which mounted on the strong back. The beam units are jointed to the ruder with shear bolts. All the beams are designed and their rigid are provided by virtual test of the rudder before manufacturing.

Fig.2 shows the schema and real installation of the static test.
