# Tracking deformation caused by tensile fatigue in quasi-unidirectional glass-fibre composites using a time-lapse correlative study

**Anuj Prajapati<sup>1,3</sup>, Robert M. Auenhammer<sup>4,5</sup>, Stuart Morse<sup>2</sup>, Ali Chirazi<sup>3</sup>, Daniel Lichau<sup>3</sup>, Lars P. Mikkelsen<sup>4</sup>, Timothy Burnett<sup>1</sup> and Philip J. Withers<sup>1</sup>**

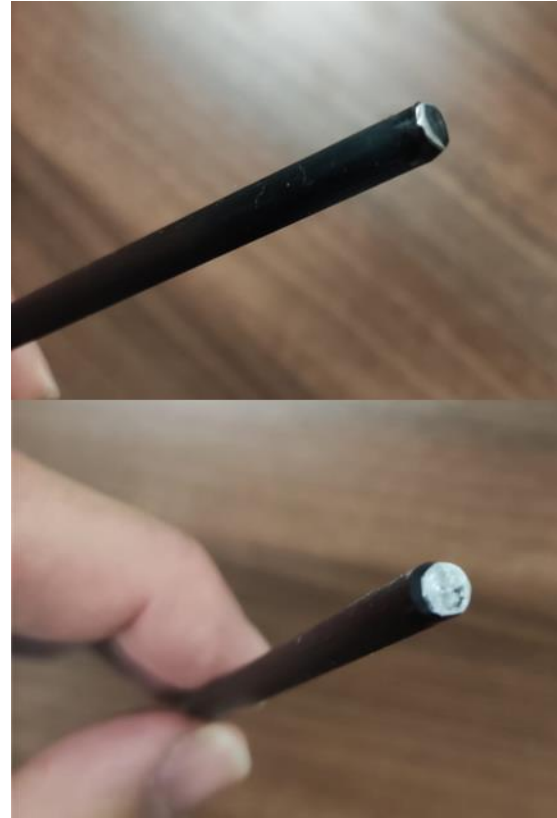
**Tension clamp**

- Steel-plate reinforced carbon rod tips
- Greased rods to move freely and induce no twisting.

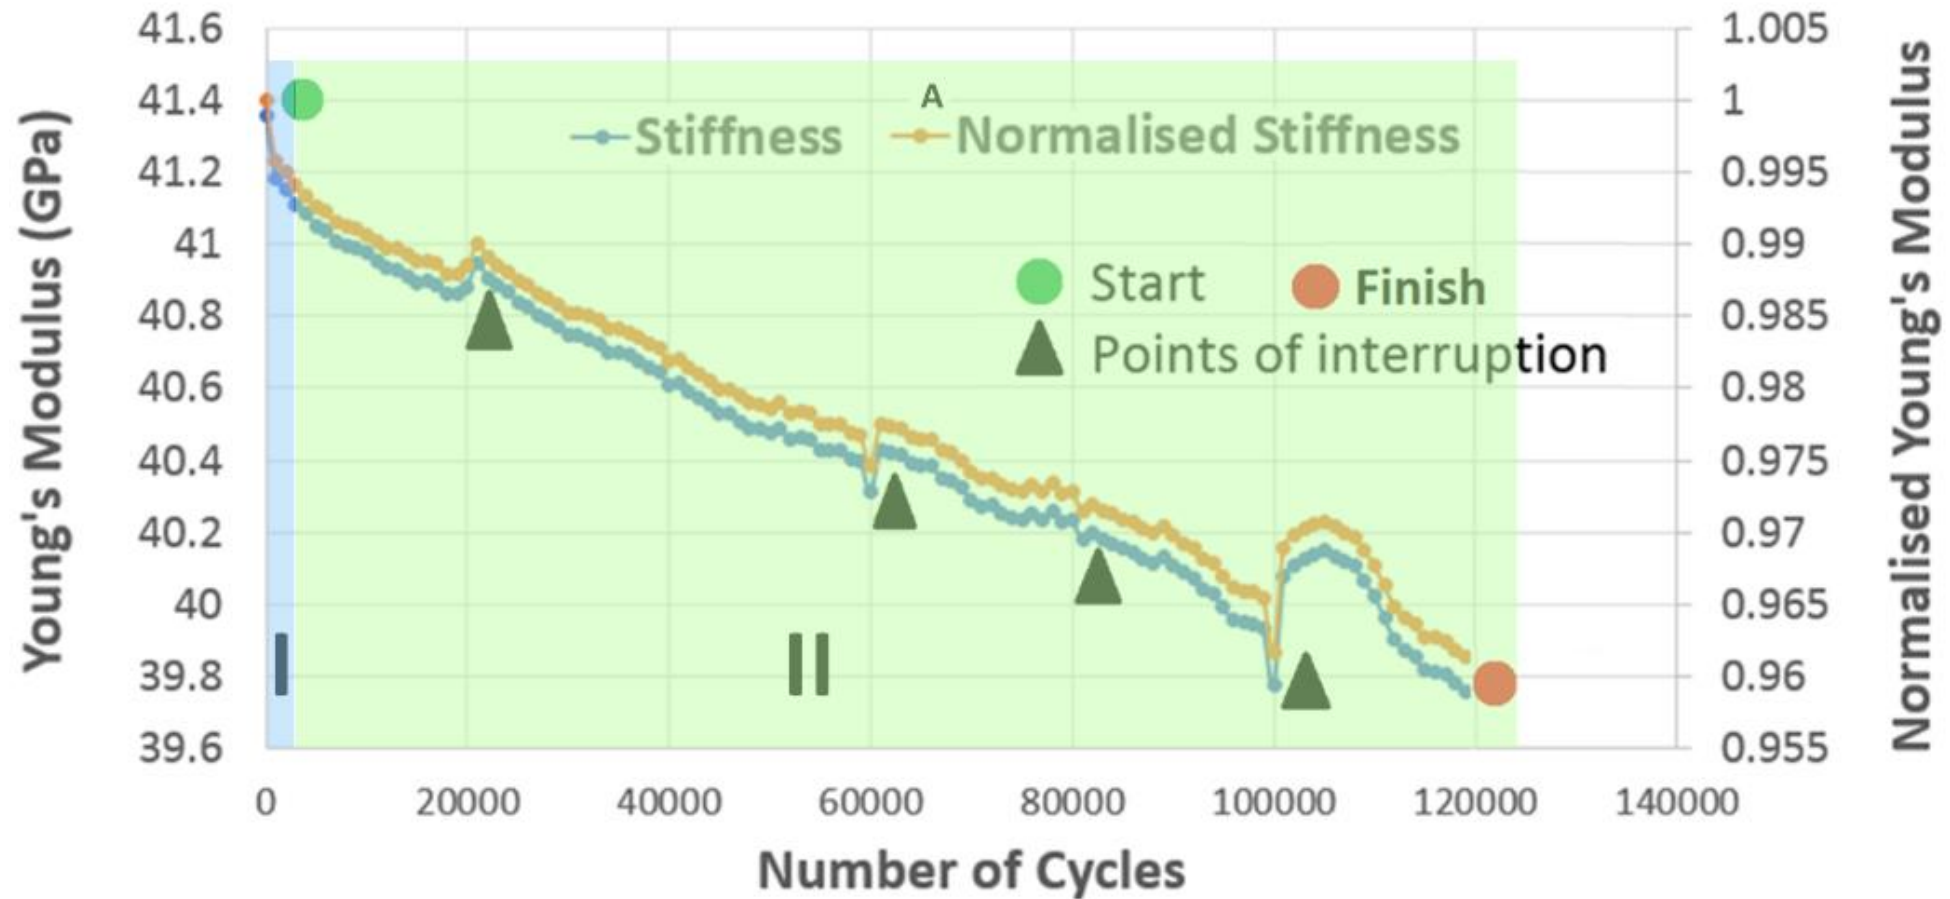
# Stiffness degradation

- Two-stage stiffness degradation

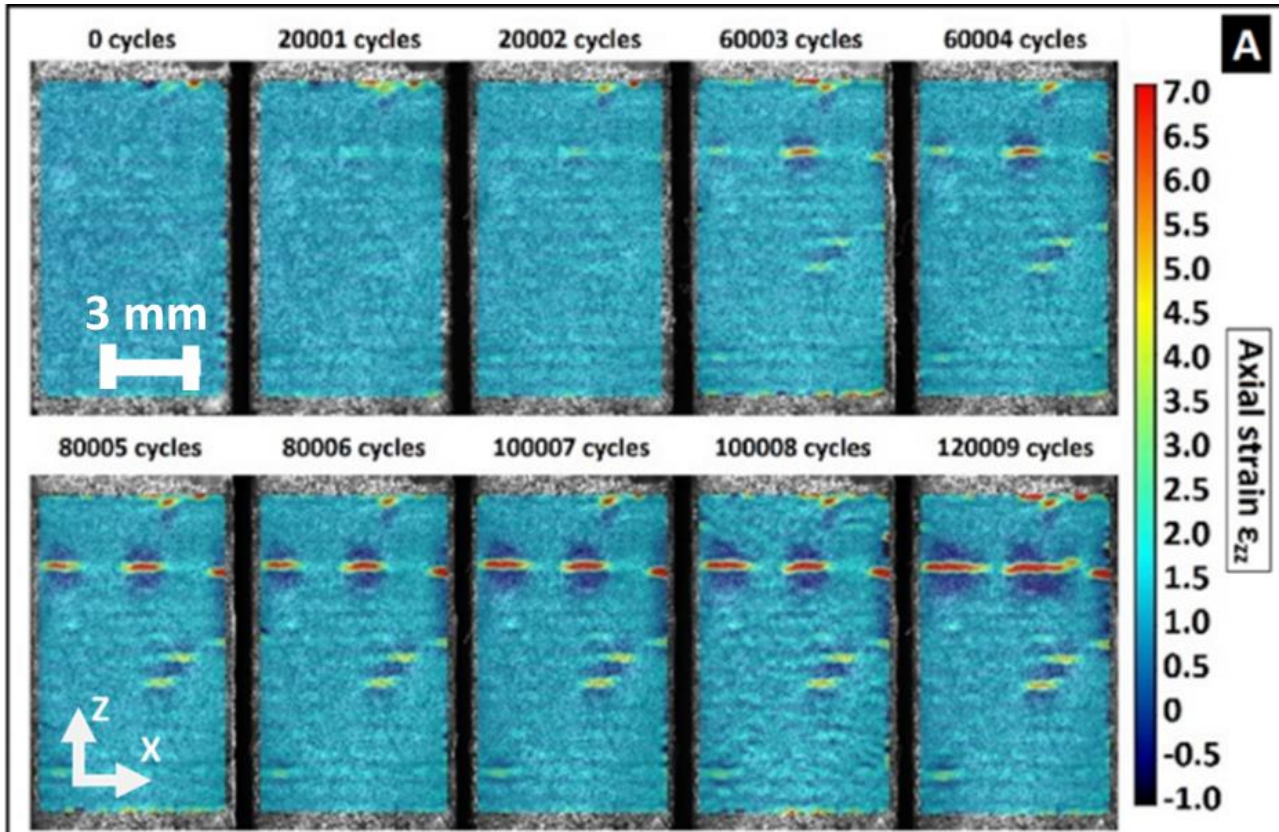
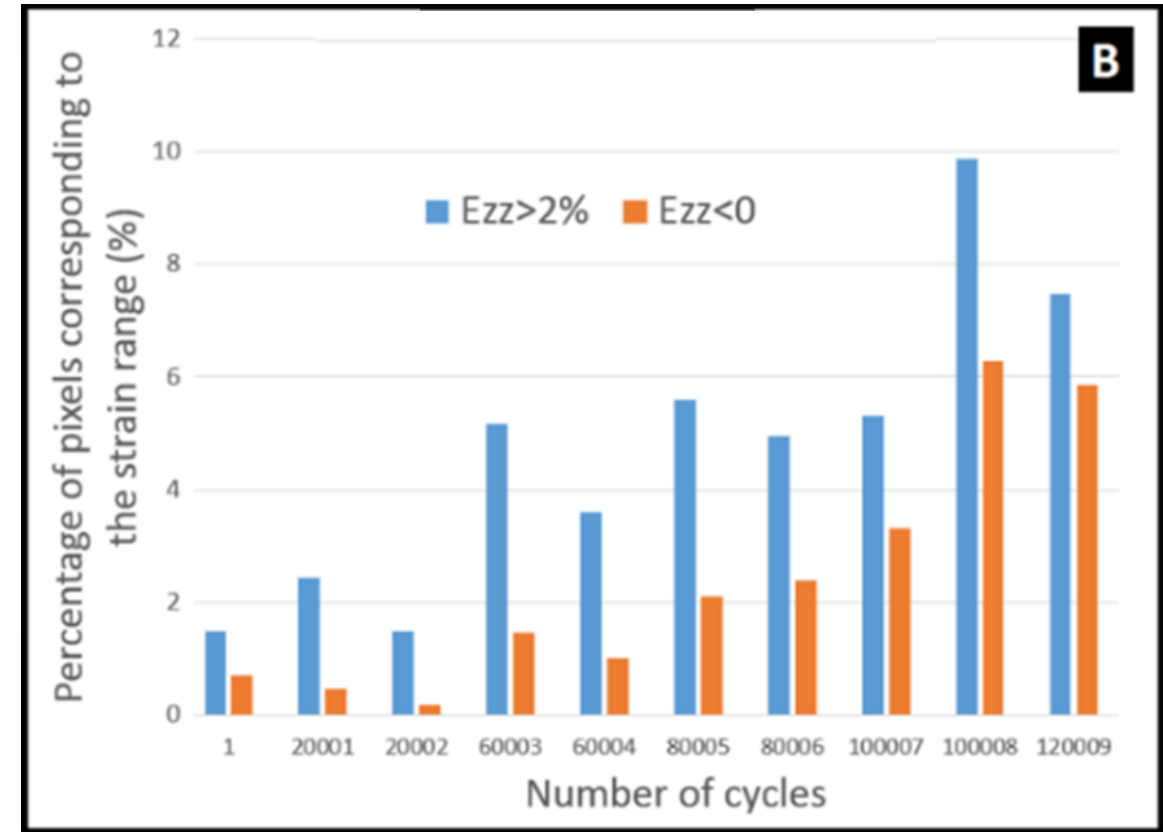
# DIC hotspots in CT

- Strain maps at max load.

- Increasing amount of extreme strains.

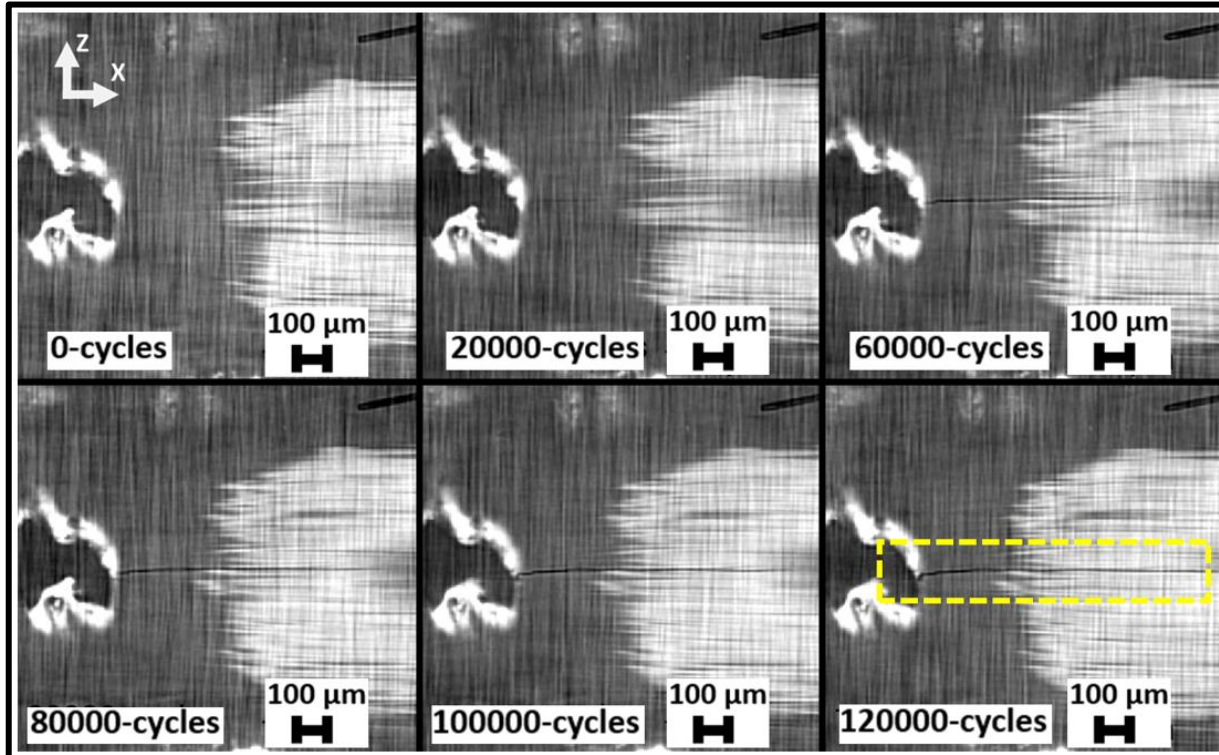
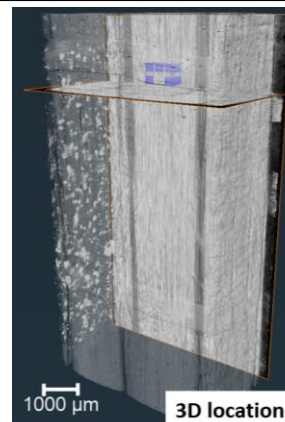
# Surface damage observed in CT

- Matrix crack originating from a surface void.
- Progresses into an off-axis crack in backing bundle.

- Off-axis crack progresses into a cluster of UD fibre breaks.

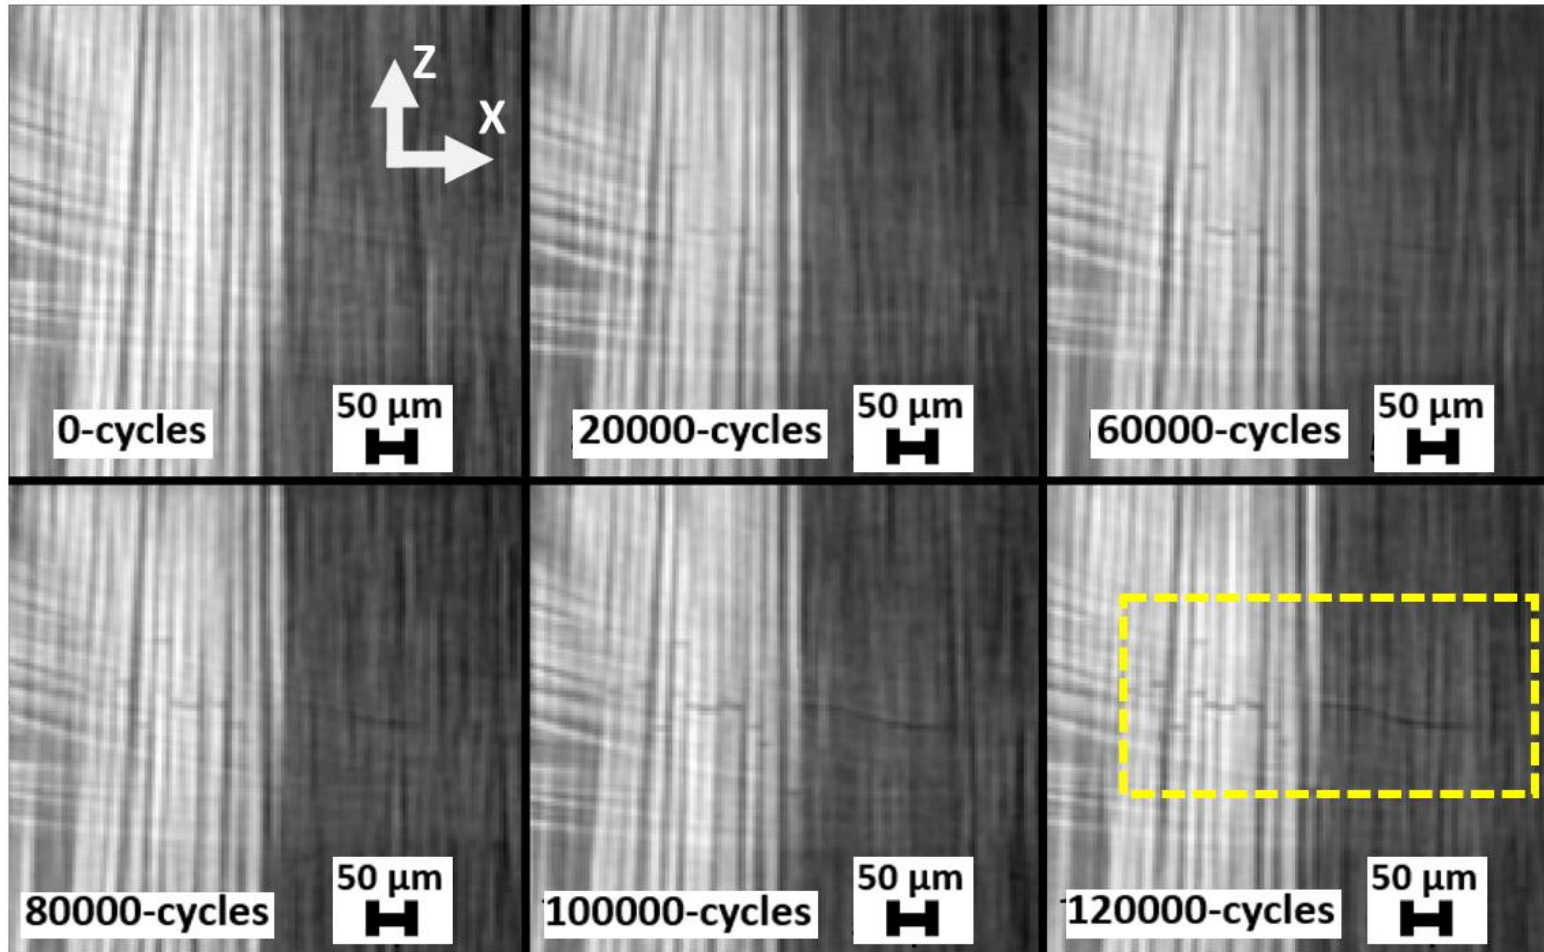
# Bulk damage observed in CT

- UD fibre breaks in the bulk, close to backing bundles, give rise to localised matrix cracking.
