INVESTIGATION OF THE FAILURE MECHANISMS FOR DELAMINATION GROWTH FROM EMBEDDED DEFECTS

E. Greenhalgh and S. Singh

Mechanical Sciences Sector, DERA, Farnborough, GU14 0LX, UK

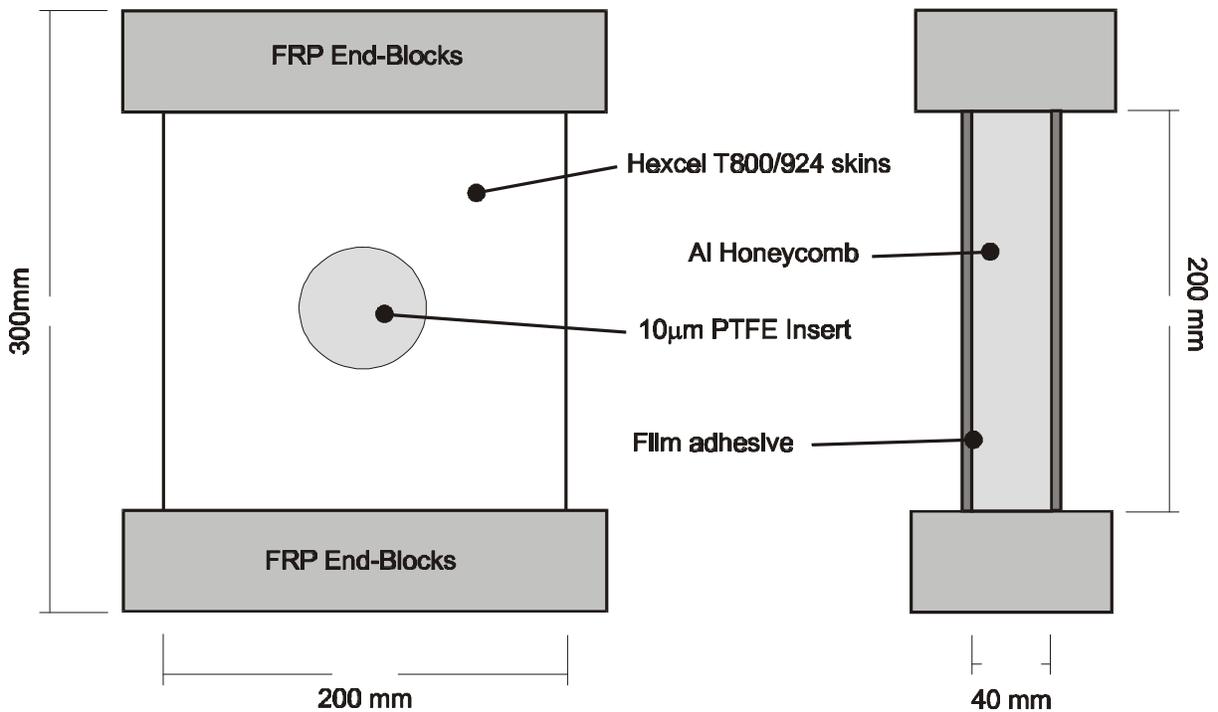
Figure 1: Geometry and strain gauge positions for the honeycomb panels

The laminates were supported using an aluminium honeycomb core (Figure 1) to form sandwich panels. These panels were stabilised against buckling to strains up to $-10000\mu\epsilon$, eliminating the need for an anti-buckling guide and the associated complications [4]. The damage growth was monitored using shadow Moiré interferometry which was calibrated using
