ARE COMPOSITES SUITABLE FOR REINFORCEMENT OF SHIP STRUCTURES?

I. Grabovac, P.J. Pearce, A. Camilleri, K. Challis and J. Lingard

*Defence Science and Technology Organisation (DSTO)
Aeronautical and Maritime Research Laboratory
P. O. Box 4331, Melbourne 3001
Australia*

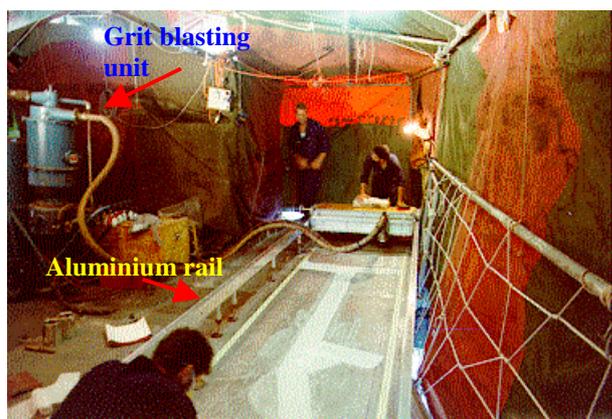
Figure 4(a). Surface grit blasting on 02-deck

In Figure 4(a), the starboard side is shown at the time of surface grit blasting using a suitable industrial unit. To assist with uniform surface coverage a set of adjustable aluminium rails were positioned on each side of work area which helped to guide a multi-purpose trolley with the attached grit blasting head. The step-up angle of ~30 degrees between the thick insert plate and the original deck plating, Figure 3, was reduced to ~10–15 degrees with epoxy filler paste, Figure 4(b). An application of a silane solution over the grit blasted area completed the surface preparation phase. This procedure was identical to that developed for aluminium surface in the earlier laboratory trial [4].

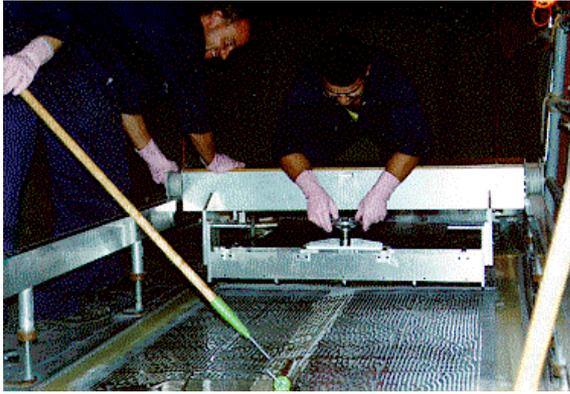
Figure 5(a). Resin dispensing and spreading

Using a simple, purpose-developed tool, the fabrication time of the adhesive bond layer had been significantly shortened. For example, the dispenser Figure 5(a), can distribute a relatively uniform quantity of resin per given area in minimal time. Although pot life for the vinyl ester resin can be modified by addition of reaction retarding additives, it is often the ambient deck temperature which cannot be easily controlled. In Sydney for example, a sunny mid-day temperature in March can produce a deck temperature of up to 60°C. At this temperature, the resin reaction would be too fast and thus work must be carried out either early in the morning or later in the day.

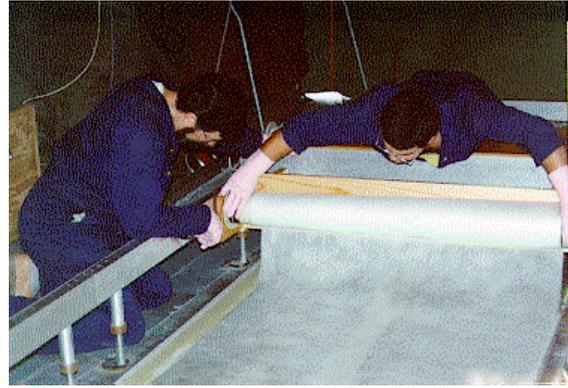
Figure 5(b). Unrolling and laying of glass fibre reinforcement

Figure 5(b) shows the mobile trolley fitted with tubes onto which the various materials needed for each stage were wound. Hence, this method allowed quick and precise laying of a scrim material, glass tissues (2 plies), a peel ply and the release film. After placing the breather/bleeder cloth under the vacuum bag, the application of vacuum makes the resin impregnate all layers, with excess resin being absorbed into the bleeder layer, Figure 5(c). If the resin reaction is retarded, the degree of overnight cure is closer to 50% or less. Once the peel ply is removed, a relatively low degree of resin cross-linking makes it possible to achieve a strong primary and secondary bonding at the interface between the adhesive and the composite layers. The size of adhesive layer was extended beyond the area of composite by an additional 100mm in width and length (ie. 5.1m x 1.1mm).

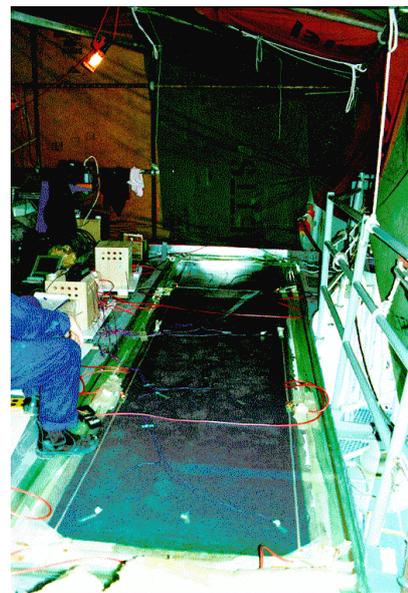
Figure 6. Composite post-cure by resistance heating

The in-house developed method is a low voltage (<120 VAC) based, resistance heating (Joule heating) utilising the electrical conductivity of carbon fibre [7,8]. Two braided copper strips running on both sides parallel to the length of CF composite were used for the power connection. The current output, provided by four transformers, was designed to post-cure the composite over a four-hour period at a temperature between 70 – 75°C. The heat-up rate and the heat distribution over a large surface area were monitored through a feedback control loop utilising surface-bonded thermocouples, Figure 6. Surface heat loss was minimised by covering the composite with a blanket. The method proved to be very efficient, inexpensive, safe and above all generated heat where it was needed assuring a post-cure in both the composite and the adhesive bond layer at the reinforcement/deck interface.

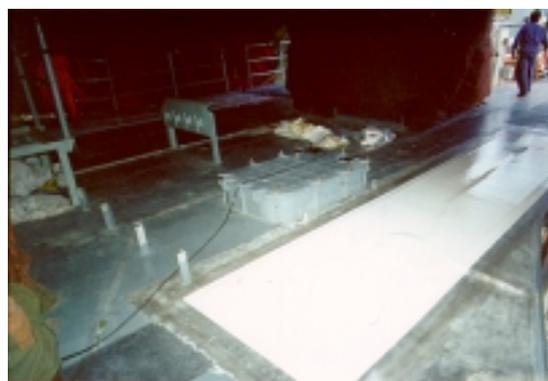
Figure 7. Applied epoxy based primer

The final surface protection applied by DSTO staff was a good coverage of an epoxy based primer which additionally sealed the edges, especially at the interface between the GRP protective layer and the aluminium deck, Figure 7. This was followed by a standard navy paint scheme that included the final non-skid layer applied to the walkway, Figure 8.
