NONDESTRUCTIVE INSPECTION AND EVALUATION METHODS FOR COMPOSITES USED IN THE MARINE INDUSTRY

SUMMARY: The paper reports on a test and evaluation programme to compare different non-destructive inspection and evaluation methods for the inspection of single skin and sandwich panels and joints. As part of the benchmark test programme a number of T-joints and top hat stiffener specimens were built using single skin and sandwich construction. These specimens contained defects of various sizes which were located at different depths. The specimens were tested in the laboratory using ultrasonic and thermographic methods. In addition field tests on ship structures were carried out in ship yards to determine the performance of the ultrasound, infrared and automated coin tap methods in a production environment. These included tests on an old 2/3 scale section of a single-skin GRP minesweeper and a small ship section of sandwich construction which had been used in explosion trials. The paper summarises the results, comparing the different methods and showing their respective capabilities and limitations.

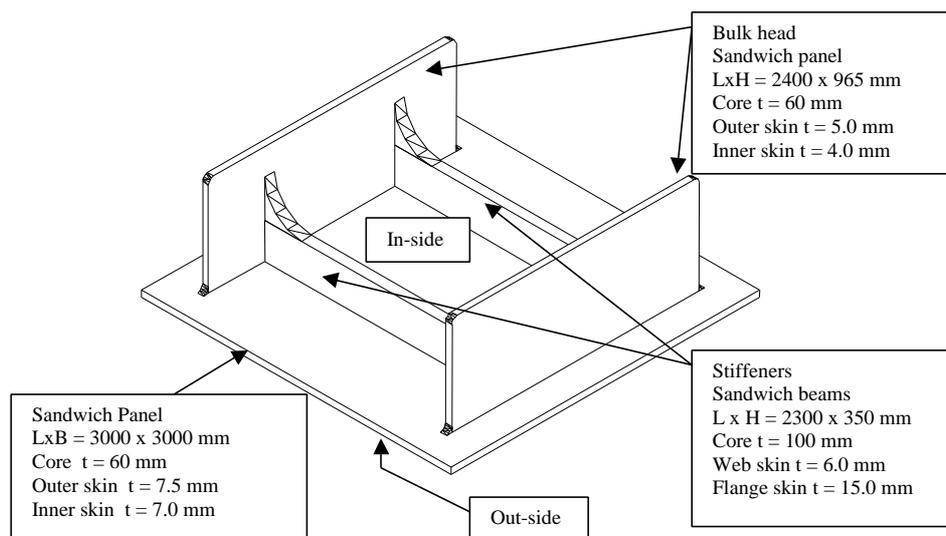
In addition to the above tests, field tests on ship structures were carried out. These included tests on an old 2/3 scale section of a single-skin GRP minesweeper and a small ship section of sandwich construction which had been used in explosion trials. The sandwich structure consisted of a panel with a 60 mm thick PVC core, two bulkheads 2.3 m apart and two stiffeners with knees. The bulkheads and stiffeners were laminated onto the inside of the panel. The special load introduction of the support structure used in the explosion trials caused delaminations between the bulkhead and the panel. Figure 2 shows this structure.

Figure 2 Sandwich test structure

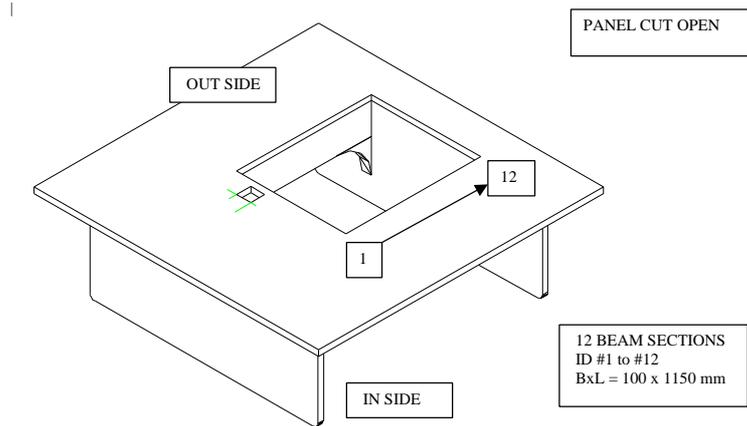
To verify the findings made with the three inspection methods a panel was removed from the test section and cut into narrow beams (see Figure 6). The beams are shown in Figure 5. They clearly show core damage, delamination and debonding. But there were no areas with excess or lack of resin. The observed defects are summarised in Figure 7. The results obtained with infrared thermography and the smart hammer seem to correlate quite well with the observation from the destructive testing. The main areas of core damage and debonding have been detected by both methods. In addition, infrared thermography found other possible defects which are not visible on the beams removed from the test section. Ultrasound did not find any defects in the panel, only the delaminations of the stiffeners.

Figure 6 Test structure with panel removed and showing the beam numbering
