APPLICATION OF ANOMALOUS WAVE PROPAGATION IMAGING METHOD WITH ADJACENT WAVE SUBTRACTION TO ACTUAL DAMAGES IN COMPOSITE WING

Abstract

Anomalous wave propagation imaging method was applied for the on-site in-situ nondestructive evaluation of actual debonding and impact damages in a composite wing with high density of structural elements. The promising results showed that it has high potential as on-site nondestructive evaluation method of other complex engineering structures.

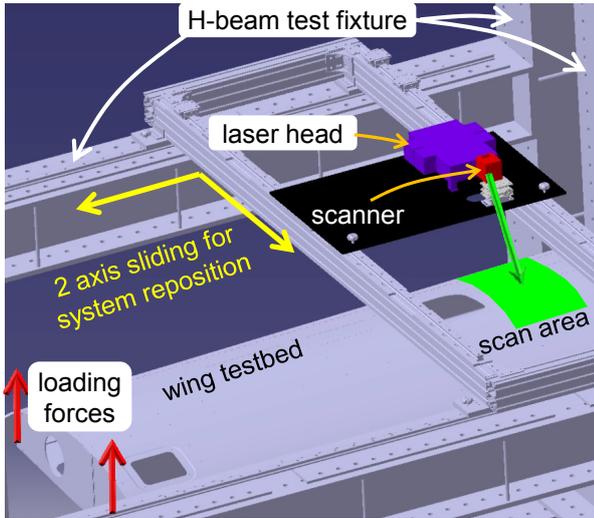
Fig. 1. Field test setup for real wing inspection.

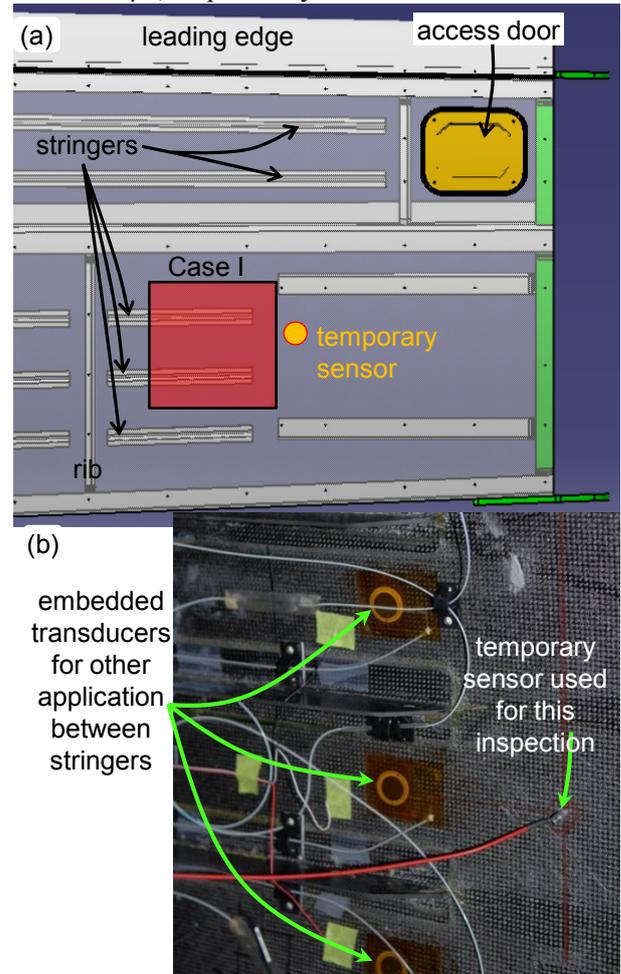
Case I was conducted to show the suitability of the AWPI for the inspection of smart structures with integrated transducers. Hence, the testbed was inspected when it was in intact condition, and the inspection area was selected to include three 18 mm PZT (lead zirconate titanate) elements bonded between the stringers, as shown in Fig. 2. These PZT elements did not participated in the waves sensing, but were merely a type of material discontinuity in this study. The ultrasonic sensor used for this inspection was temporarily bonded on the internal surface of the wing skin at the position shown in Fig. 2. The size of the inspection area, the fluence of the QL, the bandpass, and the sampling time interval were set to 300×300 mm², 37 mJ/cm², 240-290 kHz, and $T=0.4$ μ s, respectively.

Fig. 2. Inspection Case I. (a) Inspection area. (b) Internal view of the wing testbed.
