DAMAGE CHARACTERISATION AND THE ROLE OF VOIDS IN THE FATIGUE OF WIND TURBINE BLADE MATERIALS

J. Lambert^{1*}, A.R. Chambers², I. Sinclair³, S.M. Spearing⁴

¹⁻⁴ School of Engineering Sciences, University of Southampton, Southampton, UK

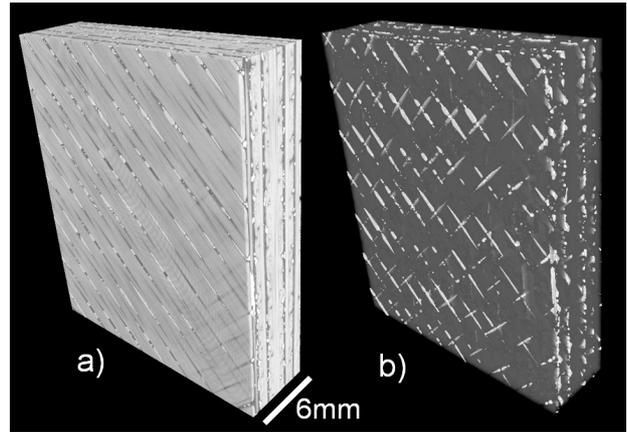
Fig 3.1. a) Reconstructed CT volume showing the voids segmented and highlighted in white. b) Same volume with the near-removal of the fibre and matrix material, highlighting the voids.
