INJECTION REPAIR OF COMPOSITES FOR AUTOMOTIVE AND AEROSPACE APPLICATIONS

Robert S. Pierce¹, William C. Campbell² and Brian G. Falzon³

Keywords: Injection repair, Dry spots, Sandwich, Delamination

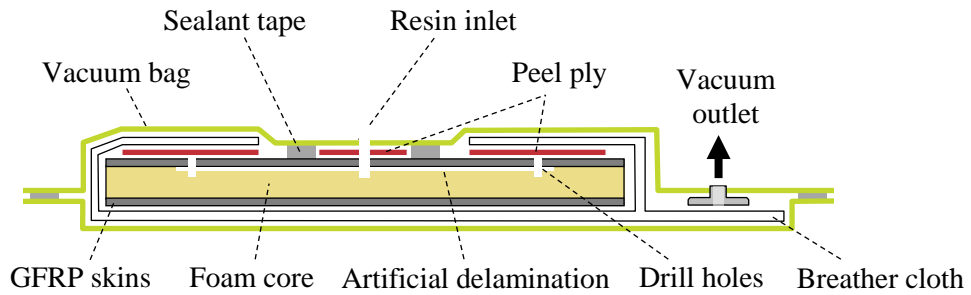
Figure 2: Injection repair bagging approach for the delaminated GFRP/foam sandwich samples.

Based on the size and location of delamination in each sample, a pattern of evenly-spaced 1.5 mm diameter holes were drilled through the outer skin; ensuring that outlet holes were a maximum of 30 mm from the nearest inlet across the whole delamination area. After drilling, separate strips of peel ply were placed over the inlet and outlet holes with sufficient space to then apply sealant tape between the inlet and outlet regions. Breather cloth was wrapped around the samples and over the outlet regions, connected to a vacuum port away from the sample itself. This was then encased in a vacuum bag as shown in Figure 2, and checked for any leaks. Low viscosity epoxy resin was then inlet into the delaminated samples at room temperature.

Vacuum bagging of the injection repair samples was complicated by the open cuts across the dry defect regions, meaning that the two long edges needed to be sealed inside the enveloping bag. Otherwise, a similar bagging arrangement with wrapped breather cloth from Figure 2 was used for the CFRP repairs. Outlet vacuum ports were placed at the pristine ends of the samples, and once bagged, the inlet configuration was established over the driest region of each sample, prior to resin injection.
