# FRACTURE SURFACES OF $\text{Al}_2\text{O}_3$ /Al-ALLOY COMPOSITES

Xicong Liu and Yue Zhuo

*Department of Materials Engineering and Applied Chemistry,  
National University of Defense Technology, 410073, Changsha, Hunan, P. R. of China*

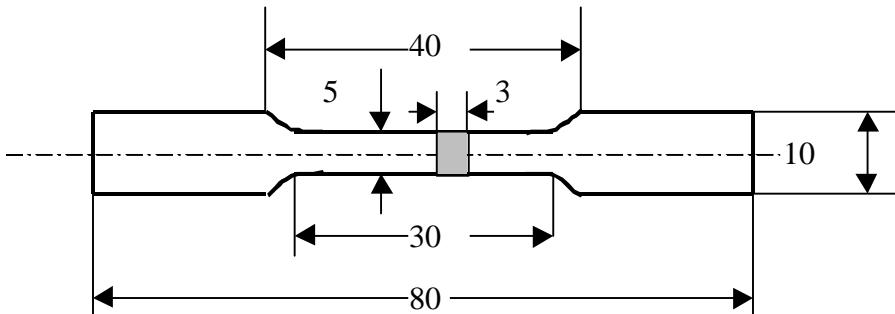
Fig.1. Dimensions of the specimens used for tension, fatigue and creep tests

After that, tensile tests at both room temperature and elevated temperatures from 200 to 350°C, creep tests at 300°C, fatigue tests in tension-tension at load ratio of 0.1 and fracture toughness tests at room temperature were performed on two composites, using an Instron 115 material test machine. The specimens of rectangular cross-section were used for tension, creep and fatigue tests, whose design is shown in Fig.1. Single edge notched specimens were used to measure fracture toughness, the dimensions were decided according to ASTM E399-83 standard. Surfaces of some specimens were polished before testing, and examined with scanning electrical microscope (SEM) or optical microscope after tests. Fracture surfaces of specimens were examined firstly with a binocular macrofractography equipment at magnifications from 2 to 10x to see the whole morphology, and then with SEM at magnifications from 1000 to 10000x to observe details in some feature zones, for example, fatigue cracks propagation zone, plastic deformation zone near the crack in fracture toughness specimens and so on.

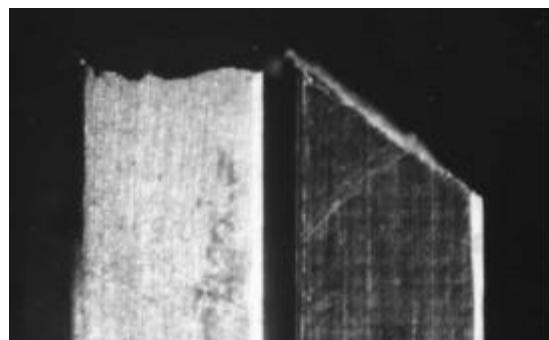
Fig.2. Profile of the fracture surfaces of  $\text{Al}_2\text{O}_3/\text{Al}-7\text{Si}-0.6\text{Mg}$  (right) and  $\text{Al}_2\text{O}_3/\text{Al}-5\text{Si}-3\text{Cu}-1\text{Mg}$  (left) composites ruptured in tension or creep tests (10x )

Macroscopically, fracture surfaces of Al<sub>2</sub>O<sub>3</sub>/Al-7Si-0.6Mg composite subjected to creep tests, tension tests at both room temperature and elevated temperatures were inclined at an angle of about 45° to the loading direction, as shown in the right of Fig.2. It follows that the specimens were fractured by shear and it was a ductile fracture mode like that of the matrix alloy alone. This indicated that the fibers of 20% in volume did not significantly affect on the macroscopic morphology of fracture surface for the composite, even though the ceramic fibers decreased substantially matrix alloy plasticity; in other words, the matrix alloy dominated macroscopic morphology of fracture surfaces for the composite. However, for Al<sub>2</sub>O<sub>3</sub>/Al-5Si-3Cu-1Mg composite, the result was different. Their fracture surfaces after tension tests varied with test temperatures, the fracture surfaces ruptured at room temperature were flat as shown in the left of Fig.2; most of the fracture surfaces ruptured at the temperature below 250 °C were still flat. Only when test temperature was elevated to above 300°C, their fracture surfaces were close to

those described previously for  $\text{Al}_2\text{O}_3/\text{Al}-7\text{Si}-0.6\text{Mg}$  composite. The difference in fracture surface between two composites resulted from the difference in plasticity. Rupture strain at room temperature for  $\text{Al}_2\text{O}_3/\text{Al}-7\text{Si}-0.6\text{Mg}$  composite was 1%, while that for  $\text{Al}_2\text{O}_3/\text{Al}-5\text{Si}-3\text{Cu}-1\text{Mg}$  composite was only 0.6%. This difference was decreased with temperature because age-hardening effect was decreased with temperature due to precipitating some alloy additions at elevated temperature as shown in Fig.3. It was this reason that the fracture surfaces for  $\text{Al}_2\text{O}_3/\text{Al}-5\text{Si}-3\text{Cu}-1\text{Mg}$  composite varied with the test temperatures. It seems that rupture strain of about 1% is a critical strain for the transfer from ductile fracture to brittle fracture. When rupture strain of composite is small than 1%, the composite shows brittle fracture, or else, it shows ductile fracture.

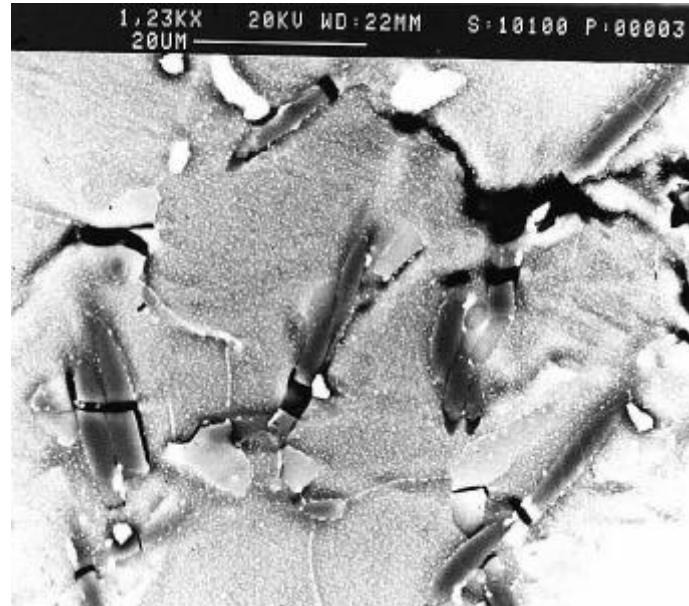
Fig.3. Precipitates (white small dots or line) in  $\text{Al}_2\text{O}_3/\text{Al}-5\text{Si}-3\text{Cu}-1\text{Mg}$  subjected to tension or creep tests at 300 °C

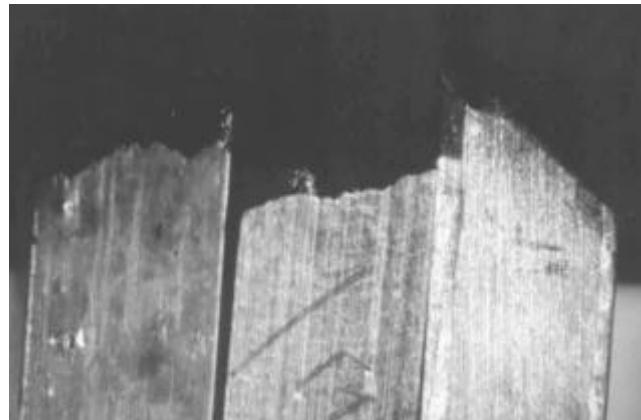
Fig.4. Profiles of fatigue fracture surfaces of  $\text{Al}_2\text{O}_3/\text{Al}-7\text{Si}-0.6\text{Mg}$  composite at different cyclic loading (maximum load from right to left: 165MPa→150MPa→135MPa) (10x)

The fatigue fracture surfaces of the two composites were also different. For  $\text{Al}_2\text{O}_3/\text{Al}-7\text{Si}-0.6\text{Mg}$  composites, crack propagation region and fast fracture region can be distinguished easily; and the fast fracture region was a shear lip. The shear fracture percentage in fatigue fracture surfaces of the composite depended on load severity; a great load resulted in a large

shear lip, while a small load resulted in a small shear lip as shown in Fig.4. As for  $\text{Al}_2\text{O}_3/\text{Al}-5\text{Si}-3\text{Cu}-1\text{Mg}$  composite, crack initiation region was more visible than that for  $\text{Al}_2\text{O}_3/\text{Al}-7\text{Si}-0.6\text{Mg}$  composite, but it was too difficult to distinguish crack propagation region and fast fracture region, and no obvious shear lip can be observed; the fatigue fracture surfaces were flat. Also, the fracture surfaces after fracture toughness tests for the two composites showed the differences described previously: one with small shear lip, the other without shear lip. Evidently, this difference in macroscopic fracture surface between two composites resulted also from the difference in plasticity as discussed previously for tensile fracture surfaces.

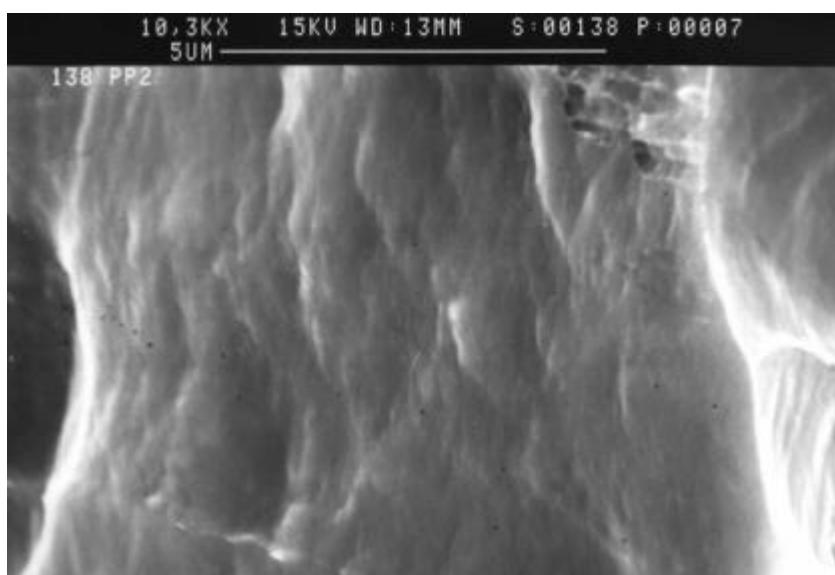
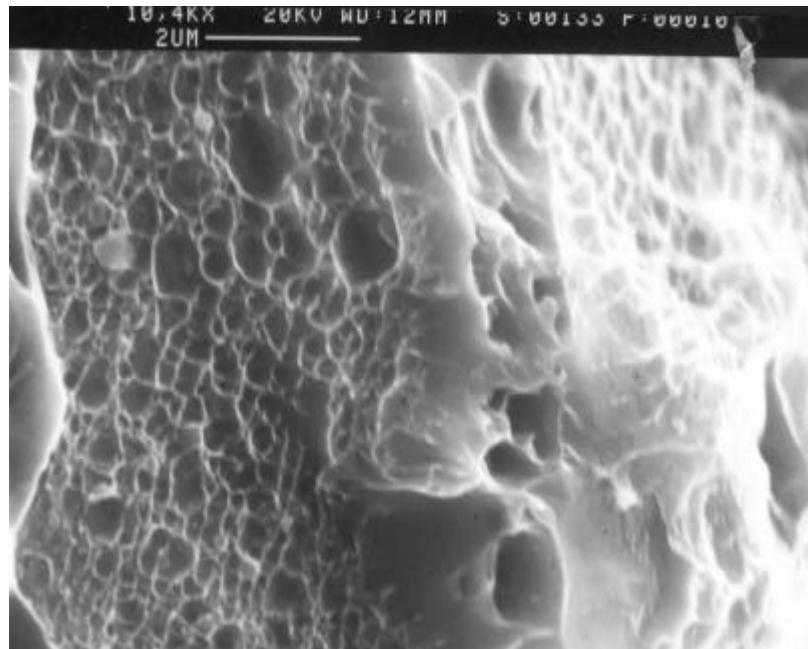
a.  $\text{Al}_2\text{O}_3/\text{Al}-7\text{Si}-0.6\text{Mg}$  composite

b.  $\text{Al}_2\text{O}_3/\text{Al}-5\text{Si}-3\text{Cu}-1\text{Mg}$  composite

Fig.5.Dimples in fracture surfaces of two composites ruptured at room temperature

Microscopically, it was observed that dimples existed in the two matrixes fractured, no matter which test the composites were subjected to. However, the dimples in fracture surfaces of the two composites were also very different. The dimples in the fracture surface of  $\text{Al}_2\text{O}_3/\text{Al}-7\text{Si}-0.6\text{Mg}$  composite were long strip cavities while those in the fracture surface of  $\text{Al}_2\text{O}_3/\text{Al}-5\text{Si}-3\text{Cu}-1\text{Mg}$  composite tested at ambient temperature were small spherical microvoids as presented in Fig.5. Existence of dimple indicates that microscopically, the two composite matrixes were fractured by microvoid nucleation, growth and coalescence as described in references (3), (4) and (5); even though macroscopically,  $\text{Al}_2\text{O}_3/\text{Al}-5\text{Si}-3\text{Cu}-1\text{Mg}$  composite showed brittle rupture features. Nevertheless, microvoids in  $\text{Al}_2\text{O}_3/\text{Al}-7\text{Si}-0.6\text{Mg}$  composite were much elongated due to its good ductile so that the dimples were in the shape of long strip. That is the reason why dimples in two composites were so different.

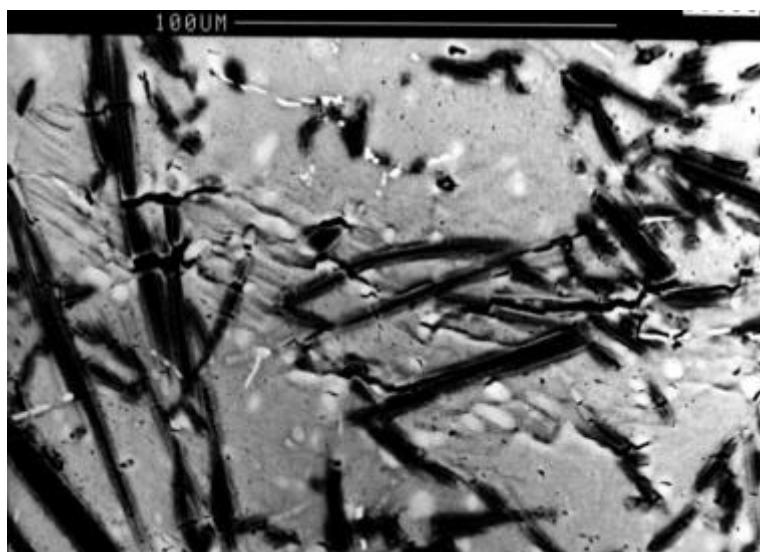
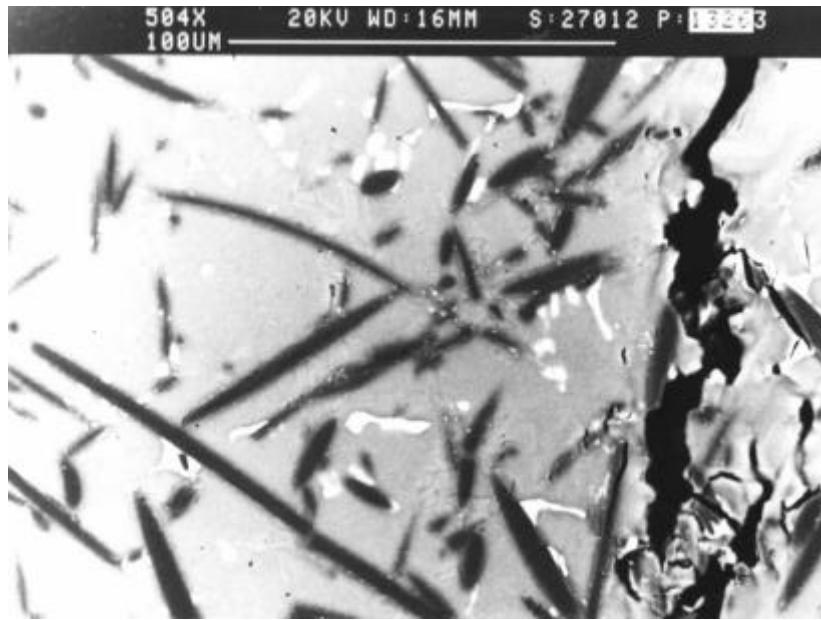
a.  $\text{Al}_2\text{O}_3/\text{Al}-7\text{Si}-0.6\text{Mg}$  composite

b.  $\text{Al}_2\text{O}_3/\text{Al}-5\text{Si}-3\text{Cu}-1\text{Mg}$  composite

Fig.6. Plastic deformation near cracks in two composites ruptured in fracture toughness tests

Compared surfaces of specimens performed fracture toughness tests, which were polished before tests, it can be observed that plastic zone near the cracks in the  $\text{Al}_2\text{O}_3/\text{Al}-7\text{Si}-0.6\text{Mg}$  composite was much larger than that in  $\text{Al}_2\text{O}_3/\text{Al}-5\text{Si}-3\text{Cu}-1\text{Mg}$  composite (see Fig.6.) But the fracture toughness value of  $\text{Al}_2\text{O}_3/\text{Al}-5\text{Si}-3\text{Cu}-1\text{Mg}$  composite was greater than that of  $\text{Al}_2\text{O}_3/\text{Al}-7\text{Si}-0.6\text{Mg}$  composite<sup>(6)</sup>. It suggests that fracture toughness for  $\text{Al}_2\text{O}_3/\text{Al}-7\text{Si}-0.6\text{Mg}$  composite should be principally contributed due to work dissipated by plastic deformation of the crack tip; while that for  $\text{Al}_2\text{O}_3/\text{Al}-5\text{Si}-3\text{Cu}-1\text{Mg}$  composite should principally attributed to formation of the fracture surfaces. This result indicates that increasing the fracture toughness of these materials can only result from microstructure changes that enhance either the ductility of the matrix or surface formation energy.

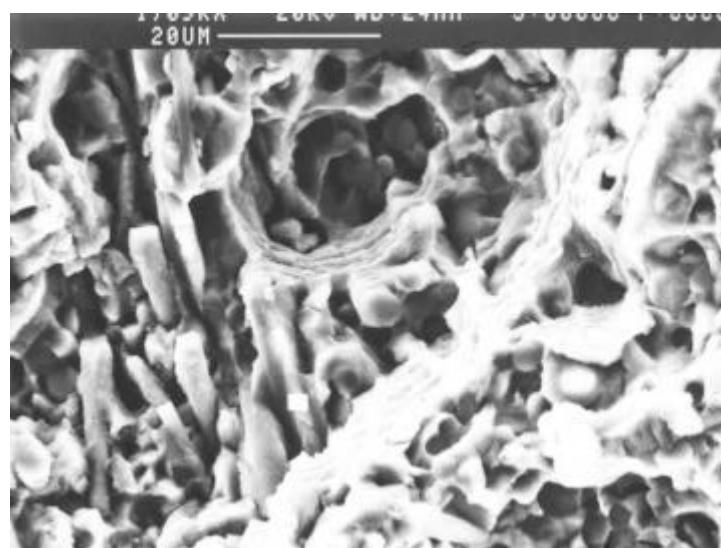
Fig.7. Fatigue strips in fracture surfaces of the composites

Fatigue crack initiation sites for the composite specimens tested were near a surface, at weak fiber/matrix interfaces, or defects like inclusion and cavity in the composite<sup>(7)</sup>. In fatigue crack propagation region of the composites fracture surfaces, some ambiguous ductile fatigue striations can be observed by scanning electrical microscope. Some of them were loop fatigue striations around fibers as given in Fig.7. It suggested that the crack should be propagated taking the fiber as a center, i.e. firstly the fiber should be damaged, and a crack should be initiated then the crack should be propagated towards to radial direction around the broken fiber. With the crack propagation, fatigue striation loops around neighboring several broken fibers were linked into a big one. Some of them were close, if there were no fibers near them, that means the fibers were clustered in the matrix, otherwise, fatigue striation loops can not be close ones. That is why most of the fatigue striations were arcs with various curvatures. The microscopic fractography for fast fracture region in fatigue fracture surface was like that in tensile fracture surface.

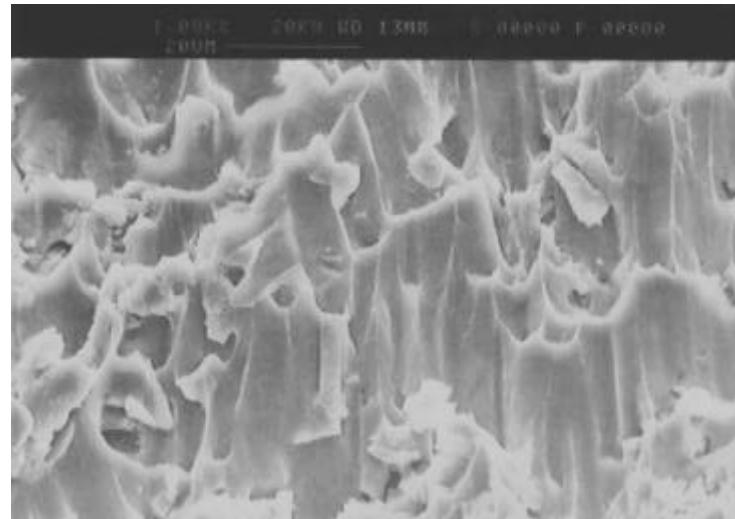
Fig.8. Fracture surface for the composites rupture at 300 °C

The fractography of the composites tested in tension at elevated temperatures depended upon the test temperatures. Some broken fibers can be observed in the fracture surface when the specimen was fractured at the temperatures below 250 °C. Few broken fibers were discovered in the fracture surface for the specimens ruptured at the temperatures above 300 °C, in which almost all broken fibers were deeply embedded into the matrix in shape of sleeve as shown in Fig.8. The higher the test temperatures, the longer the sleeves. It suggests that matrix should be elongated freely after the fibers in it were broken, which was approved by stress-strain curve shown in Fig.9. In fact, stage III in fig.9 was creep of the matrix near the ends of the broken fibers. Therefore, creep fractography of the composites at 300 °C was similar to tensile fractography of the composites tested at the same temperature.

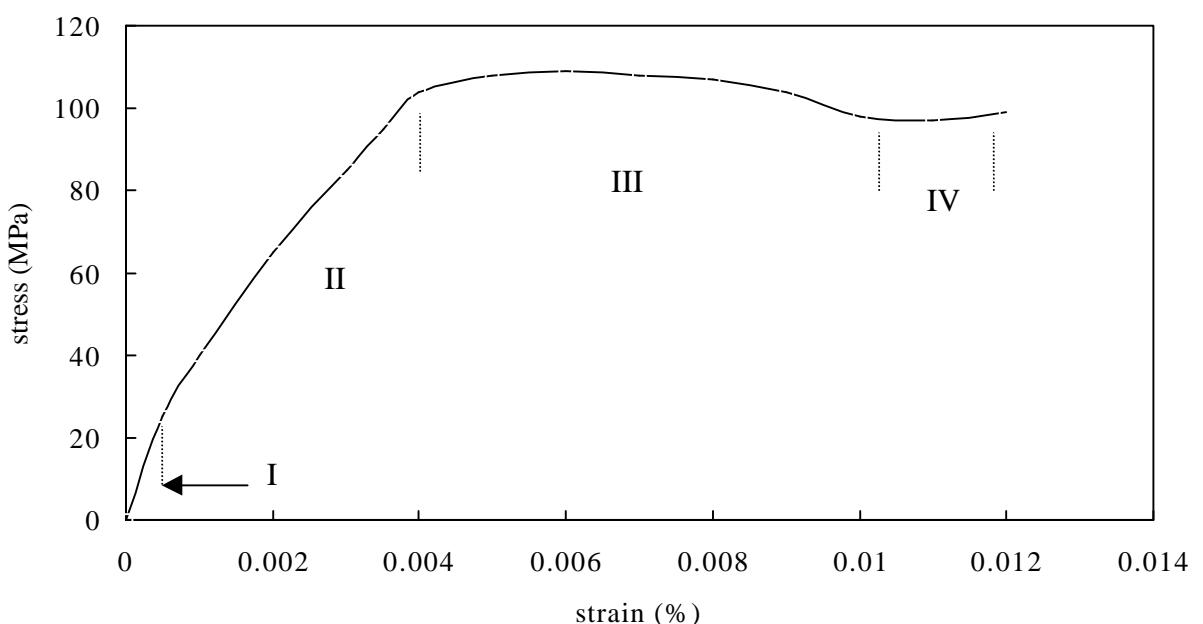
Fig.9. Stress-strain curve for the composite tested at 300 °C
