# **C-130 HERCULES COMPOSITE FLAPS FATIGUE TEST PROGRAM**

J. Ayling

*Hawker de Havilland Pty Ltd  
361 Milperra Road, Bankstown, New South Wales, 2200, Australia*

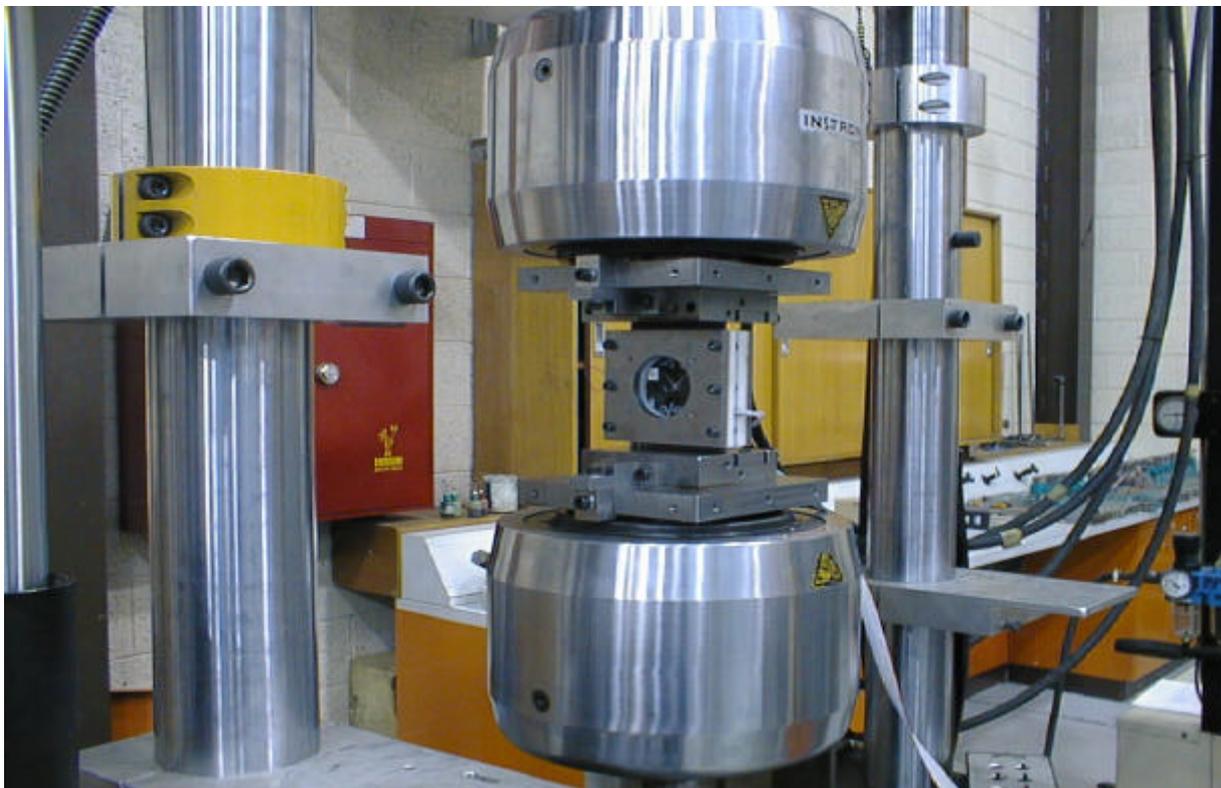
Fig. 2: Typical Coupon Test Installation

Fig. 2 presents the typical test setup for each coupon and Fig. 3 presents a through transmission ultrasonic (TTU) C-scan of a coupon with BVID before and after testing, including a sectional view of the damaged region.

Five coupons were statically loaded in compression until failure to determine the average failure load for the laminate with induced damage. From these static test results, three load levels were calculated and the remaining coupons were tested using constant amplitude cycling with an R ratio of 10 and a frequency of 5 Hz. To ensure statistical confidence in the results, five coupons were fatigue tested at each load level. Each coupon was supported to prevent buckling, in both the static and fatigue tests; these anti-buckling supports were designed not to inhibit the growth of the BVID site in each coupon.
