# **ON TRANSVERSE FRACTURE MECHANISMS OF 1140+/Ti-6Al-4V AND SCS-6/Ti $\beta$ 21S COMPOSITES UNDER TENSILE LOADING**

**SUMMARY:** The transverse behaviour of 1140+/Ti-6Al-4V and SCS-6/Ti  $\beta$ 21s composites has been investigated by tensile tests in air and in situ within a FEG-SEM using direct observations. Acoustic Emission Analysis(AE) has also been used to assess and locate positions of damage. It has been observed that debonding in both composites can start at very low stresses due to defects and/or undulations at interfaces. AE events can be found almost immediately on loading during premature debonding of SCS-6/Ti  $\beta$ 21s, but few for the 1140+/Ti-6-4 composite. Many AE events of high energies were detected in the region of the first knee on stress ~ time curves. The peak energies of AE obtained in 1104+/Ti-6-4 and SCS-6/Ti  $\beta$ 21s are of ~150 and ~650 $\mu$ J, respectively. Cracking of carbon coatings and/or reaction zones also produce distinct AE events. Distinct differences in AE behaviour have been found between 1140+/Ti-6-4 and SCS-6/Ti  $\beta$ 21s composites.

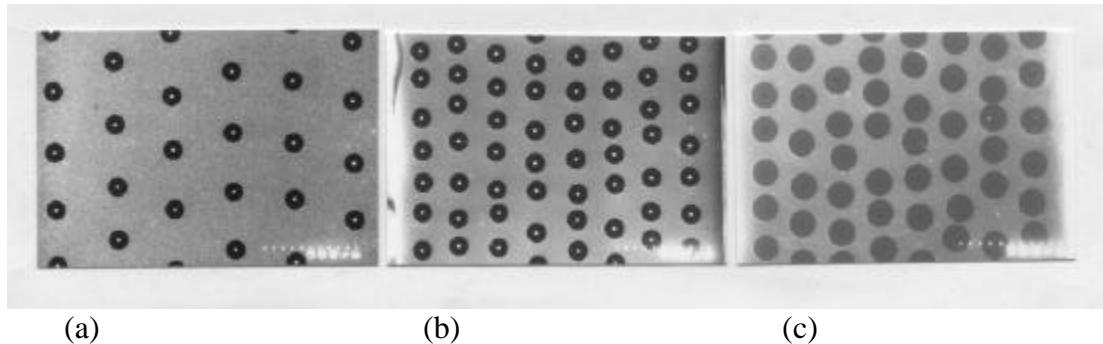
*Fig. 1: Transverse sections of the composites: (a) 8% 1140+/Ti-6-4; (b) 21% 1140+/Ti-6-4 and (c) 35% SCS-6/Ti  $\beta$ 21s.*

The composites studied here are 8 and 21% 1140+/Ti-6-4 and 35% SCS-6/Ti  $\beta$ 21s. The 1140+/Ti-6-4 composites were received in the form of a 12-ply plate with thickness of ~3.5 mm and an 8-ply plate with thickness of ~1.82 mm, for the 8 and 21% fibre volume fraction composites, respectively. The 35% SCS-6/Ti  $\beta$ 21s plate was also an 8-ply plate with a thickness of approximately 1.8 mm. The chemical composition of the Ti  $\beta$ 21s is: 15Mo, 2.7Nb, 3Al, and 0.2Si(wt.%). These plates were then machined by using electro-discharge-machining(EDM) to produce conventional transverse tensile testpieces of length ~180 mm and width ~4 mm and *in situ* transverse testpieces of length ~80 mm and width ~2.5 mm. The distributions of fibres in transverse sections are shown in Fig. 1.

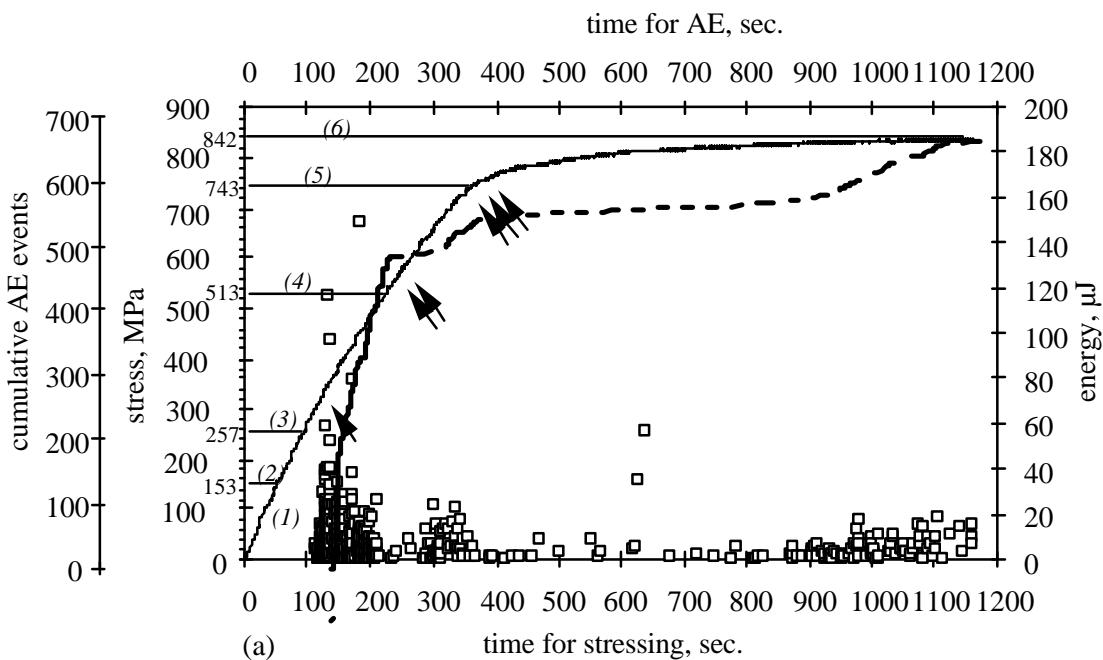
*Fig. 2: Plots of stress vs time(solid line), cumulative AE events vs time(dashed line) and energies of AE events vs time(open squares) of the 8%1140+/Ti-6-4 under a conventional tensile test in air. Some in situ observation results(tested in the SEM) are also indicated by (1)-(6): (1) premature debonding due to defects and undulations; (2) 153 MPa, beginning of micro-debonding at the "perfect" carbon/carbon interfaces; (3) 257 MPa, fully debonding of all interfaces in the SEM; (4) 513 MPa, cracking of the reaction zone and carbon coating; (5) 743 MPa, multiple cracking of the carbon and reaction zone at the interfaces; and (6) 842 MPa, catastrophic failure of the in situ testpiece tested in the SEM.*

Figure 2 shows the results obtained from the 8% 1140+/Ti-6-4 composite. A linear increase of stress with time is first seen after loading starts (region I). At a stress of approximately 350 MPa, a slight change of gradient takes place, as arrowed, which produces the first "knee" on the curve (region II) and it is followed by a second linear period (region III ), within which a slight change of gradient is also noted at  $\sim 520$ MPa, see double arrows. A second distinct further non-linearity on the stress~time curve occurs at  $\sim 720$ MPa (region IV), and afterwards the stress increases little before final catastrophic failure at a stress of 830 MPa(region V). Similarly five regions can also be identified on the stress ~ strain curve of the material, Fig. 3.

The cumulative AE events(dashed line) and the energy distribution of AE events(open squares) during the test are also displayed in Fig. 2. It can be seen that no AE events have been detected in the region I. A burst of AE events takes place spontaneously as the curve starts to deviate from linearity. These AE events have the highest energy, a maximum of  $\sim 150\mu\text{J}$ , and this is approximately four times higher than other AE events( $<30\mu\text{J}$ ). During the second linear period, a smaller second burst of AE events( $<30\mu\text{J}$ ) was observed. Over the second "knee" and most of region V, AE events were infrequent until approaching the

final failure of the specimen, where many AE events were again noted. The number of AE events occurring at different regions are highlighted by the cumulative AE events curve(dashed line), Fig. 2. A dramatic increase of AE events is evident at the first knee.

Figures 2 and 4 show that for 8 and 21% 1140+/Ti-6-4 composites no AE events have been detected in the linear region (I), i.e. the observed period of premature debonding. A burst of AE events(with energy of  $\sim$ 150  $\mu$ J) occur at the first knee where debonding on the surface has been seen to be complete at surface positions.

Figures 2 and 4 have shown a burst of AE events at the first "knee" with the highest energy ( and amplitude), where the interface on the surface has already been seen to be fully open under *in situ* observations. As known during transverse tensile testing, the surface material is under two dimensional plane stress and inside the test piece is under three dimensional plane strain. A higher effective strain is obtained at the surface, which decreases towards the depth of interface tubes. Therefore it can be expected that the three-dimensional

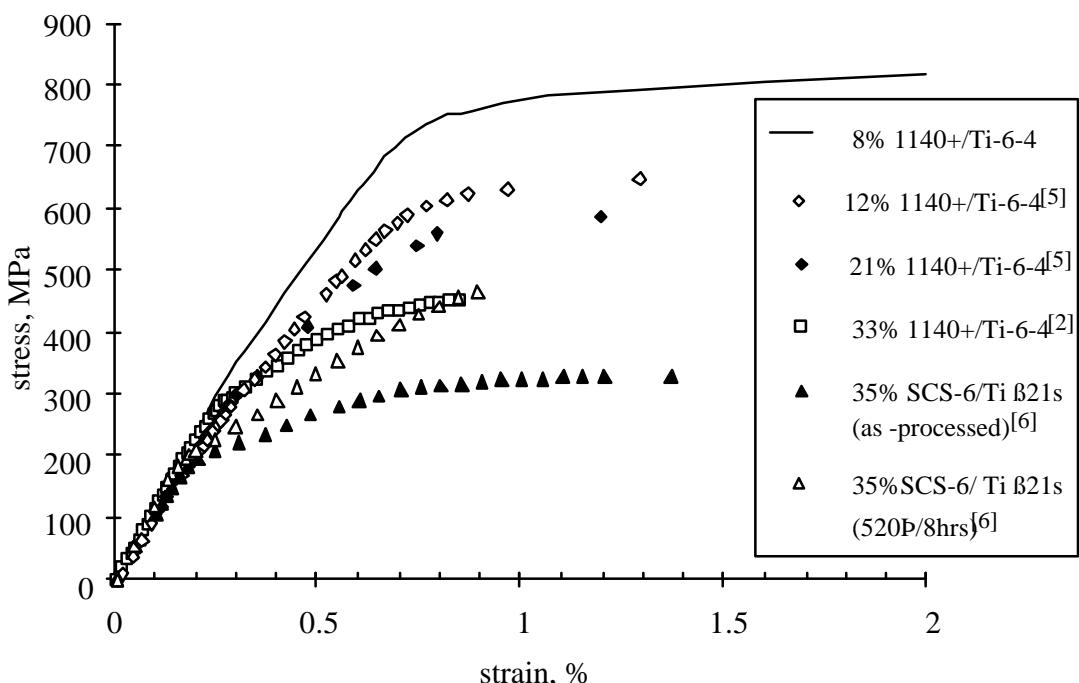
*Fig. 3: Stress versus strain curves of various conditions of 1140+/Ti-6-4 and SCS-6/Ti  $\beta$ 21s composites under tensile loading.*

The tensile test results and some AE information obtained from 8 and 21%1140+/Ti-6-4 and 35%SCS-6/Ti  $\beta$ 21s MMCs are displayed in Figs. 2-5. The level of stress is indicated on the left-hand ordinate axis and the scale for AE parameters is indicated on the right-hand ordinate. The abscissa(time) is necessary to facilitate matching AE events to applied stresses. The transverse stress ~ strain responses of a range of 1140+/Ti-6-4 and SCS-6/Ti  $\beta$ 21s composites have been examined before<sup>[2, 5, 6]</sup> and the characteristics of the stress ~ strain curve is similar to that seen on the stress *versus* time curve in this study, Fig. 3. Thus the dynamic mechanisms are discussed in terms of applied stress level .

From the stress~strain curves of 8, 21 and 33% 1140+/Ti-6-4 composite (Fig. 3) it can be seen that differences between 21 and 33% are unclear. However the average stress for the first "knee" of the 8% 1140+/Ti-6-4 is higher. An analytical result of thermal residual stress by finite element method from a previous study<sup>[9]</sup> has found that an increase of fibre volume fraction may actually lead to a decrease of thermal residual stress (for a given type of fibre distribution pattern). However the scale in reduction of residual stress becomes smaller with an increase of fibre volume fraction at higher volume fractions. The residual stress at  $\theta=0$  changes little when the volume fraction increases from 30 to 40%, whereas a distinct increase of residual stress can be seen when the fibre volume fraction reduces from 20 to 10%. This appears to be consistent with the results obtained in this study, Fig. 3.

It is also noted in the Fig. 3 that the first knee of the 35% SCS-/Ti  $\beta$ 21s is more distinct than that of 1140+/Ti-6-4 composites. Debonding in the SCS-6/Ti  $\beta$ 21s takes place at the carbon/reaction zone interface. The Young's modulus of solution treated Ti  $\beta$ 21s alloy is of ~75 GPa<sup>[10]</sup>, which is significantly lower than the value (115 MPa) of the transverse SCS-6/Ti  $\beta$ 21s composite. Thus a very sharp change of gradient at the first knee can be expected because not only does the composite now contain areas of debonding, but also the modulus of the matrix becomes progressively more important. However in the transverse 35% 1140+/Ti-6-4 composite, the Young's modulus is  $105\pm2$  MPa<sup>[2]</sup>, which is very similar to the value (106 MPa) of the Ti-6-4 alloy<sup>[11]</sup>. Therefore any change in gradient now derives from areas of debonding only.

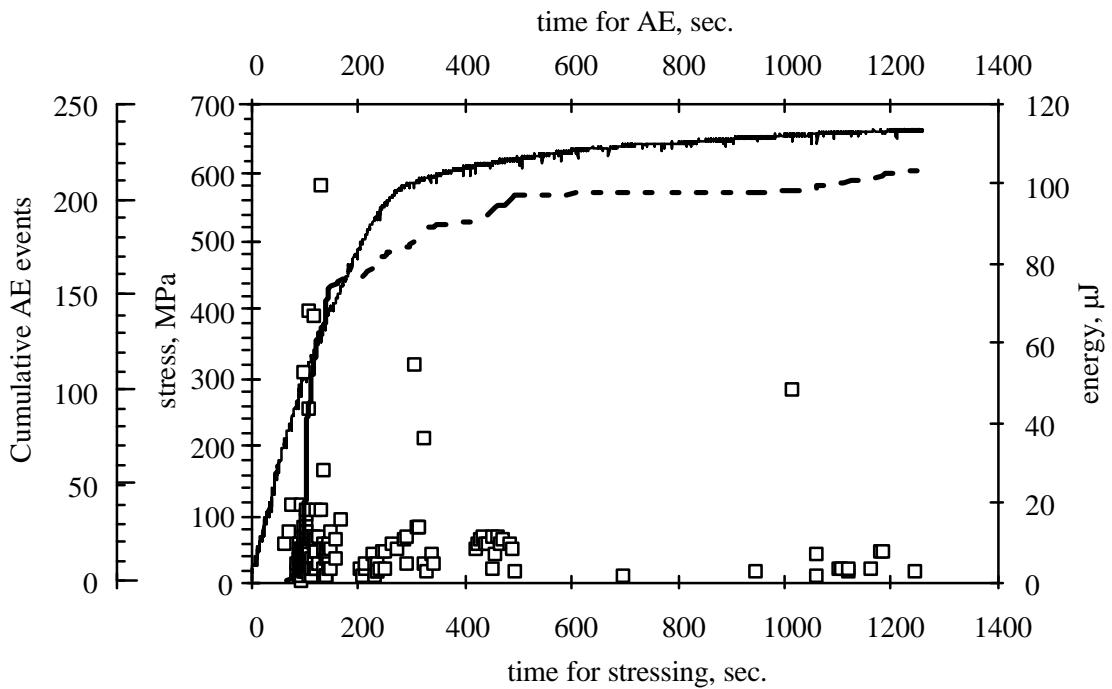
Fig. 4: Plots of stress vs time(solid line), cumulative AE events vs time(dashed line) and energies of AE events versus time(open squares) obtained from the 21% 1140+/Ti-6-4 composite under a conventional tensile test in air.

The results obtained from the 21% 1140+/Ti-6-4 composite are shown in Fig. 4, which are very similar to that seen in the 8% 1140+/Ti-6-4 composite. The second knee on the stress~time curve of the 21% 1140+/Ti-6-4 composite occurs at a lower stress of ~600 MPa(compared with ~720 MPa in the 8% 1140+/Ti-6-4 composite). Bursts of AE events were again seen at both "knees" and limited counts were scattered throughout the rest of the period. The characteristics of AE events appears to be very similar in both composites.

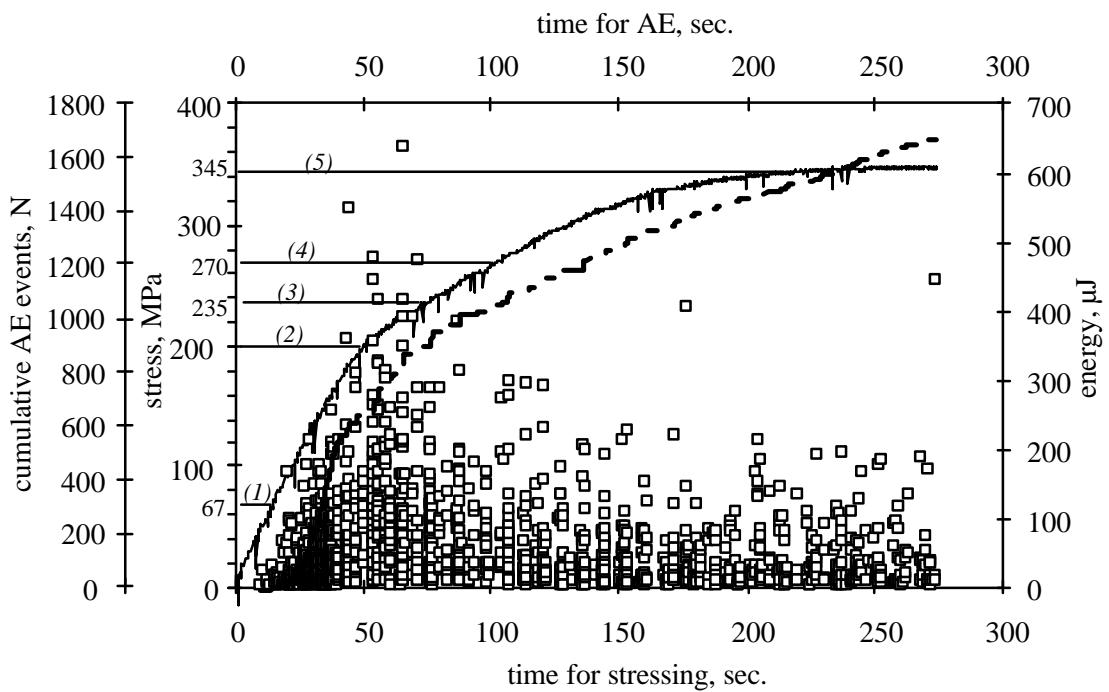
Fig. 5: Plots of stress vs time(solid line), cumulative AE events vs time(dashed line) and the energies of AE events vs time of the 35% SCS-6/Ti $\beta$ 21s under a tensile test in air. Some in situ observation results(tested in the SEM) are also indicated by (1)-(5): (1) 67 MPa, premature micro-debonding due to defects; (2) 201 MPa, full debonding of all interfaces; (3) 235 MPa, multiple cracking in the reaction zone; (4) 270 MPa, occurrence of slip bands in the bulk matrix and (5) 345 MPa, catastrophic failure of the in situ testpiece.

Figure 5 shows the results obtained from the 35%SCS-6/Ti  $\beta$ 21s composite. The differences are obvious, compare with Figs. 2 and 4. A radical change of gradient at the first "knee" is now seen on the stress~time curve. It is also of interest to see in this material that AE events have been received almost immediately on loading, Fig. 5. Many AE events are now present in the linear region I. Note that the energy of the AE events increases with the increase of the applied stress, Fig. 5. The number of AE events is approximately five times higher in the 35%SCS-6/Ti  $\beta$ 21s composite, compare Figs. 5 and 2. It is also noted that the energy range in the SCS-6/Ti  $\beta$ 21s is much larger than that in the 1140+/Ti-6-4 composites. The peak energy of the AE events at the first knee now reaches ~650  $\mu$ J. AE events obtained in the regions of III, IV and V are also much more numerous than those obtained in 1140+/Ti-6-4 composites and they have an energy range of ~300  $\mu$ J, Fig. 5, which is approximately half of its peak energy at the first knee(~650  $\mu$ J). However this value is still approximately ten times higher than energies seen over the similar regions in the 1140+/Ti-6-4 composites(< 30 $\mu$ J), Figs. 2 and 4.

For the 35%SCS-6/Ti  $\beta$ 21s composite, premature debonding also starts from very low stresses due to defects. Fig. 5 shows that AE events can now be received during premature debonding in the first linear region. The AE events with a peak energy again occurs at the first knee, but now with a maximum energy of  $\sim$ 650  $\mu$ J.
