LOW-VELOCITY IMPACT DAMAGE OF KNITTED CARBON FABRIC/EPOXY COMPOSITES

Gao Yang, Chwee Teck Lim and Seeram Ramakrishna

Department of Mechanical Engineering

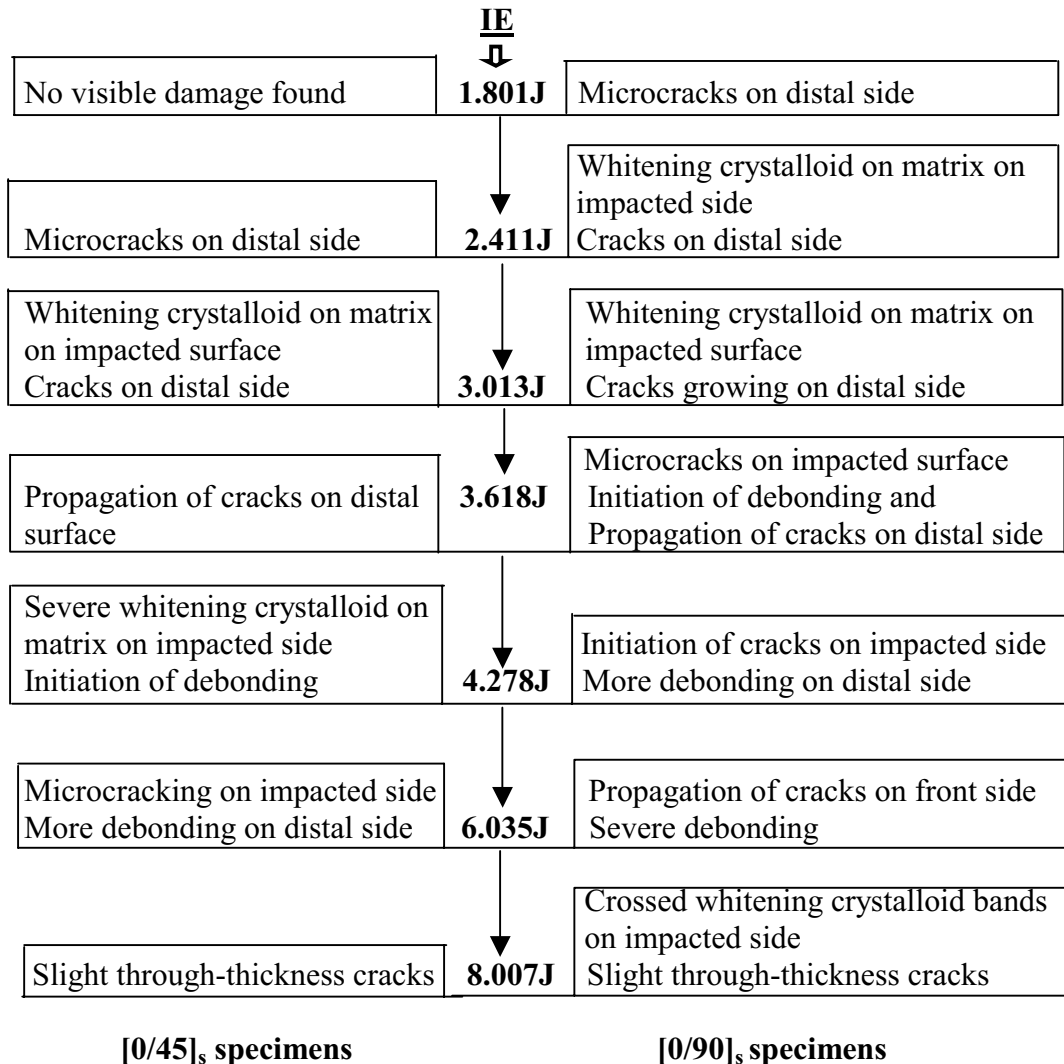
Figure 2 Relating impact damage with IE for the 4-ply specimens

For BVID situations, no visual damage is observed. The stereomicroscopic images show that there are crystalloid damage and some disordered microcracks around the impact spot. In some specimens, slight matrix/fibre debonding is found. Figure 2 describes the damage

patterns of [0/45]_s and [0/90]_s specimens when subjected to different incident impact energies (IE). Figure 3 shows representative photographs of damage on the surfaces of specimens. Figure 4 shows the representative stereomicroscopic pictures of matrix/fibre debonding, whitening crystalloid matrix damage and fibre breakage. Here, whitening crystalloid damage is defined as the local whitening of the matrix around the impact spot due to impactor hitting on the matrix.

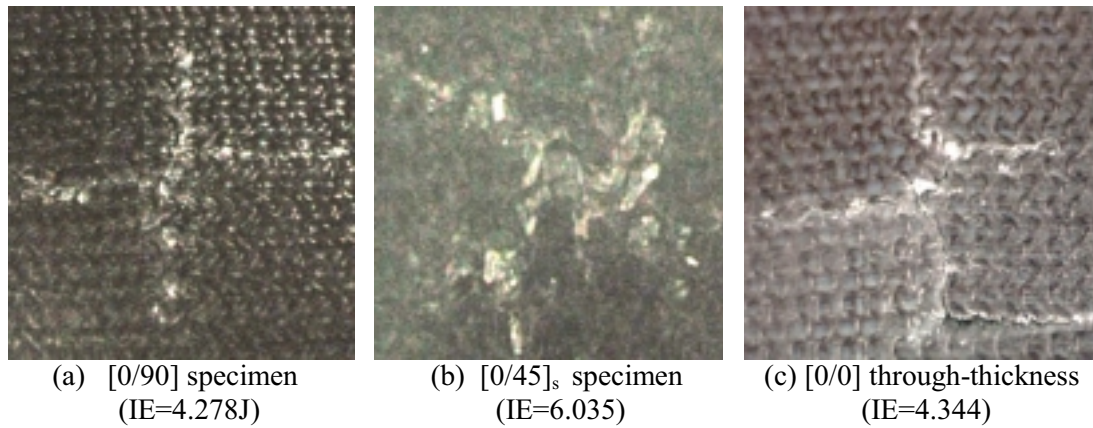
Figure 3 Photographs of crossed-crack damage on impacted surface

- Matrix cracks cross at nearly right angle in both the wale and the course directions for unidirectional and orthogonally stacked specimens (Fig.3 (a)), while matrix cracks radiate haphazardly for [0/45]_s specimens (Fig.3 (b)). For severe through-thickness crack or crush damage, damage modes may not appear as a single cross shape but may appear as different patterns of cross-cracks (Fig.3 (c)).

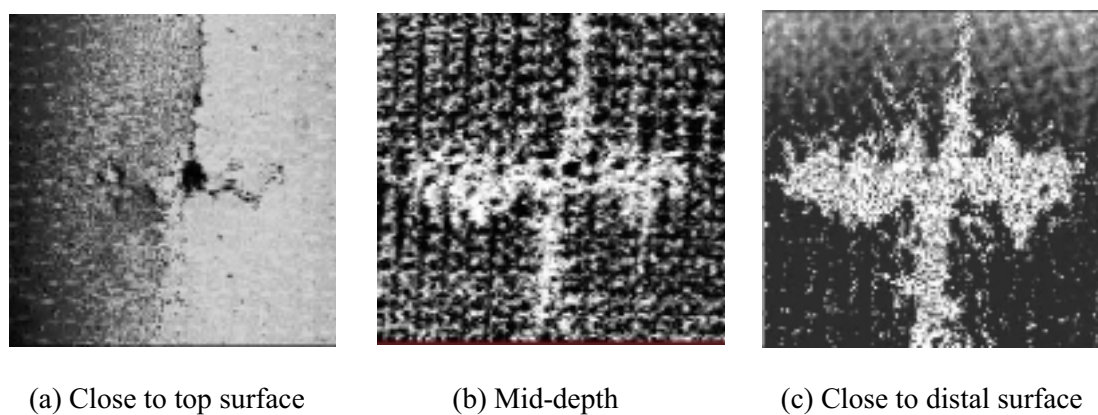
Figure 5 Typical C-scan images at different depth of a impacted $[0/0]_s$ specimen (IE=10.185J)

With further increase in incident impact energy, visual cracks and through-thickness cracks start to occur. Figure 5 shows representative C-scan images for the [0/0]_s specimen with through-thickness cracks. Here crossed debonding bands along the cracks are clear. Figure 6 shows typical C-scan images for the [0/45]_s specimens with slight cracks on distal surface. Due to smaller IE, the images of cracks are not obvious and no clear debonding bands along the cracks are observed. From the images obtained, the damages are crossed matrix cracks and/or matrix/fibre debonding and the damages possess the following features:

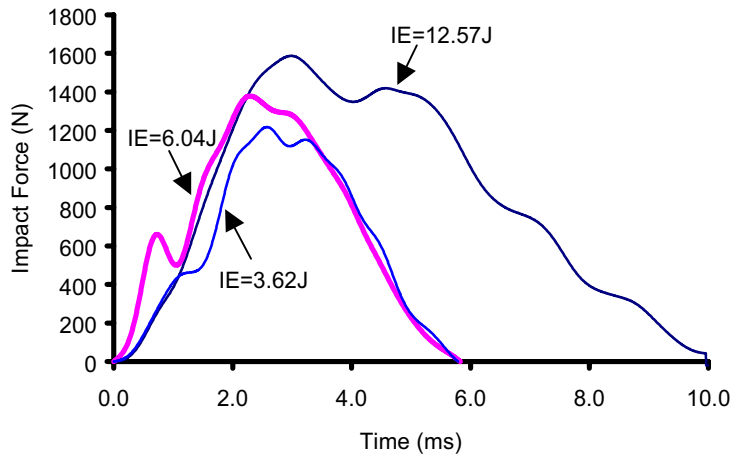
Figure 7 Representative impact force curves for $[0/0]_s$ lay-up specimens

Figure 7 shows representative plots of impact force vs. time. It was observed that there exists a threshold value of impact force. When impact force is lower than the threshold value, the force keeps rising and no damage which may lead to reduce stiffness of specimens occurs. But as impact force exceeds the threshold value, the force will initially drop (see IE=6.04J in Fig. 7) or form a force plateau (see IE=3.62J in Fig. 7). This sudden change of impact force slope shows that matrix cracking, and/or matrix/fibre debonding, and/or fibre breakage may have occurred at that moment. Thereafter, impact force continues to reach a maximum before decreasing to zero. There are two situations in which no force drops or force plateaus occur. One is when incident impact energy is too small to make any significant damage. In this situation, no obvious damage can be observed. Another situation is when incident impact energy is great enough so that matrix cracking, matrix/fibre debonding and fibre breakage happen at about the same time and results in loss of load-bearing ability (see IE=12.57J in Fig. 7). Severe through-thickness cracks occur and specimens fail structurally.

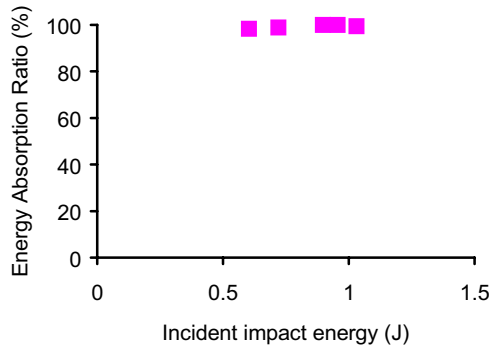
Figure 7 Impact on 1-ply specimens

Figure 8 to 13 show plots of energy absorption ratio (namely AE-ratio) vs. IE for various stacking sequences with incident impact energy. Generally, for BVID situations, the energy absorption ratio is small. However, energy absorption ratio can be more than 80% when through-thickness damage occurs. Specimens with more layers can bear greater impact force than that with fewer layers, however, the later
