LOW VELOCITY IMPACT RESPONSE OF THIN WALLED GRAPHITE/EPOXY CYLINDERS

SUMMARY : Helical and hoop wound graphite/epoxy (Gr/Ep) composite cylinders have been tested under low velocity impact (LVI) loading. The studies were conducted in two phases. In Phase I, the impact energy levels ranged from 1 to 6 ft-lbs, while in Phase II, the impact energy levels ranged from 35 ft lbs-50 ft lbs. Nondestructive evaluation (NDE) tests (ultrasonic and vibration) were conducted to assess the damage evolution in the cylinders. Ultrasonic NDE was utilized to assess process integrity and to map the impact damage. Vibration based NDE tests were conducted prior to, and after impact to determine modal response (frequency and damping ratio) of the composite cylinders under a simply supported boundary condition. The microstructure of some of the cylinders has also been studied by sectioning them at impact locations.

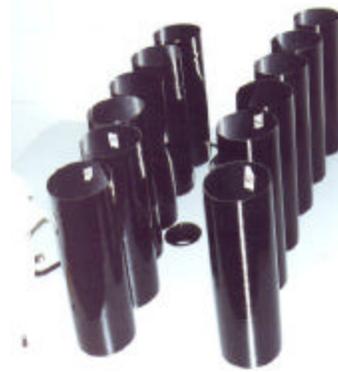
Figure 1. Hoop and helical wound Gr/Ep cylinders

Ultrasonic C-Scan Testing: A total of twelve (six hoop wound and (six helical wound) Gr/Ep cylinders (Fig.1) were studied. The cylinders had an average weight of 274 gms (0.604 lbs), length 319 mm (12.5"), wall thickness 1.5 mm (0.06"), inner diameter 127.5 mm (5.01") and outer diameter 129 mm (5.07"). The lay-up comprised three layers. All cylinders were subjected to pre-and post-impact ultrasonic C-scan testing. A Testtech system with a five-axis robot in conjunction with a USP-12 Krautkramer Branson ultrasonic pulser receiver was used for ultrasonic testing of the cylinders. The following approach was taken in scanning the cylinders. The cylinder was held in a grooved head, which was attached to a rack and pinion arrangement. It was ensured that the central rod of the fixture was parallel to the axis of the cylinder. A 5 MHz pulse-echo immersion type ultrasonic transducer was focused with respect to the uppermost position on the cylinder. A developed view of the cylinder was obtained by indexing the cylinder on the rack and pinion fixture.
