INVESTIGATION OF A COMPOSITE REPAIR METHOD BY LIQUID RESIN INFUSION

M. Hautier, D. Lévêque, C. Huchette, P. Olivier*
ONERA, DMSC

SUMMARY

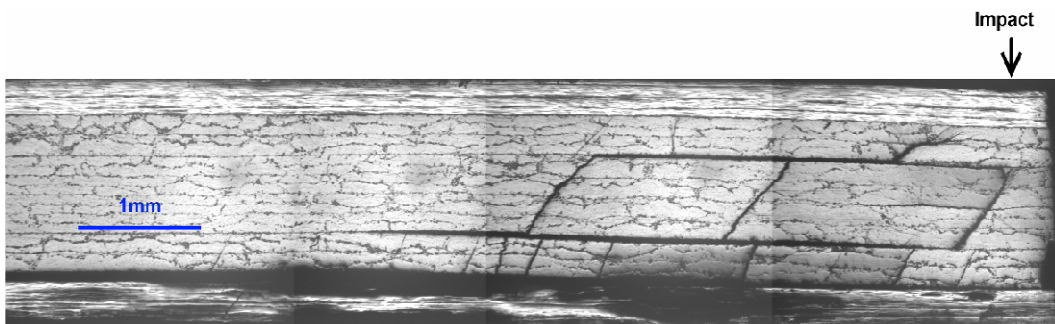
Figure 1: Impact Damage with delaminations between plies and transverse cracks on a $[0_2/+60_2/-60_2]_s$ laminate.

Therefore the detection of such damage and their repair is of great interest. Plenty of methods do exist and even more are being developed. Quasi-isotropic laminates are the most used stacking sequence and the damage induced by an impact is very specific. It is organized in delaminations with a conical double helix shape connected with some transverse cracks in the plies (Figure 1). The size of the damage grows from the impact side to the rear side. Generally for low energy impact there is very little fibre breakage.

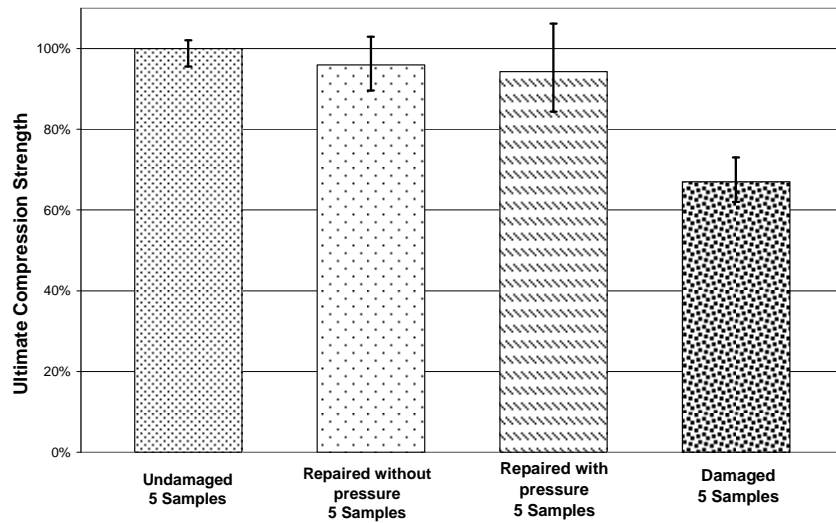
Figure 5: CAI results on undamaged, repaired and damaged samples (mean normalized strength and min/max values).

In order to follow the spoiling of the sample during compression test, a 3D image correlation system was used. Global buckling was observed on the undamaged and repaired samples whereas a local buckling was observed on the damaged samples. No significant compression modulus difference was observed between undamaged and repaired samples. Concerning the ultimate compression strength good results were achieved regarding the relative 'poor' quality of the infiltrated resin. As shown on Figure 5 the repaired samples do recover at least 90% of the ultimate strength.

The influence of the injection pressure on the quality of the repair was also investigated. As we suspected in the resin development, the injection pressure seems to mostly influence the infiltration time. The difference in ultimate compression strength of the repaired samples with or without pressure is not significant regarding the dispersion of compression tests.

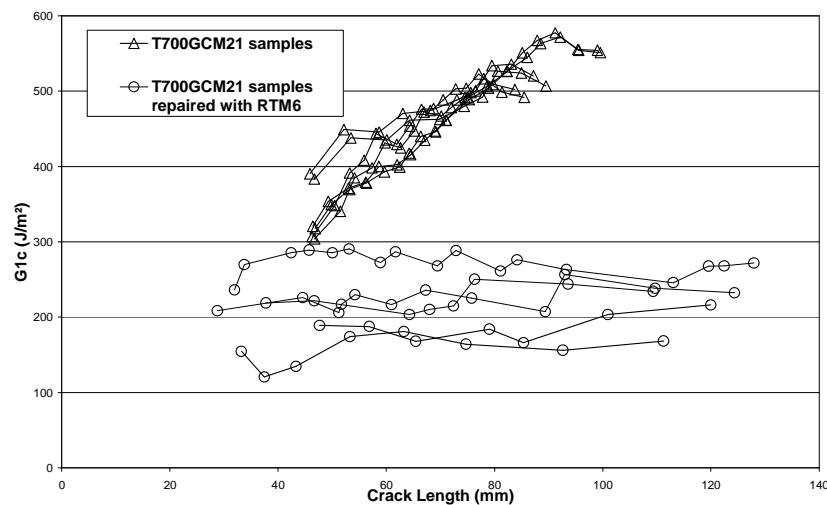
Figure 7: DCB results on T700GC/M21, sane and repaired with RTM6 resin

As it can be found in the literature [8], composites do follow an R-curve chart type. This is due to fibre bridges virtually which increase the energy necessary to propagate the crack. Initial and propagation values of the same samples of T700GC/M21 are in accordance with what can be found on this particular material [9].

In the repaired samples, all the bridges due to the in-thickness miss-alignment have been destroyed in the repair process. This explains the relatively constant energy rate for all the repaired samples. We can observe on Figure 7, that with RTM6 repair resin we do not resituate the initial properties of the T700GC/M21 (see **Table 1**). However, it seems that the repair is at least as good as the repair resin and with a better repair resin we should get a better behaviour in DCB test.

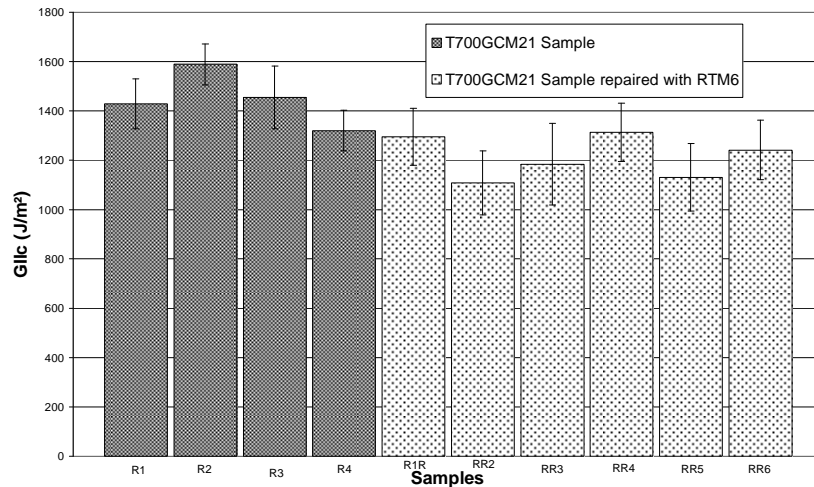
Figure 8: ENF test results on T700GC/M21; sane and repaired samples with RTM6 resin

As for the DCB results, the repaired samples do not reach the values of the sane T700GC/M21 samples Figure 8 but compared to the values found in the literature for RTM6 system by itself, the repair seems again to be at the maximum capacity of what can deliver this epoxy resin [10].
