# THE IMPACT DAMAGE AND THE LOW COMPRESSIVE STRENGTH OF COMPOSITE LAMINATES

H. Suemasu

**Keywords:** *Laminate, Impact damage, Buckling, Finite element analysis, Energy release rate*

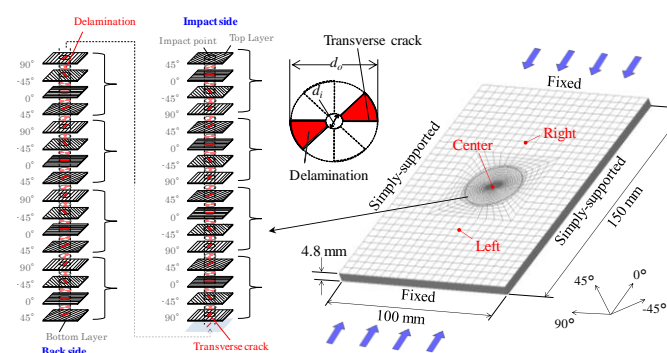
Fig.1 Spiral shape damage and finite element discretization.

Compressive behavior of the Quasi-isotropic laminates with a spiral shape damage was numerically analyzed by a finite element method (Abaqus 6.7). Fig.1 shows an analytical model of a rectangular laminate with the damage consisting of inter-connecting delaminations of 1/8 sectors of a annular ring and transverse matrix cracks. Quadratic 20 node solid elements were used. The contact of the damaged portion was approximately considered by using a nonlinear spring elements. Material properties of IM600/#133 were used. Energy release rate along the delamination edges is calculated by VCCT. Several cases of different outside diameters  $d_o$  were analyzed. The diameter  $d_i$  of the center undamaged portion was set 5.0 mm.

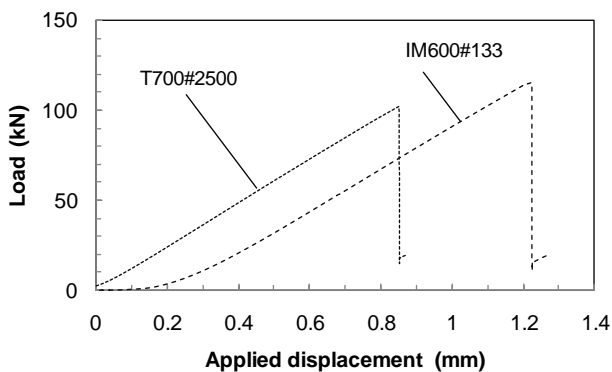
Fig.2 Relationships between the applied load and the cross-head displacement.

The applied load was plotted against the cross-head displacement in Fig.2. Slight reduction of the stiffness occurred at about 80 kN for T700/#2500 and 100 kN for IM600/#133. The specimens failed at 102 kN and 116 kN, respectively. The C-scan images of the damage area was shown in Fig.3. For a IM600/#133 specimen, audible sound occurred several times without visible change of the damage in the C-scan images. Damage growth was found at the both sides of the damage just after a large sound at 119 kN at the fourth ply interface from the back surface. The specimen broke soon after the reloading. The final failure behavior of T700/#2500 specimen recorded by a high-speed video camera (Fig.4) showed unstable growth of the damage in transverse direction to the load. IM600/#133 specimen (not shown here) tended to break more violently at higher load than the T700/#2500 specimen.

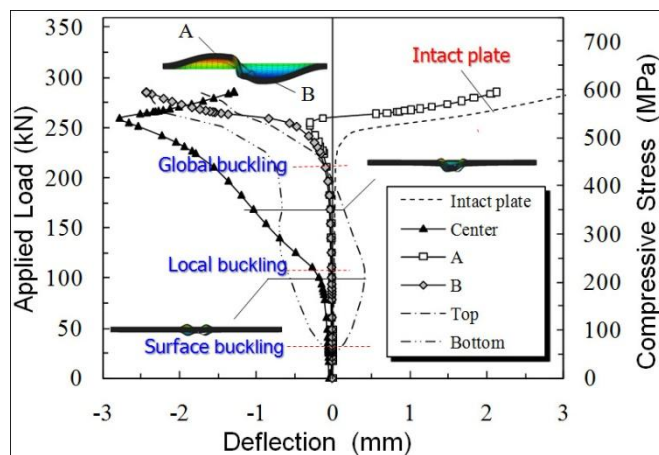
Fig.5 Relationships between applied load and deflection( $d_0 = 30$  mm)

Deflections of several points obtained by a finite element method are plotted against the load for the model of  $d_o=30$  mm in Fig.5. The postbuckling was found to consist of four stages as

Stages (c) and (d) did not realize in the experiment owing to the specimen failure.

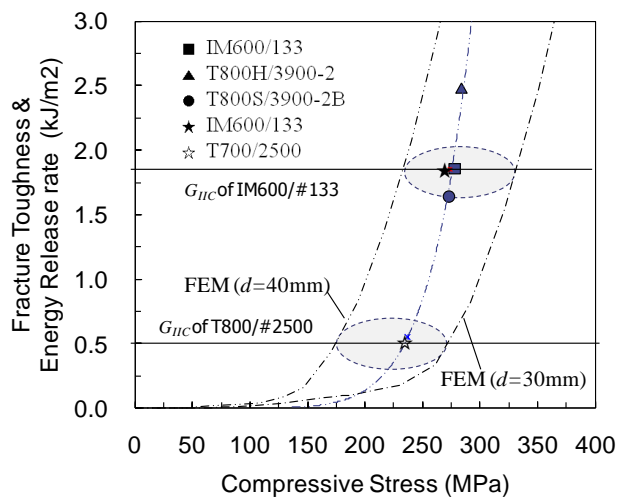
Fig. 6 The relationship between the applied load and maximum energy release rate at the outer edge. (■ ▲ ● : JAXA ACDB database, ★, ☆ : present experimental results)

Energy release rate, calculated along the whole inside and outside edges of the spiral shape damage, had local maximum in the direction transverse to the load for outside edges and in the longitudinal direction for the inside edges. The maximum values of the energy release rate at the transverse edge for the cases  $d_o=30$  mm and 40 mm are plotted in Fig. 6 with the test data (CAI strength vs. the Mode II interlaminar toughness). The test results well agrees with the possible strength supposed from the applied load and maximum energy release rate curves.
