HIGH-VELOCITY IMPACT DAMAGE BEHAVIOR OF GRAPHITE-EPOXY COMPOSITE LAMINATES

K. Woo^{1*}, I. Kim², S.C. Ha², H. Shin², and J.H. Kim³

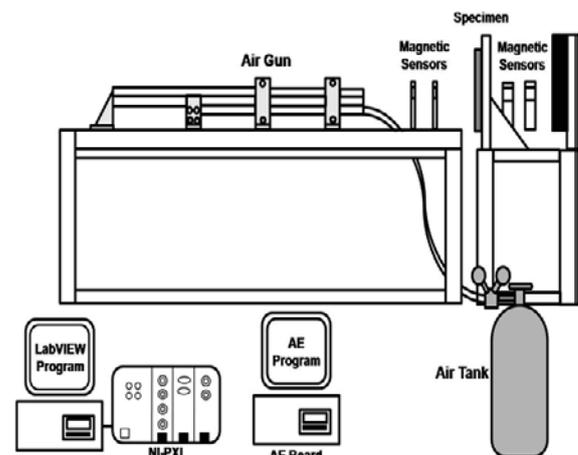
(a) Air-gun impact tester

Fig. 1. Experimental set-up.

The experimental set-up and specimen are shown in Fig. 1. The specially fabricated compressed air gun impact tester was used to fire a 6.5 mm diameter (1.1 gram) steel ball at various impact velocities on to the composite panel. The facility consists of a pressurized air tank, gun barrel, four high precision

magnetic velocity sensors for measuring the steel ball velocity, AE (acoustic emission) sensor and supporting fixtures. The velocity limit of the air gun is approximately 325 m/s. The two magnetic sensors are mounted at the end of gun barrel at a distance of 10 cm apart and the other two magnetic sensors are mounted at the rear of impact specimen for measuring the residual velocity after penetration.

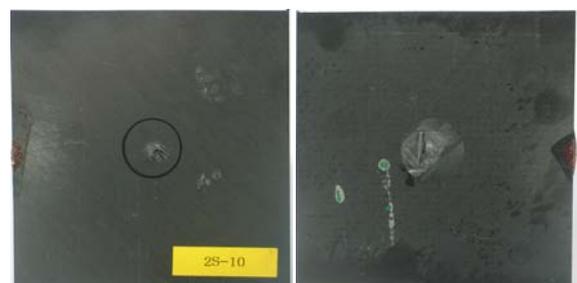
(b) Impact specimen

Table 2 shows the dimensions of composite specimen. The specimens used in this study were laminates made of graphite/epoxy unidirectional prepreg (USN 150B) with $[45/0/-45/90]_{ns}$ stacking sequence. The specimen was placed on a rigid support with a circular hole and clamped by a steel fixture without preload. The portion of the specimen located at the hole (the circled region in Fig. 1(b)) was the deformable portion. In this study, 2 cases of different stacking sequences with 16 and 24 plies were considered.

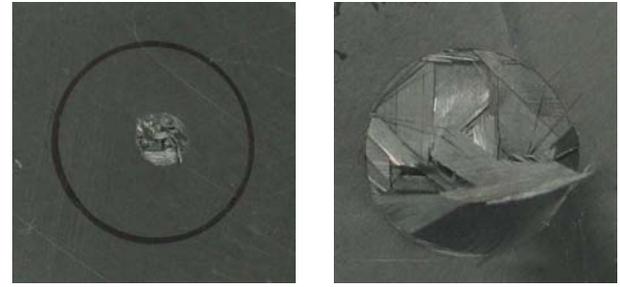
(a) Front surface (b) Back surface

Fig. 2. Photos of front and back surfaces of damaged specimen ($d/D = 4$ and the number of plies = 24, $v_i = 223$ m/s).

Fig. 2 shows the photos of impacted specimen when $d/D = 4$ and the number of plies = 24. The initial impact velocity was 223 m/s. At this velocity the impactor penetrated the laminate with the residual velocity of 34.83 m/s. As can be seen in the figure,

an extensive amount of damage occurred at the back surface of the laminated specimen. The damage propagation was constrained by the rigid boundary.

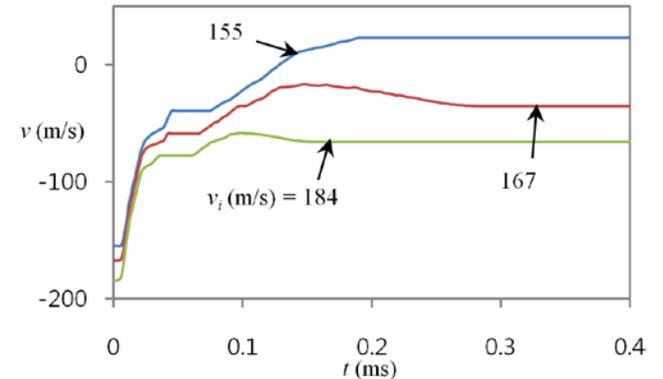
(a) 16 plies

Fig. 3. Time history of impactor velocity.

Fig. 3 shows the variation of impactor velocity versus time. As can be seen in the figure, the impactor velocities decreased rapidly due to the

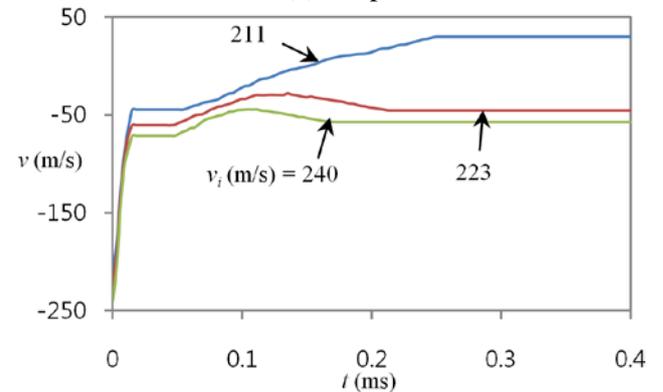
(b) 24 plies

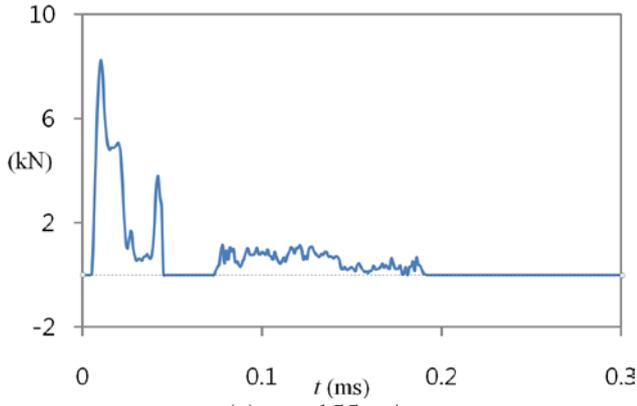
(a) $v_i = 155$ m/s

Fig. 4. Time history of contact forces for 16 ply laminates.

The time history of contact forces are shown in Figs. 4-5. All cases showed very high contact forces for the initial contacts, while the forces of the second contacts were significantly smaller. This indicates major portion of the impact damage occurred during the first contact. One can see that while the contact forces were always positive for the cases where the penetration was not occurred (Fig. 4(a) and Fig.

5(a)), small negative contact forces occurred at the later stage for the cases where the penetration occurred. This was the inverse contact and had the effect of pushing forward the impact projectile, and thus increasing the residual velocity. One can also observe that the contact duration time decreased as the difference between the impact velocity and the penetration impact velocity increased.

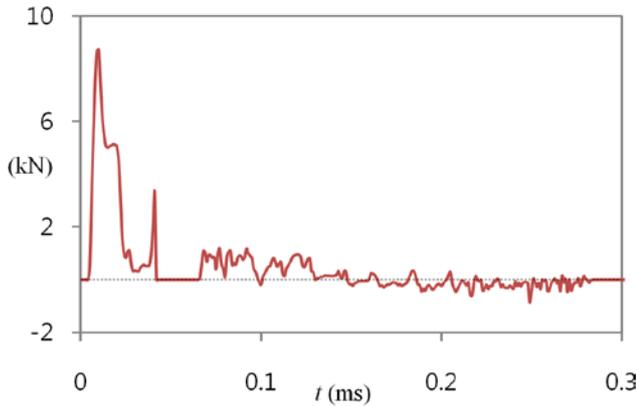
(b) $v_i = 167$ m/s

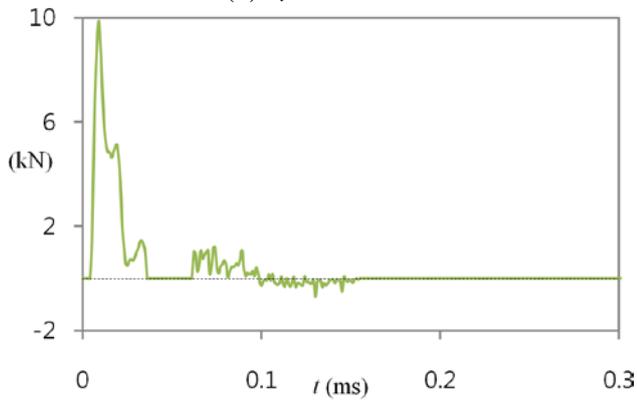
(c) $v_i = 184$ m/s

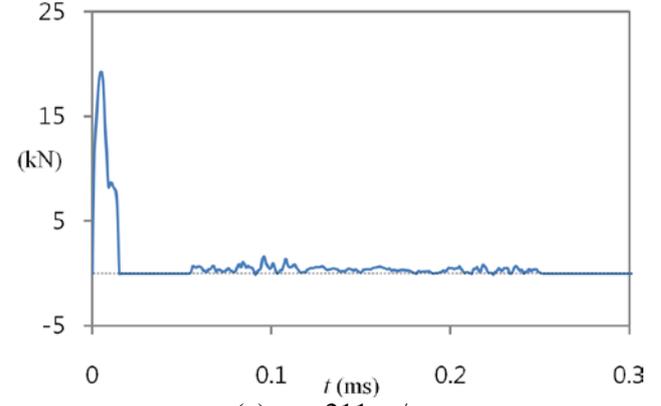
(a) $v_i = 211$ m/s

Fig. 5. Time history of contact forces for 24 ply laminates.

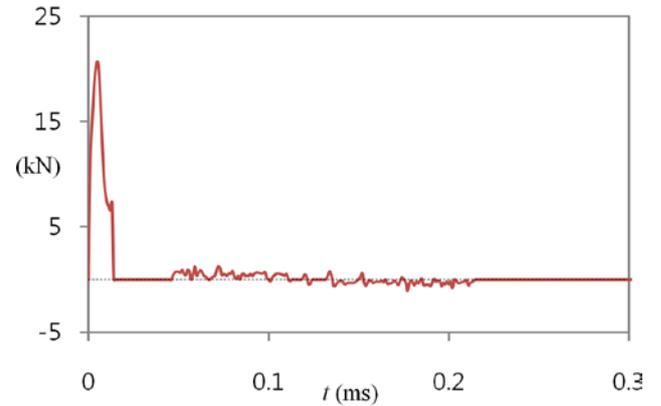
(b) $v_i = 223$ m/s

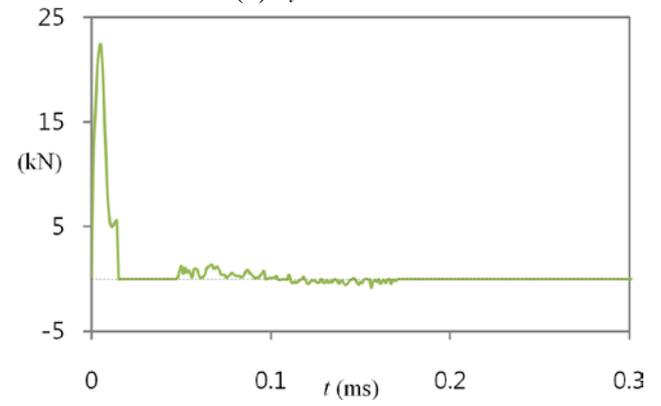
(c) $v_i = 240$ m/s

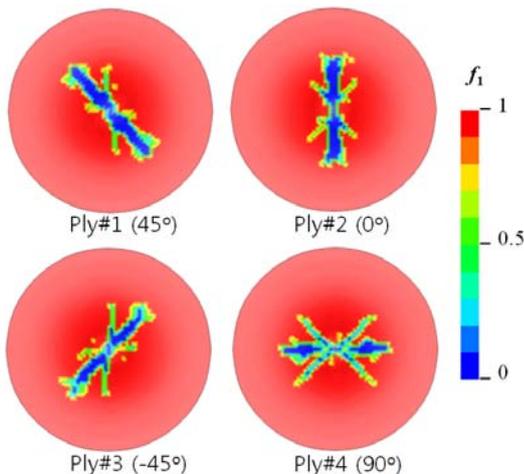
Fig. 6. Fiber tensile failure indexes of back surface layers at $t = 9 \mu\text{s}$.

Figs. 6-7 show the fiber tension damage (f_1) for the back surface plies and the fiber compression damage (f_2) for the front surface plies, respectively, at $t = 9 \mu\text{s}$ for the 24 ply case with $v_i = 223 \text{ m/s}$. Here, '1' indicates the material was undamaged and '0' indicates the fiber damage occurred completely. As expected, initially the fiber tensile damage (f_1) occurred in the laminas located at the back surface, while the fiber compressive failure dominated the damage in the laminas located at the front surface. Also, the damage occurred in the orthogonal direction to the fiber direction.

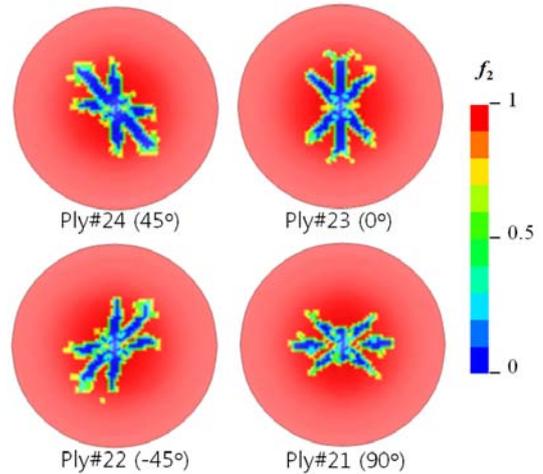
Fig. 7. Fiber compressive failure indexes of back surface layers at $t = 9 \mu\text{s}$.
