# HIGH-VELOCITY IMPACT DAMAGE PROGRESS IN CFRP LAMINATES

E. Oka<sup>1</sup>, K. Ogi<sup>1\*</sup>, A. Yoshimura<sup>2</sup>, T. Okabe<sup>3</sup>

**Keywords:** *CFRP, High-velocity impact, Delamination, Matrix cracking, FEM*

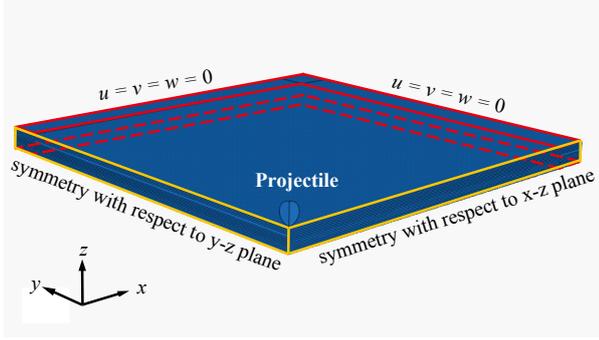
Fig.1. Model for finite element analysis.

Dynamic FEA was performed using a commercial FE software (Abaqus, MSC). A quarter three-dimensional model was adopted for symmetry as shown in Fig. 1. The 8-node solid elements were employed in addition to the 8-node cohesive elements, that were inserted at all the interlayers. Additionally, the cohesive elements were also introduced on the front and back surfaces for reproducing splitting cracks. Additional user subroutine programs for the maximum stress failure criteria was applied to the intralaminar failure. The relation between the traction force and relative displacement for cohesive elements was assumed to be bilinear [2]. For the onset of failure in cohesive elements, the following quadratic criterion was employed:

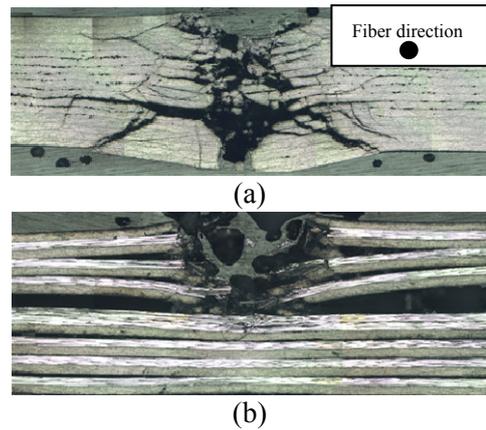
Fig. 4 Cross-sectional views of the (a) UD and (b) CP laminates for  $v = 400$  m/s.

Figure 4 shows the cross-sectional views of the UD and CD laminates for  $v = 400$  m/s. A deep crater, delamination, and breakage of several laminae are observed in both laminates. Cone cracking is observed only in the UD laminate while the opening displacement of the delamination is larger in the CP laminate. It should be noted that the projectile perforated only through the UD laminate at this impact velocity. Simulated internal damage states that correspond to Fig. 4 are depicted in Fig. 5. Damage states including crater depth and delamination are reasonably reproduced in the analysis, although cone cracking is not reproduced.

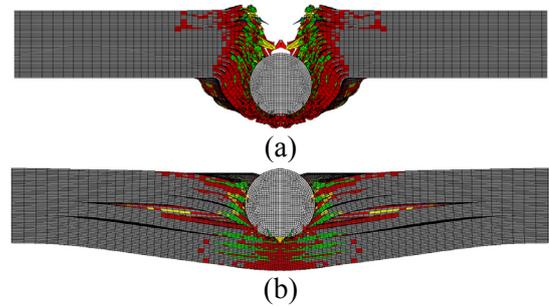
Fig. 5 Simulated internal damage states of the (a) UD and (b) CP laminates for  $v = 400$  m/s.

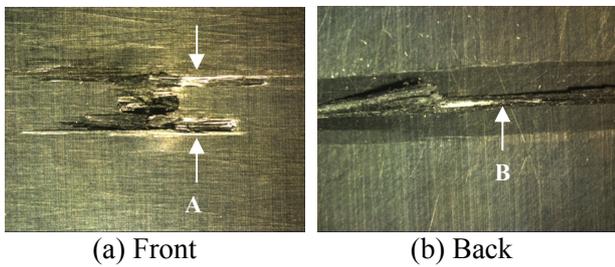
Fig.2. Observed damage states on the (a) front and (b) back surfaces of the UD laminates after impact ( $v = 400$  m/s).

Figure 2 presents the damage states on the front and back surfaces in the UD laminate. Some splitting cracks in the fiber direction (arrow A) were propagating from a crater on the front surface. In contrast, only splitting cracks (arrow B) were generated on the back surface. The surface failure mode makes little difference between UD and CP laminates.

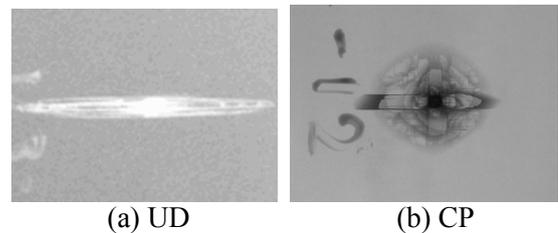
Fig.6. Soft X-ray photos of the internal damage states in the UD and CP laminates ( $v = 400$  m/s).

Figure 6 shows the soft X-ray photos of the UD and CP laminates after impact. The delamination in the UD laminate extends in the fiber direction, which results in a galaxy-shaped delamination. This delamination is narrow because it propagates along the splitting cracks on the surfaces. In contrast, the circle-shaped delamination was generated in the CP laminate. This shape results from the superposition of two peanut-shaped delaminations. Figure 7 demonstrates the simulated delamination in the UD

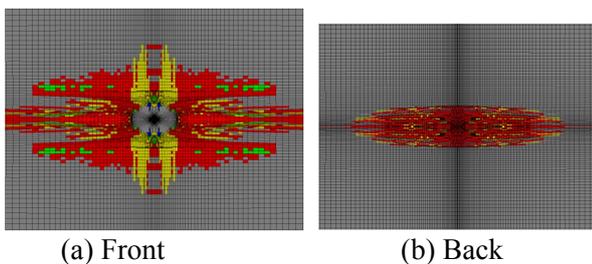
Fig.3. Simulated surface damage states of UD laminates after impact ( $v = 400$  m/s).

Figure 3 depicts the simulated matrix-damaged region on both surfaces of the UD laminate. The

damage states including a crater and splitting cracks are well reproduced in the analysis.

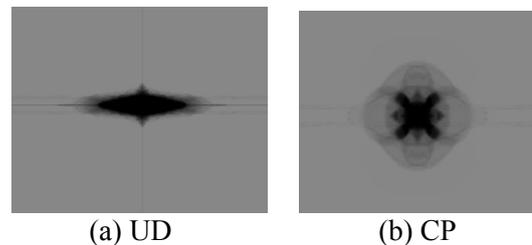
Fig.7. Simulated delamination in the UD and CP laminates after impact ( $v = 400$  m/s).

and CP laminates. The shape of the delamination is a galaxy in the UD laminate and a circle in the CP laminate. Table 5 summarizes the measured and predicted delamination area in the UD and CP laminates for two impact velocities. It is demonstrated that the delamination area is greater at a larger impact velocity, and that the delamination area is greater in the CP laminate than in the UD laminate. Comparison between the measured data and the predictions is reasonable in both laminates.

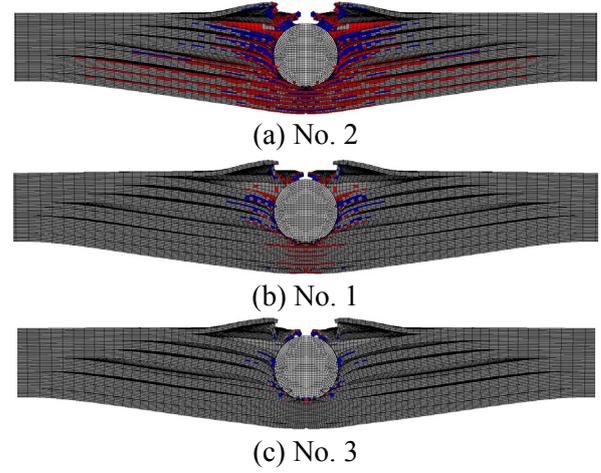
Fig. 8 Effect of  $\sigma_{1T}$  and  $\sigma_{1C}$  on failure of laminae in the CP laminates impacted at  $v = 400$  m/s.
