# DEVELOPMENT OF ROBUST REPAIR PROTOCOLS FOR COMPOSITE AIRCRAFT STRUCTURES

**Keywords:** Repairs, Bonded patch, Breathable adhesive, Wet patch, Impregnation

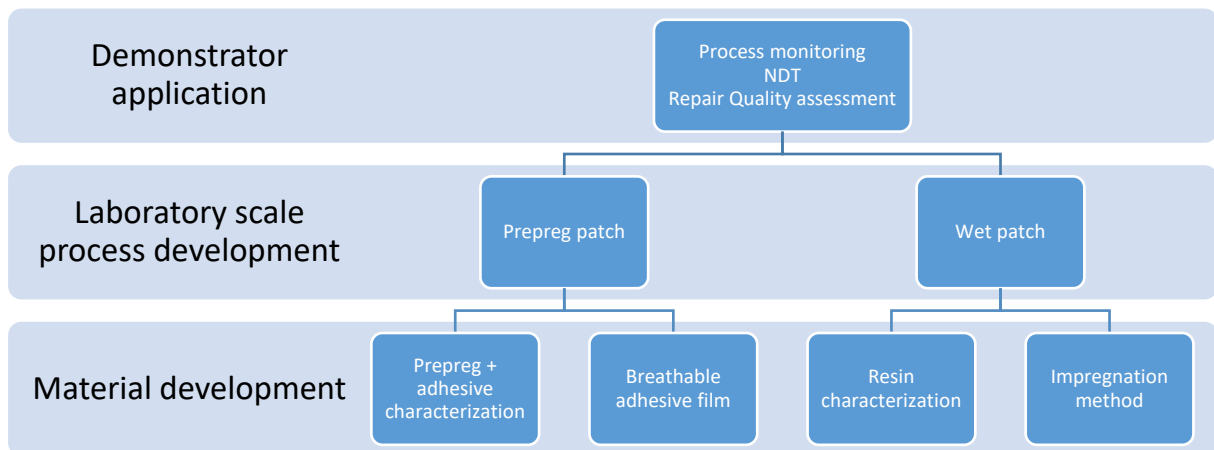
Figure 1: Task organization for the development of robust quality repair processes.

The objective of this work is to optimize both prepreg and wet patch repair processes in order to minimize voids in the bondline and maximize the patch strength recovery. Figure 1 illustrates the approach used to develop robust processing protocols for both prepreg and wet patch repairs. Material characterization involved the development of thermochemical and rheological models of the resins and adhesives used in this research. Laboratory scale controlled experiments were used to optimize a breathable adhesive film and fibre preform impregnation method for the prepreg and wet patch respectively. Finally, the repair protocols were tested on a ~14-year-old aircraft component where the repair process was monitored and the quality of the repairs was assessed by non-destructive and destructive tests.

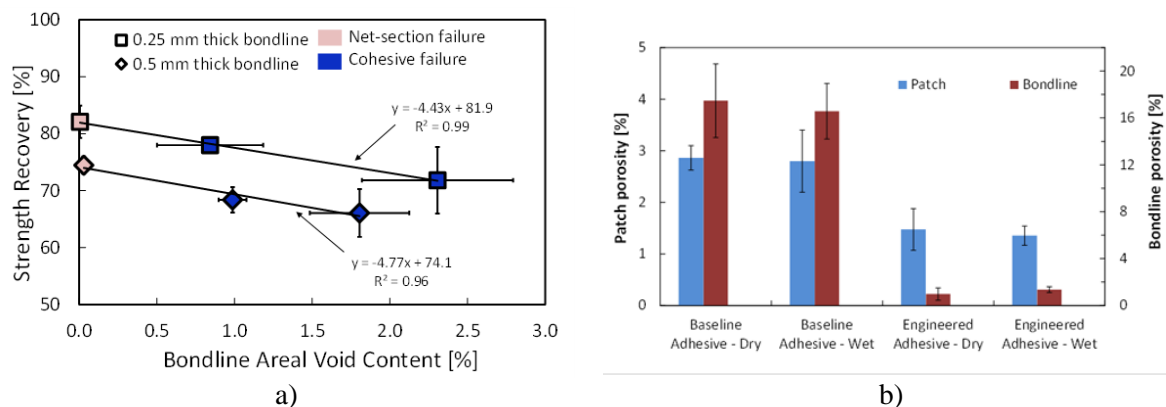
Figure 3: a) Bonded scarf repair tensile strength recovery as a function of bondline void content for two bondline thicknesses (3 ° scarf angle). Observed failure modes, either net-section or cohesive, are indicated for each repair group by the colour code. b) Average and standard deviation of measured void content in repair patch and bondline for sandwich panel cross sections.

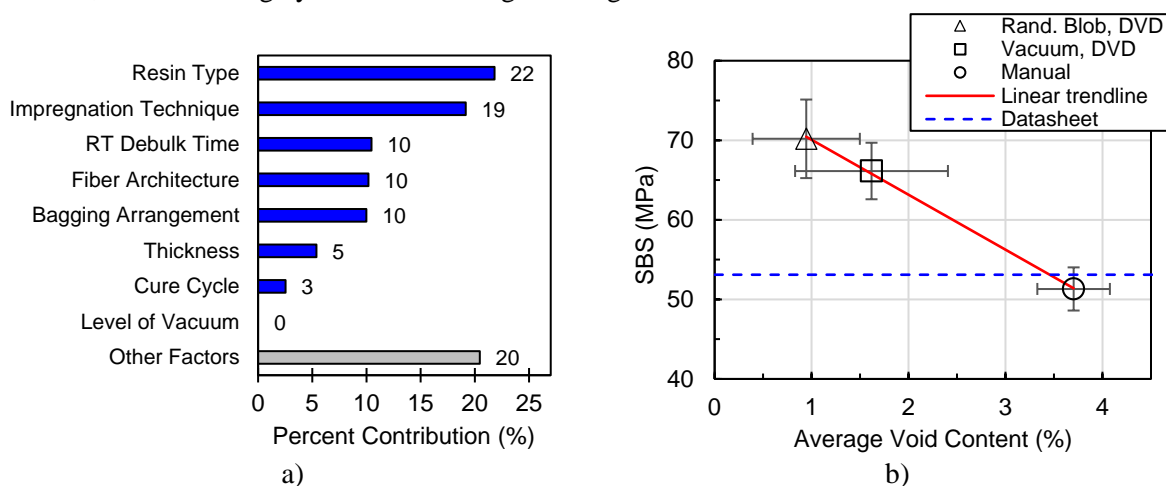
Figure 4: a) Percentage contribution of the processing parameters on the void content in the repair patch with the wet impregnation method. b) Variation of Short Beam Strength of the repair patch as a function of measured patch void content.

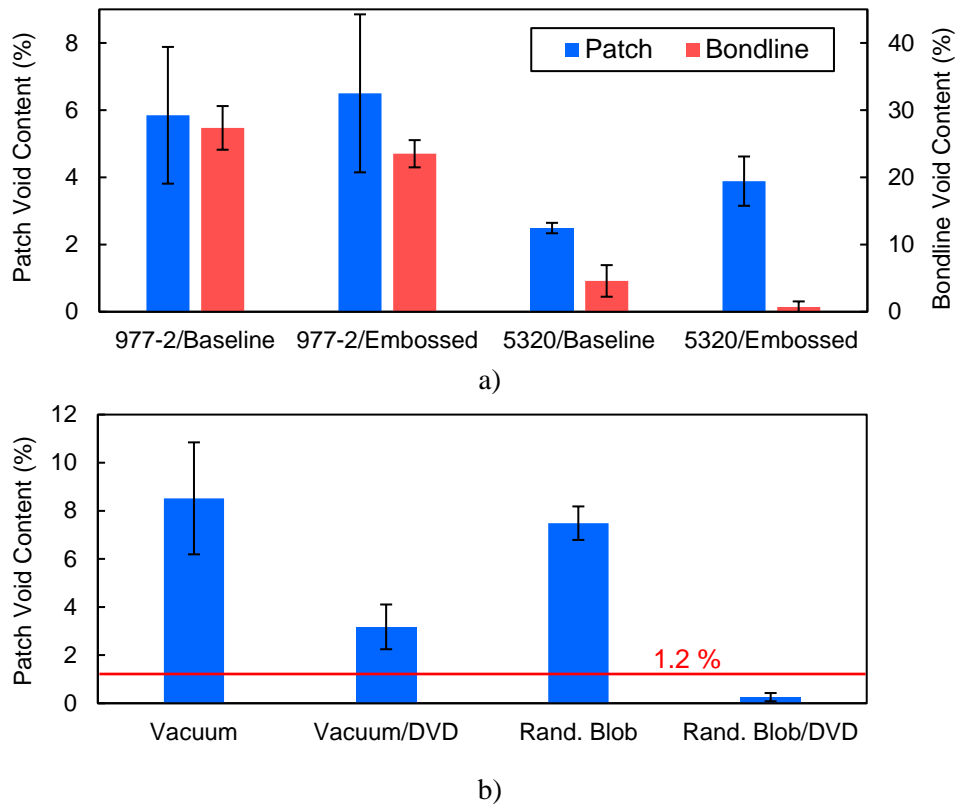
Figure 8: a) Void content in the patch and bondline for the prepreg repairs. For patch void content, error bars represent the minimum and maximum values measured, while error bars represent the standard deviation for bondline void content. b) Void content in the patch for the wet layup repairs. The DOE study from the laboratory experiments predicted 1.2% as the void content of the optimally processed patch.

The embossed/perforated film adhesive yielded no improvement in porosity with the 977-2 prepreg (Figure 8a)), likely due to the 977-2's cure cycle which led to adhesive gelation at a much higher temperature of 144 °C. Such autoclave prepreps with 177 °C cure cycles in general do not seem suitable as a repair material. They yield very high patch and bondline void contents with such VBO processes, and the 177 °C cure risks surpassing the parent structure's glass transition temperature causing warping or damage. The embossed/perforated film adhesive yielded a void free bondline with the 5320 semipreg, but was slightly detrimental to the patch void content (Figure 8a). With the 5320 semipreg, a good quality repair was achieved even without embossed adhesive: for semipregs with high crimp fibre architectures such as plain weave, the embossed adhesive may not be necessary.

For the wet layup repairs, the DVD was the most important factor, significantly reducing porosity for both vacuum and random blob impregnation (Figure 8b). While resin impregnation method was less important, the random blob method led to slightly lower porosity than vacuum impregnation both with and without DVD.
