RUNWAY DEBRIS IMPACT ON GENERIC COMPOSITE TURBOFAN BLADE MULTISCALE PROGRESSIVE FAILURE ANALYSIS

Keywords: Composite fan blade, Runway debris, Impact, Multiscale, Progressive failure analysis

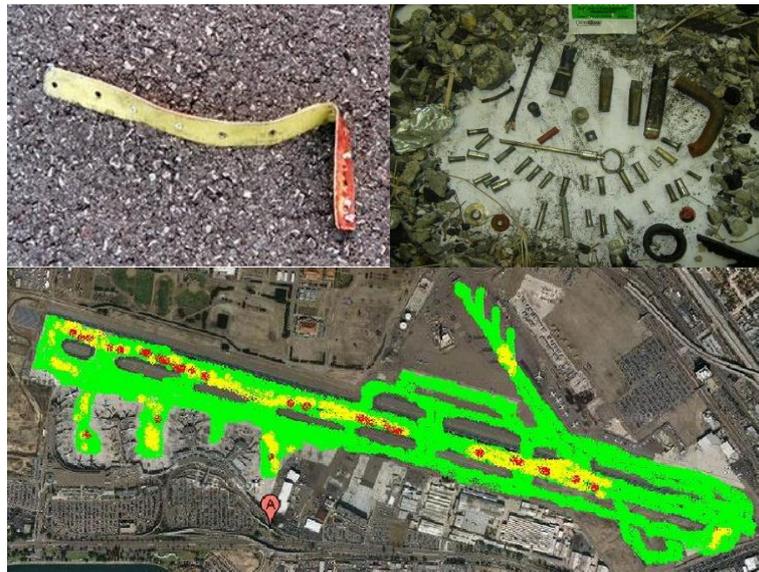
Relying on test solely to evaluate such effects is costly, time consuming, and can delay engine certification and entry into market. To mitigate risk associated with potential impact damage in-service, the authors evaluated the benefits resulting from the application of advanced multi-scale/multi-physics durability and damage tolerance approach to reduce testing and accelerate certification of composite fan blade. The analytical approach combined micromechanics with finite element analysis, damage tracking and fracture, and lamina property prediction. Figure 1 shows an example of runway debris and FOD system [2].

Figure 1 Runway debris and FOD detective system
