STRUCTURAL BEHAVIOUR AND ROBUSTNESS ASSESSMENT OF AN INFRACORE® INSIDE BRIDGE DECK SPECIMEN SUBJECTED TO STATIC AND DYNAMIC LOCAL LOADING

Keywords: Bridge deck, Robustness, InfraCore® Inside, Fatigue, Web buckling, Finite element

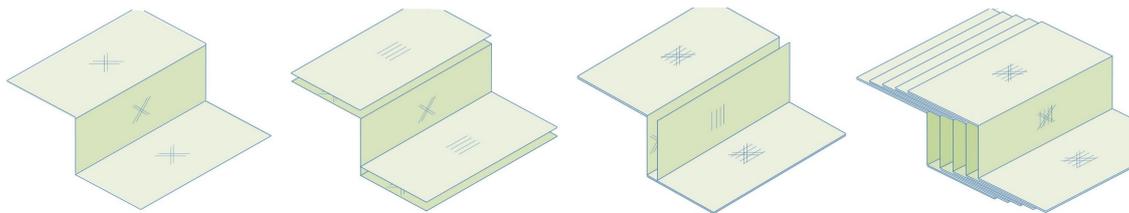
Although the fibre lay-up can be tailored according to specific situations, a typical Z-profile composition might be (See Figure 3) : one Z-shaped layer of 45/-45°(50%/50%) fabric, one additional flat UD-0°-layer in the flanges, and one additional flat UD-90°-layer in the web. This Z-shaped fabric building block is stacked with foam core elements in between creating an InfraCore® Inside sandwich panel.

Figure 3: InfraCore® Inside: fabric stacking sequence.

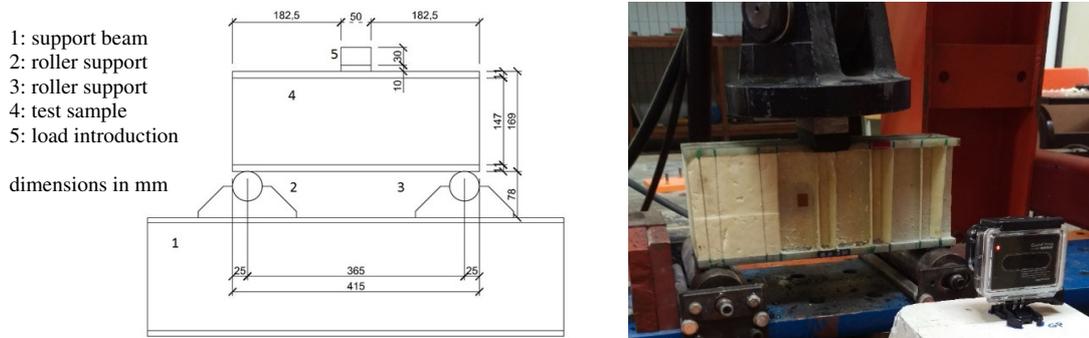
The three point bending setup (See Figure 5) consists of a rigid support beam on which two roller supports are mounted creating a 365mm span, the test specimen, a neoprene load surface of 50mm (Specimen 1) and 100mm (Specimen 2) lengthwise, and a rigid load introduction block of equal length. The dimensions of the test samples are for specimen 1: 415mm (L) x 111mm (W) x 169mm (H) and for specimen 2: 416mm (L) x 111mm (W) x 169mm (H). The load is generated by a hydraulic actuator with a maximum capacity of 250kN.

Figure 5: Test setup (for 50mm load width).

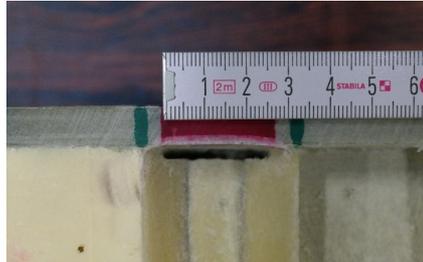
In both samples a flaw was introduced as a 25mm long longitudinal crack in a web (See Figure 6), vertically directly under the top flange, and horizontally at the location of maximum shear transfer between flange and web (i.e. between 100 and 125mm) from the supports. Specimen 1 was tested in

Figure 6: longitudinal flaw introduction in web (25mm).

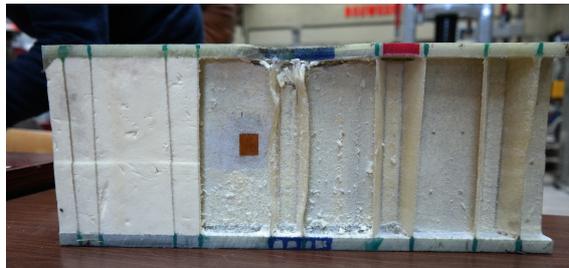
In an unfactored test situation ($\gamma_m=1$; $\gamma_c=1$), and with $k=9$ (glass – polyester) and $\sigma_{Rk} = 497$ MPa (static tensile strength) the number of cycles up to failure should exceed 165.096 cycles. Specimen 1 was subjected to 1.000.000 load cycles of 60 kN (5kN – 65kN) in the 3PBT setup described in paragraph 2. No indication of crack propagation at the flaw was found, hereby exceeding the expected number of cycles at least 6 times. Evidently, it should be noted that this comparison is based on a calculated and not experimentally verified stress, that cannot be calculated nominally. After this, the specimen was subjected to a monotonic load increase up to 90kN at which the specimen failed due to buckling of the longitudinal webs followed by interlaminar failure of the laminate in the top flange (See Figure 7). This failure corresponds to an average vertical pressure on the webs of 112,5 MPa directly under the load. It should be noted that given that the specimen was cut from a larger part, the contribution of the corrugated web stiffeners, interrupted by the saw cut (See Figure 7) is negligible. In a continuous specimen, the resistance to direct load introduction is probably higher.

Figure 7: Specimen 1 after failure.

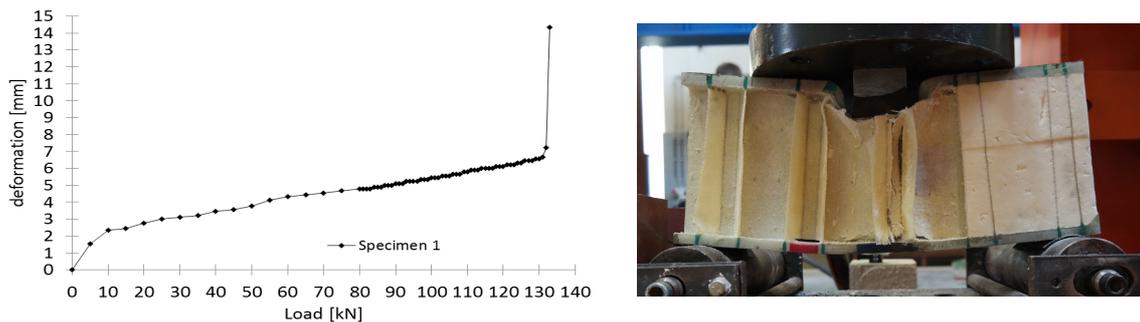
(i.e. 180° rotation around the longitudinal axis) and subjected to static testing up to failure. Figure 8 shows the vertical deformation of the test sample at midspan. Initially, the specimen shows substantial deformation increases, but these stabilize after roughly 10 kN and then monotonically increase with 0,0340 mm/kN up to failure at 133 kN, again due to buckling of the web under the load (See Figure 8), but remarkably at a much higher total load. This corresponds to an average vertical pressure on the webs of 166,25 MPa directly under the load. Apparently, the fatigue loading has indeed decreased the web buckling resistance to some extent. Nevertheless, in service conditions no actual fatigue load on a bridge is limited a surface as small as the one used in the test setup, so this phenomenon is not to be feared. The remaining stiffness of 0,0340 mm/kN corresponds very well to the initial stiffness of the specimen, not measured during the fatigue test on this specimen but found from previous static testing on similar specimens with equal laminate specifications.

Figure 8: Vertical deformation (midspan) of failed specimen top down in 3PBT / failure mode.

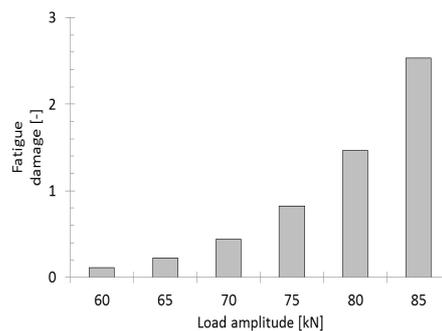
A second series of tests was conducted on specimen 2. In this series, and based on the failure phenomenon from specimen 1, the load width (in the span direction) is doubled to 100mm to reduce the risk of premature failure due to web buckling. Based on finite element analysis (See paragraph 4) a maximum shear induced principal tensile stress at the flaw edge was found of 2,33 MPa per kN. For a 60 kN load this amounts to 139,8 MPa. By application of Eq. 1, the number of cycles up to failure should exceed 90707 cycles. However, given the significant underestimation of the expected number of cycles of specimen 1, it was chosen to increase the load in steps of 5 kN after each batch of 10.000 cycles (i.e. 5-65 kN / 5-70 kN / etc). When applying a Miner's rule approach of cumulative damage, the damage level of each consecutive batch is almost double that of the previous one (See Figure 9).

Figure 9: Fatigue damage per batch of 10.000 cycles (Specimen 2).

Specimen 2 was subjected to 10.000 load cycles of 60/65/70/75/80/85 kN in the 3PBT setup described in paragraph 2, totalling 60.000 cycles and a cumulative damage of 5,6 (based on calculated stresses), far exceeding the expected number of cycles. Again, no indication of crack propagation at the flaw was found. After this, the subject was subjected to a 90 kN cycle (5-95 kN) for which the specimen failed after only 1.395 cycles, again due to buckling of the longitudinal webs followed by failure of the laminate in the top flange (See Figure 10). This failure corresponds to an average vertical pressure on the webs of 59,37 MPa directly under the load. This value is considerably smaller than in

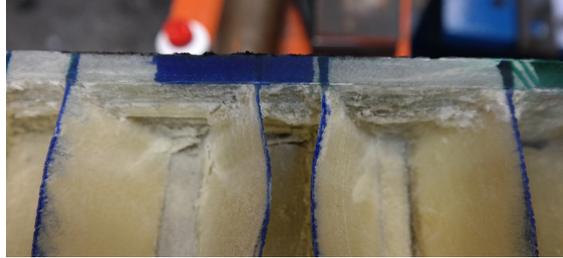
specimen 1, but in fact the failure phenomenon was observed to be asymmetric, with essentially one web failing. This can be attributed to a transversely slightly asymmetric location of the webs in the test specimen. It should again be noted that as the specimen was cut from a larger part, the contribution of the corrugated web stiffeners, interrupted by the saw cut (See Figure 10) is negligible. Due to both reasons, the resistance to direct load introduction is certainly higher in a continuous specimen.

Figure 10: Specimen 2 after failure (detail).

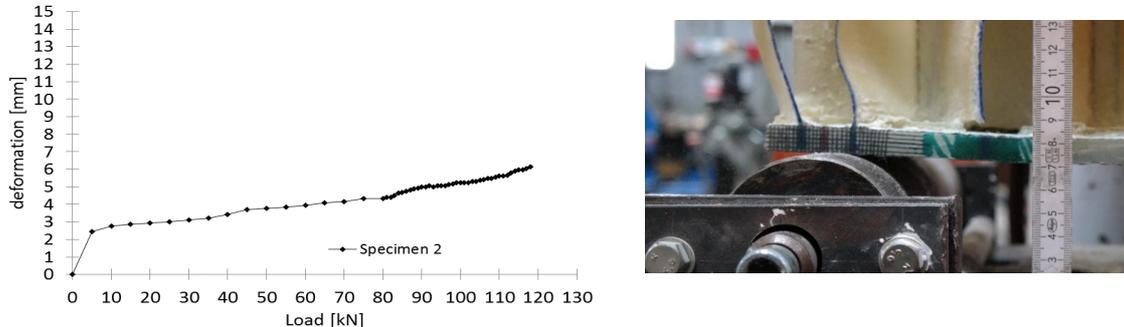
After completion of the test, it was again noted that although the specimen failed, it did not collapse, and maintained integrity. To assess how much integrity was left, the specimen was rotated top to bottom (i.e. 180° rotation around the longitudinal axis) and subjected to static testing up to failure. Figure 11 shows the vertical deformation of the test sample at midspan. Initially, the specimen shows substantial deformation increases, but these stabilize after roughly 10 kN and then monotonically increase with 0,0308 mm/kN up to failure at 118 kN. In this case failure initiated at the left support initiating delamination in the webs. The fact that the web did not fail at midspan again indicates that the fatigue loading has probably also here decreased the web buckling resistance to some extent. In service conditions this phenomenon is not to be feared. The remaining stiffness of 0,0308 mm/kN is slightly smaller compared to the value of Specimen 1 corresponding to the wider load area..

Figure 11: Vertical deformation (midspan) of failed specimen top down in 3PBT / failure mode.

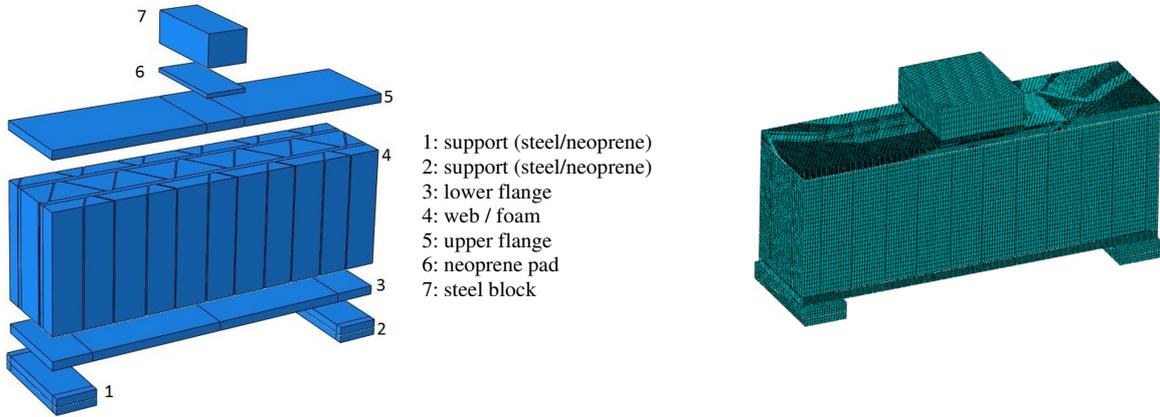
In order to assess the values for the load amplitude level in the static and fatigue tests of paragraph 2, a numerical model was generated with the finite element software Abaqus [8]. Figure 12 displays the numerical model. A combination of linear hexahedral elements (C3D8) and linear wedge elements (C3D6) are used, totaling 670.057 elements. For the stress assessment at the flaw, the number of elements is locally increased totaling 4.492.712 for the most detailed model. Linear elastic material properties are attributed in line with Table 1, and a load of 1 kN is applied to the steel loading surface. In Figure 13 the vertical deflection are visualized for both specimens proving good accordance with the vertical deflection values in the robustness tests mentioned in paragraph 3. Figure 14 shows the main stress components (CSYS : global) per kN applied load in the test specimen. General longitudinal bending, local transverse bending and vertical stresses in the webs are clearly visible. Finally, Figure 15 shows the shear induced longitudinal stresses on the bottom side of the top flange, calculated for specimen 2 in the most detailed model as 2,33 MPa per kN (See paragraph 3). Although the model is already quite elaborate, it could be further improved as it does not include geometric non-

Figure 12: Numerical model (50mm load (left) – 100mm load (right)).

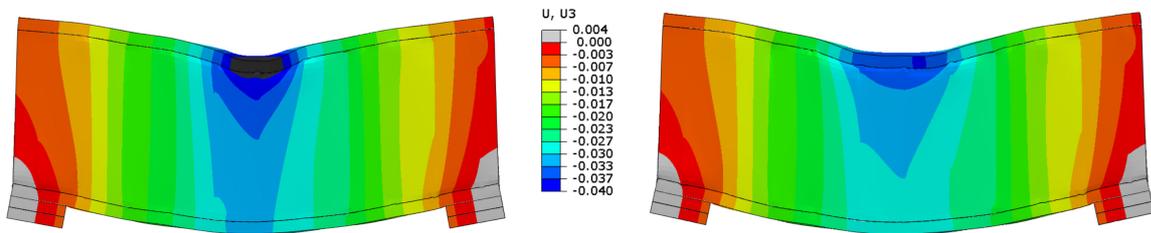
Figure 13: Vertical deflections per kN [mm] (50mm load (left) – 100mm load (right)).

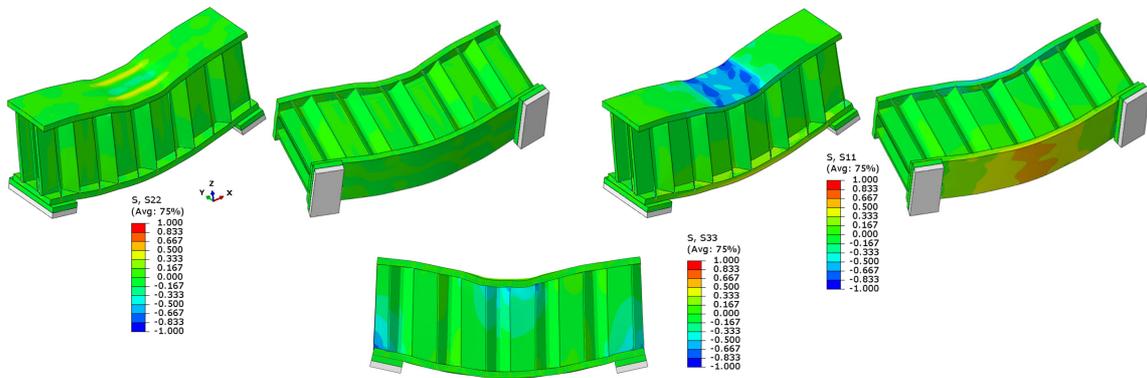
Figure 14: Stresses per kN [MPa] for specimen 2 model (CSYS : Global)

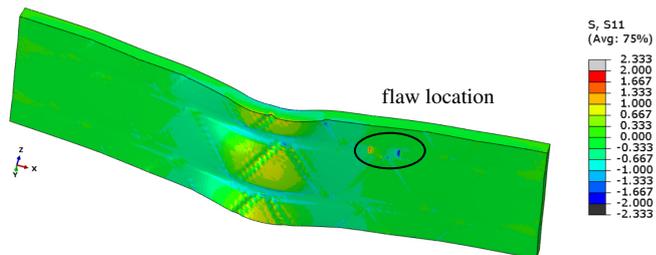
Figure 15: Stresses per kN [MPa] for specimen 2 model (lower side of top flange) (CSYS : Global)
