# THE EFFECTS OF PRE-BOND MOISTURE AND ENVIRONMENTAL AGING ON THE FRACTURE TOUGHNESS OF BONDED COMPOSITE REPAIRS

**Keywords:** Bonded Joints, Composite Repairs, Adhesives, Pre-bond Moisture, Fracture Toughness

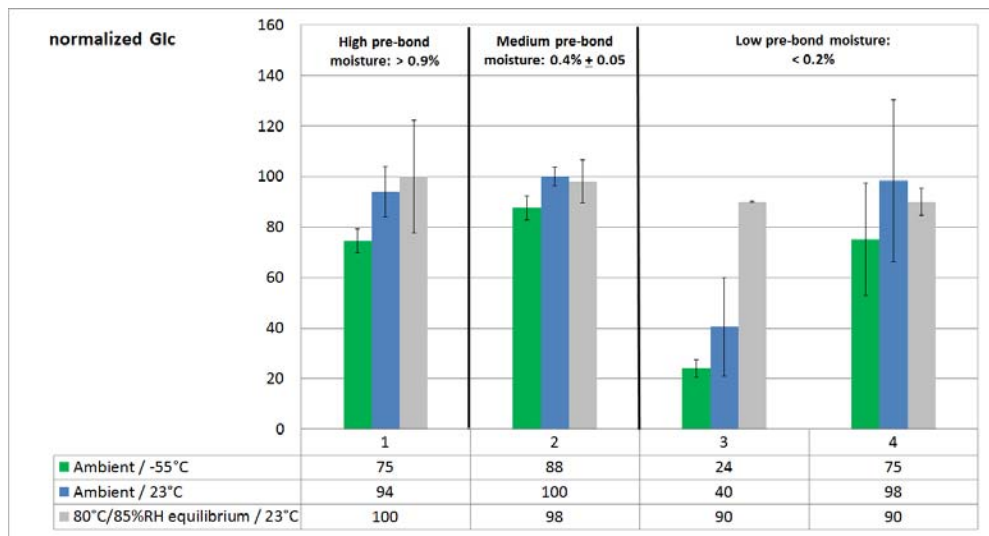
Figure 2: Fracture toughness of co-bonded specimens prepared with high, medium and low pre-bond moisture.

A representative set of results of Mode I fracture toughness determined in co-bonded specimens with high ( $> 0.9\%$ ), medium ( $0.4\% \pm 0.05$ ) and low ( $< 0.2\%$ ) pre-bond moisture content is shown in Fig. 2 for three test conditions, room temperature/ambient,  $-55^{\circ}\text{C}$ /ambient and room temperature/wet.

Values are presented normalized to the highest average value. The presence of high or medium pre-bond moisture produced high G<sub>Ic</sub> values at all tested conditions. With low pre-bond moisture two types of responses were found in the specimens stored at ambient conditions prior to test (room temperature/ambient and -55°C/ambient) depending on the procedure followed to reach the low moisture content in the pre-cured adherent prior to bond. When the pre-cured panel was submitted to several long drying/conditioning/drying cycles up to low moisture content, the G<sub>Ic</sub> values of the co-bonded specimens were low (specimens labelled 3 in Fig. 2), while if the pre-cured panel was only dried (specimens labelled 4 in Fig. 2), the G<sub>Ic</sub> values were high. But in both cases, when the co-bonded specimens were tested at room temperature after being saturated with moisture in a climatic chamber the difference did not appear anymore and both types had a high G<sub>Ic</sub> value. The path followed to reach high or medium pre-bond moisture in the pre-cured panels did not show any influence in the G<sub>Ic</sub> values.

Neither can the adhesive be seen in the specimen with low pre-bond moisture (specimen (b) in Fig. 3). But in this case, the fluorescence microscopy revealed that the adhesive had kept well bonded to the co-bonded adherent (the repair prepreg) and had pulled out the pre-cured substrate. This type of failure was the one regularly found in the sets which pre-cured substrate had been submitted prior to bond to long drying/conditioning/drying cycles (specimens labelled 3 in Fig. 2). In some specimens of this type adhesion failure was also found.

If the pre-cured substrate had been only dried shortly up to low moisture content prior to bond the co-bonded specimens (labelled as 4, in Fig. 2) tested at ambient conditions presented a mix of failure modes. In Fig. 4 (a), the initiation and propagation zones of two specimens of this type, tested at room temperature/ambient, are shown: there is a mix of failure in the co-bonded adherent and failure in the pre-cured substrate as well as small zones with cohesive failure. The presence of failure in the co-bonded adherent contributed to increase the fracture toughness as the crack grew, as indicated above, in the lamina with fibre bridging. The presence of some spots with cohesive failure also contributed to increase the GIc value: the normalized GIc values were 81 and 98.

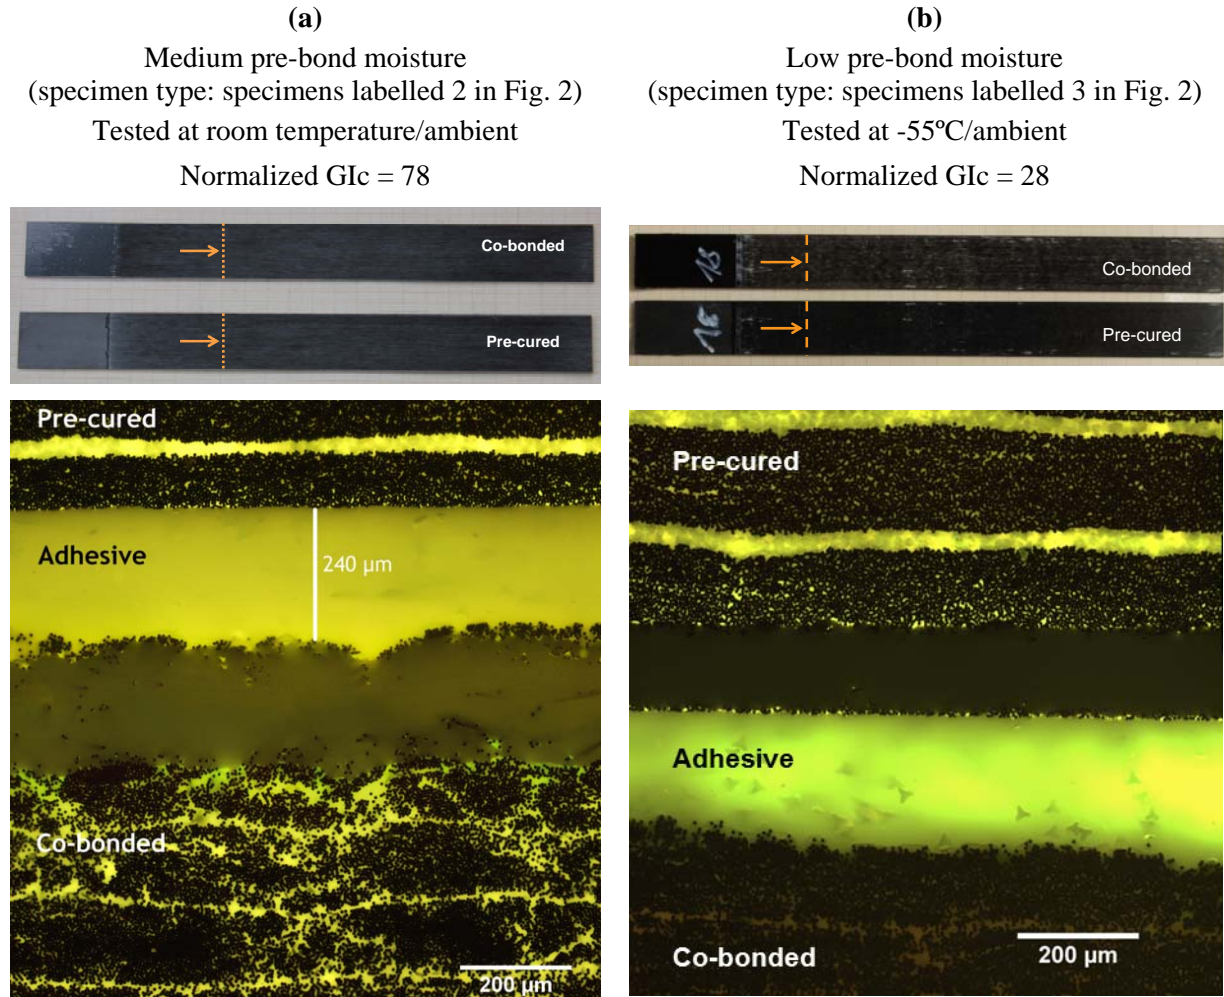
Figure 3: Fractured surfaces and optical micrographs of the transverse cross sections of tested co-bonded specimens with (a) medium pre-bond moisture tested at room temperature/ambient and (b) low pre-bond moisture, tested at -55°C/ambient

The failure surfaces of the specimens were inspected visually and recorded by macrophotography. In Fig. 3, the starter crack formed by the Teflon insert was at the left hand end of the specimens, with the crack growth running from left to right. The adherents (the pre-cured substrate and the co-bonded repair prepreg) are identified in the Figure. Two specimens are shown: (a) with medium pre-bond moisture and (b) with low pre-bond moisture, tested at ambient conditions (room temperature/ambient and -55°C/ambient, respectively) and with normalized G<sub>Ic</sub> values of 78 and 28, respectively. The specimen with medium pre-bond moisture is representative of the specimens labelled 1 in Fig. 2. The specimen with low pre-bond moisture is representative of the specimens labelled 3 in Fig. 2. It is from one set of six specimens which pre-cured substrate had been submitted to long drying/conditioning/drying cycles up to low moisture content.

In the fractured surfaces of the specimen with medium pre-bond moisture (specimen (a) in Fig. 3) the adhesive cannot be seen but only the carbon composite surfaces. The inspection by fluorescence microscopy of the fracture surfaces in sections transversal to the crack propagation (see Fig. 3) revealed that the adhesive had kept well bonded to the pre-cured substrate and had pulled out the co-bonded adherent. Actually, the crack grew in the co-bonded adherent (the repair prepreg) through the lamina with a considerable amount of fibre bridging. The same type of failure was consistently found in the remaining specimens of this set and also in all sets with high/medium pre-bond moisture.

the same types of those seen for the specimens tested at ambient conditions (see Fig. 3 (a)): the adhesive remained bonded to the pre-cured substrate and pulled out the co-bonded adherent (the repair prepreg).
