## A RESEARCH ON THE VALIDITY OF COMPOSITE PENEL REPAIRED WITH THE PRESSURIZER

**Keywords:** Composite repair, Out-of-autoclave, Scarf repair

### ABSTRACT

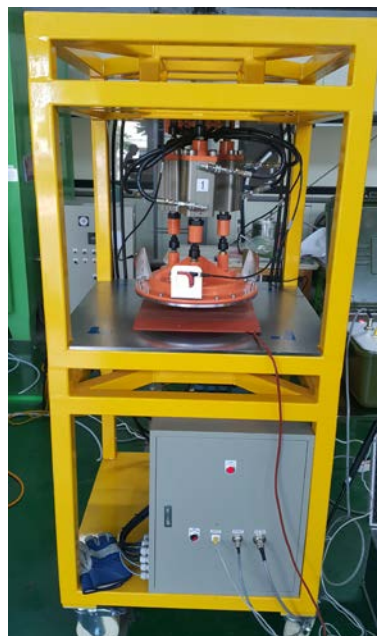
Figure 1: The front view of pressurizer.

As the applications of composite structures are increasing, the importance of their repairs has been highlighted. Scarf-patch repair is a widely used method for composite structures. For the field repair where autoclave is not available, heat blanket is often used for curing. The problem of using the heat blanket is that it cannot apply enough pressure for the adhesive curing. It may result into the degradation of bonding strength. In this paper, however, it has used a pressurizer designed to be suitable for the field repair with heat blanket. Eventually, additional curing pressure is given during scarf-patch repair. As a result, the scarf-patch repair may have better performance than when only the vacuum was used. The improvement of repair method and the excellence of pressurizer have been demonstrated through the test of mechanical properties. The mechanical tests included static tension at RTD and ETW and a repeated load under the different conditions. A vacuum-only condition means the traditional field repair method where there was no additional curing pressure during patch repair. The pressured condition has additional curing pressure by pressurizer.
