CREATING KISS-BONDS FOR NON-DESTRUCTIVE INSPECTION

Robert Telford¹, Anthony O'Carroll¹ and Trevor M. Young¹

¹ Irish Composites Centre, Bernal Institute, University of Limerick, Ireland

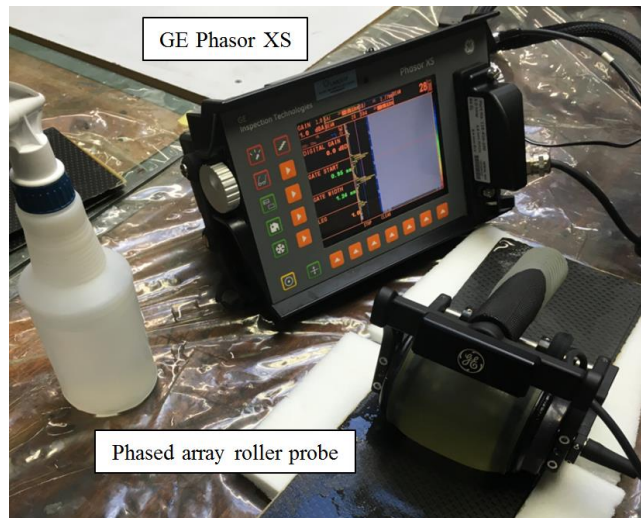
Figure 3: GE Phasor XS with a phased-array roller probe

Ultrasonic evaluation was conducted using a GE Phasor XS system with a phased-array roller probe, pictured in Figure 3. A combination of A-, B-, and C-scan were used to detect and characterise the defects. Using water as a couplant, all defects were readily detected using ultrasonics.

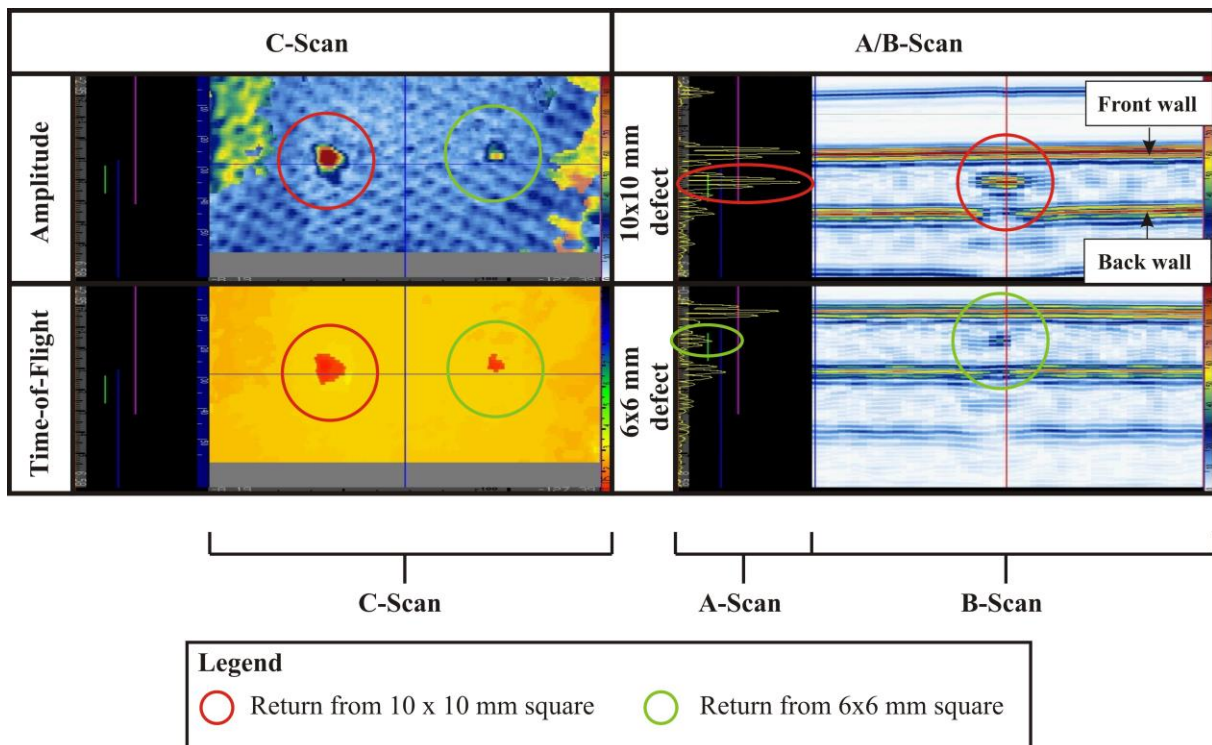
Figure 4: Typical ultrasonic result (example given from panel 1)

The system was first calibrated on a panel which did not contain any defects. The interference, amplitude, and time-of-flight gates were then set appropriately. These are indicated as the purple, green and blue vertical lines respectively in the A-Scan in Figure 4. The amplitude gate was set so that it would be triggered by any defect within the panel, while remaining uninfluenced by the front and

It can be seen in the ultrasonics result of panel 1 (shown in Figure 4) that both defects were detectable by C-Scan (both amplitude and time-of-flight). The A-/B-scan of the 10 x 10 mm square shows that the defect breaks the back wall completely, indicating that in this instance a dis-bond was created. On the other hand, a kiss-bond is detected by monitoring the back wall echo and amplitude gates of the 6 x 6 mm defect; a clear distinction can be made between this defect and that of the 10 x 10 mm defect. Use of time of flight data can be used in support of this.

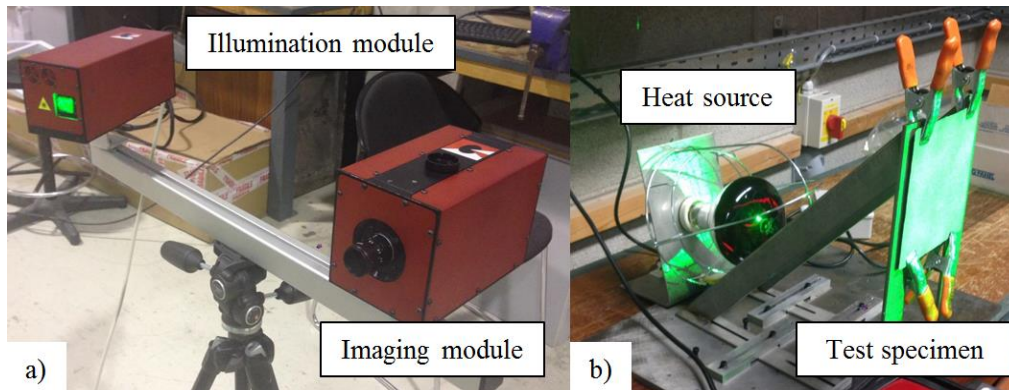
Figure 6: a) Laser Optical Engineering Laser Shearography Illumination and Imaging modules. b) Test specimen clamped into position and the location of the heat source

Laser shearography was also used to detect and analyse the defects. A Defect Dect system manufactured by Laser Optical Engineering Ltd. was used. Shown in Figure 6(a), this system consists of an illumination module (DDIM-150) and an imaging module (DDSM-15). The illumination module contains a class 2M laser with a wavelength of 532 nm. The imaging module contains a CCD camera with image resolution of 1280x1024 and a frame rate of 25 fps.

The specimen was rigidly clamped to right-angle sections which in turn were fastened to a 15 mm thick steel tool plate, as shown in Figure 6(b). Such a heavy-duty set-up reduces rigid-body-motion of the specimen, which in turn allows for an increase in sensitivity of the shearography system (crucial for the low surface strains expected from kiss-bonds).
