# FUNDAMENTAL RESEARCH ON REPAIR OF CARBON FIBER REINFORCED THERMOPLASTICS

M. Tamaru<sup>1\*</sup>, T. Kin<sup>1</sup>, I. Ohsawa<sup>1</sup>, T. Matsuo<sup>1</sup>, J. Takahashi<sup>1</sup> and K. Uzawa<sup>1</sup>

<sup>1</sup> Department of Systems Innovation, The University of Tokyo, Tokyo, Japan

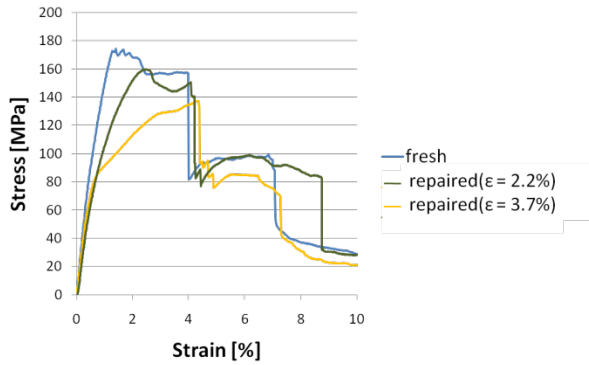
Fig.9 SS curve of fresh and repaired (without patch) CF/PP.

The repaired specimens are loaded till their maximum stresses, which are 2.0% of strain for CF/EP specimen, 2.2% and 3.7% of strain for two CF/PP specimens without patch respectively. Figs.8, 9 and 10 show each stress-strain behavior and Tables 1, 2 and 3 show mechanical properties of each.

In the case of CF/PP repaired only by heat press (Fig.9), initial stiffness is recovered as well as energy absorption ability.

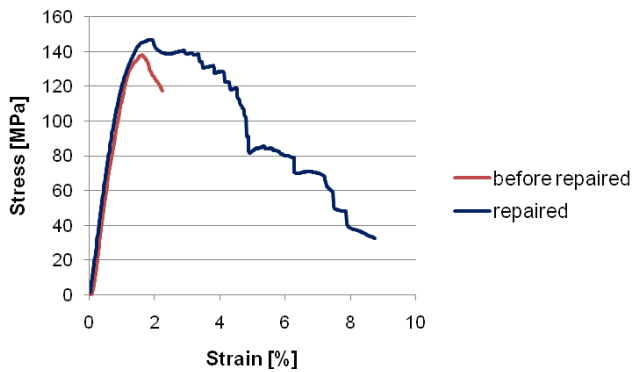
Fig.10 SS curve of original and repaired (patched) CF/PP.

In the case of CF/PP repaired by heat press with patch (Fig.10), mechanical properties are perfectly recovered, and the strength is rather higher than fresh material. It is of course by the contribution of increased  $V_f$ , but the more important technical merit is an excellent matting and adhesion between matrix material and reinforcing material. It must become an advantage of CF/PP in practical application.

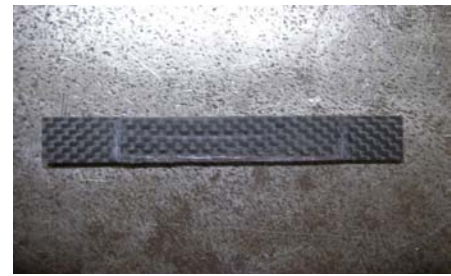
Fig.11 Repaired CF/EP with patch.

Moreover, the appearance of repaired CF/PP is almost as same as fresh material comparing to CF/EP (Figs.11 and 12).

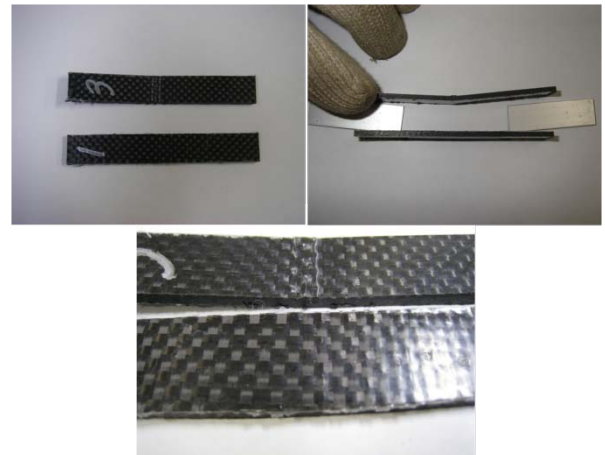
Fig.12 Comparison between the fracture material and the repaired material in case of CF/PP. (Left: overall view, Right: side, Center: closeup of fracture part)
